AIR TRANSPORTATION SAFETY INVESTIGATION REPORT A21Q0052

COLLISION WITH A LAWN TRACTOR

Privately registered
Nanchang CJ6A, C-GYAC
St-Esprit Aerodrome, Quebec
05 July 2021

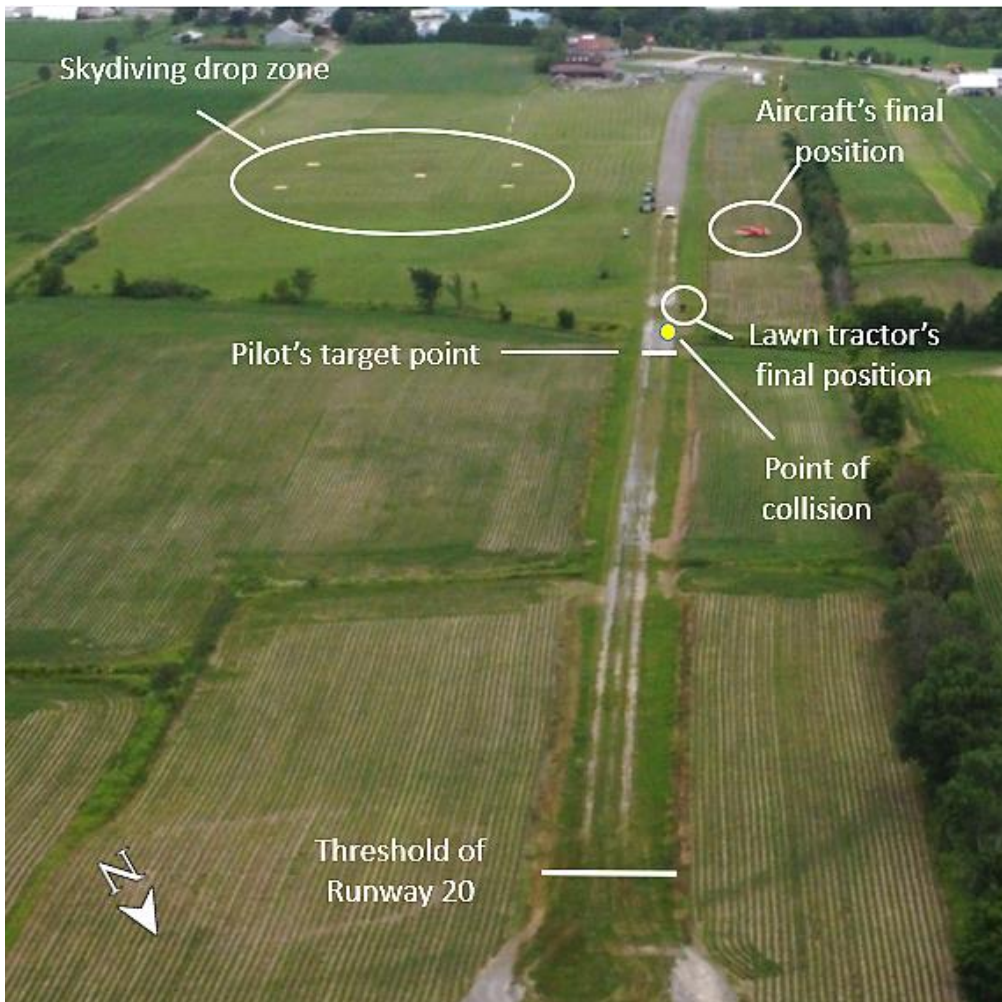
After the Twin Otter had landed, the pilot of the Nanchang, who did not see any traffic in the circuit or on the ground, joined the left base leg of the circuit at an altitude of approximately 500 feet above ground level (AGL) before turning onto final at approximately 300 feet AGL. Because the surface of the grass strip runway was in poor condition at the threshold and beyond, the pilot chose a target point approximately 800 feet beyond the threshold and began to flare approximately 300 feet before the target point (Figure 1). At about the same time, a lawn tractor that was performing maintenance work at the aerodrome crossed Runway 20 near the pilot's intended target point and began a turn to the left to cut the grass parallel to the runway.

Figure 1. Aerial photograph of the St-Esprit Aerodrome showing the threshold of Runway 20, the skydiving drop zone, the target point, the point of collision, and the final positions of the aircraft and the tractor (Source: TSB)

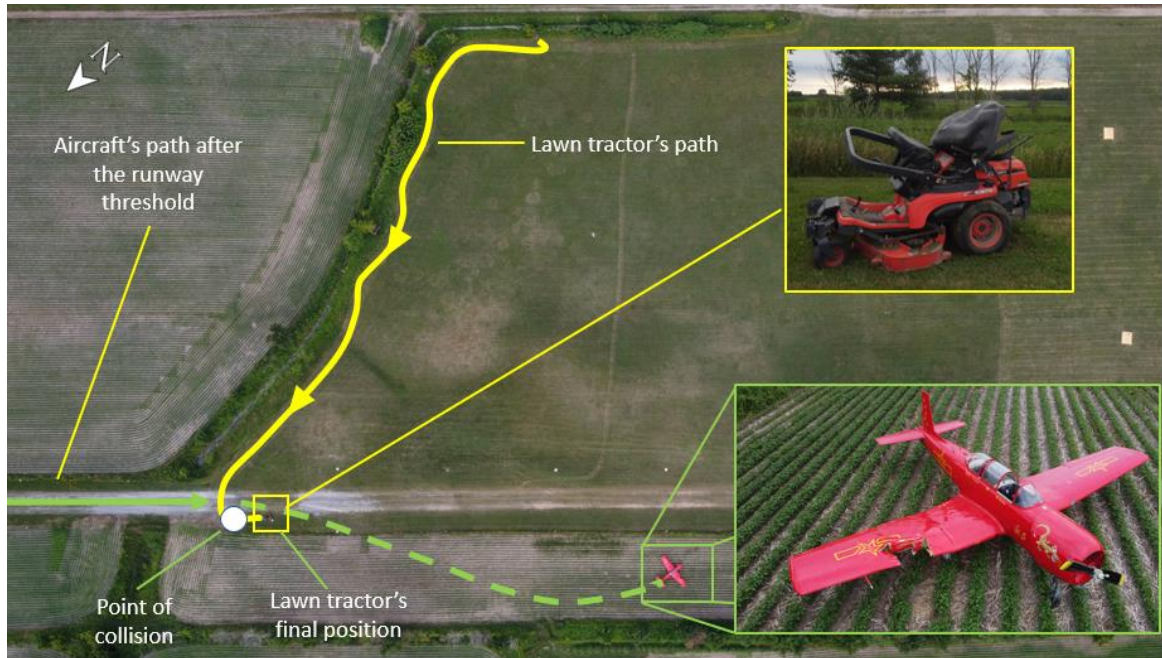
Seeing damage to the right wing, the pilot realized that he had struck something. He exited the aircraft and saw the lawn tractor to the right of the runway not very far from the touchdown point. The aircraft had struck the tractor, and the driver was fatally injured. The pilot was not injured. There was major damage to the aircraft's right wing (Figure 2).

Figure 2. Aerial photograph of the point of collision at the St-Esprit Aerodrome, showing the tractor's path and the aircraft's path, and the extent of the damage in the close-ups (Source: TSB)
