AIR TRANSPORTATION SAFETY INVESTIGATION REPORT A22W0005

LOSS OF CONTROL AND COLLISION WITH TERRAIN

Delta Helicopters Ltd.
Bell 206B JetRanger II (helicopter), C-FCQJ
Camrose Aerodrome, Alberta, 23 NM ESE
23 January 2022

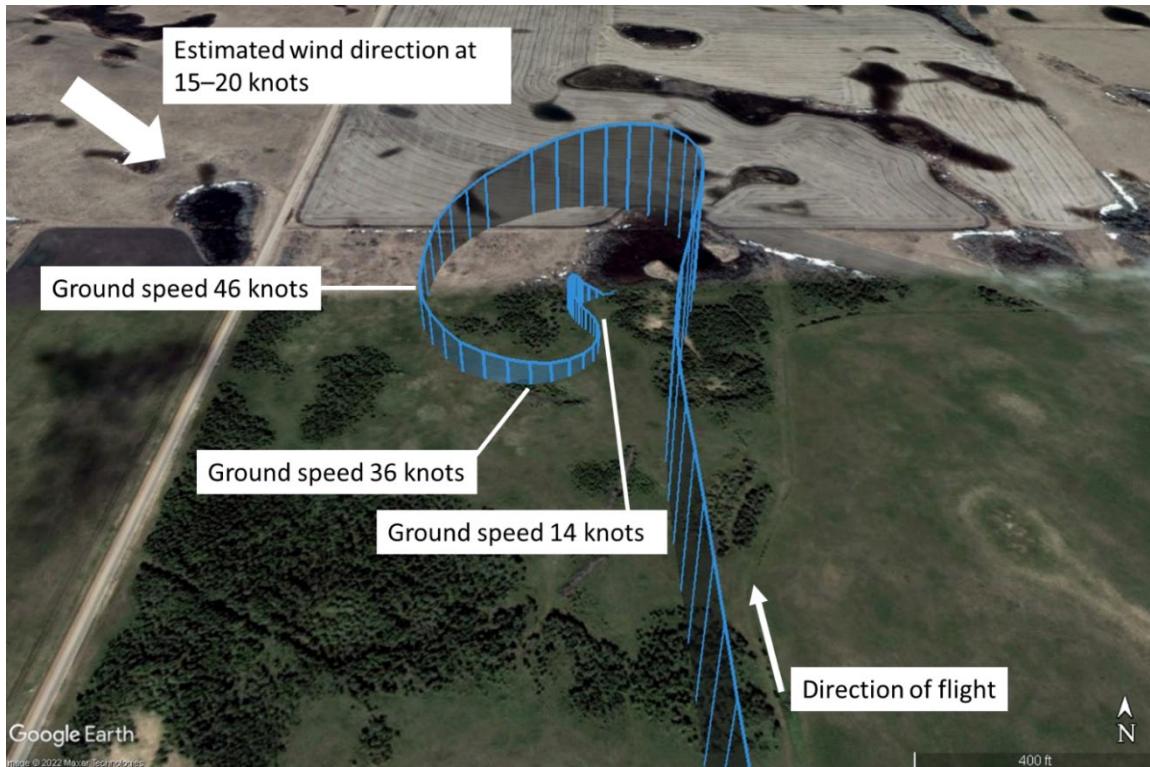
Figure 1. Helicopter flight path (Source: Google Earth, with TSB annotations)

toward the next survey line, which was flown in a northbound direction and commenced at 0922. During the course of the northbound survey, several low-altitude, slow-speed flight manoeuvres were performed so that the observers could survey the wildlife they had spotted. At approximately 0946, the observers spotted several animals in some scrub bush, and the pilot performed a descending, decelerating 360° left turn to allow the observers to count and classify the animals. After completing the left turn, the helicopter was on a track of 330° magnetic (M) at an altitude of approximately 2400 feet ASL (80 feet AGL) and at a ground speed of approximately 9 knots. At this time, the helicopter entered an uncommanded rotation to the right (Figure 1).

The pilot attempted to regain directional control; however, during the attempt, the helicopter descended and impacted terrain with little-to-no forward speed. The helicopter came to a rest in scrub bush in an upright position and largely intact. The landing skids were significantly spread apart due to the impact forces, and the rear landing skid cross tube was pushed up into the fuselage and ruptured the fuel cell. All occupants were seriously injured by the impact forces and were contaminated with jet fuel.

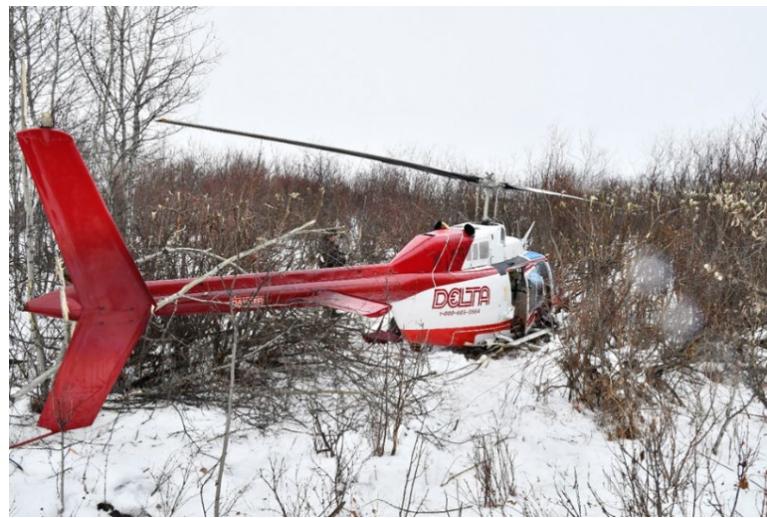
Figure 2. Accident site (Source: TSB)

Examination of the helicopter at the accident site indicated that the tail rotor blades were significantly damaged, and the steel tail rotor drive shaft located under the engine, between the engine reduction gearbox and the oil cooler blower assembly, was sheared in torsional overload. TSB investigators confirmed drive shaft continuity forward and aft of the failed driveshaft. Flight control continuity was also confirmed for all 4 axes. There were no signs of a pre-existing mechanical problem with the helicopter before the impact with terrain.

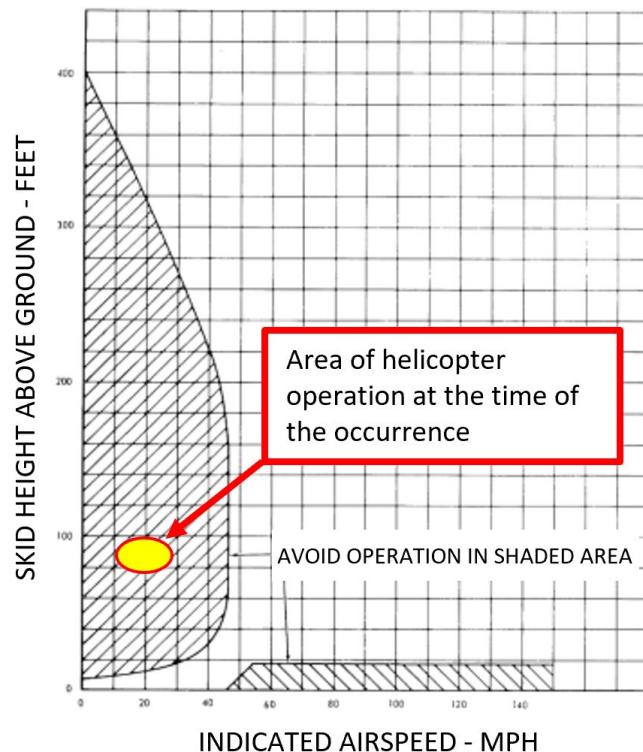
Figure 3. Height-velocity diagram, showing area of helicopter operation at the time of the occurrence (Source: Bell Textron Inc., Bell Model 206B Rotorcraft Flight Manual, with TSB annotations)

The Bell 206B rotorcraft flight manual³ includes a height-velocity diagram (Figure 3), which provides information and guidance to pilots on the safe operation of the helicopter. The height-velocity diagram defines the conditions from which a safe landing can be made following an engine failure in flight (emergency). A notation on the diagram encourages pilots to avoid operation in the shaded area.

An unanticipated yaw can pose a significant threat during flight at low speeds and in high power regimes, and when a helicopter is operated within critical wind azimuth regions. At the time of the occurrence, the helicopter was approximately 280 pounds below the maximum gross weight, and in an out-of-ground-effect hover (at 80 feet AGL). Winds were gusty and turbulent, and were coming from the left of the helicopter as the turn was being completed. Given the helicopter's final track of 343°T (330°M), and the wind encountered likely coming from the general direction of 300°T (287°M), the relative wind was approximately 45° to the left of the helicopter's nose (315° in Figure 5) and was somewhat lower than the 25 knots experienced at cruise altitude. As a result, the helicopter was operating in a high-power regime, within the critical wind azimuth regions of the main rotor disc vortex interference, and tail rotor vortex ring state.

Pilots are reminded that flying an aircraft at low altitude leaves little margin for error and decreases the time and altitude available to effectively manage any unanticipated aircraft state.

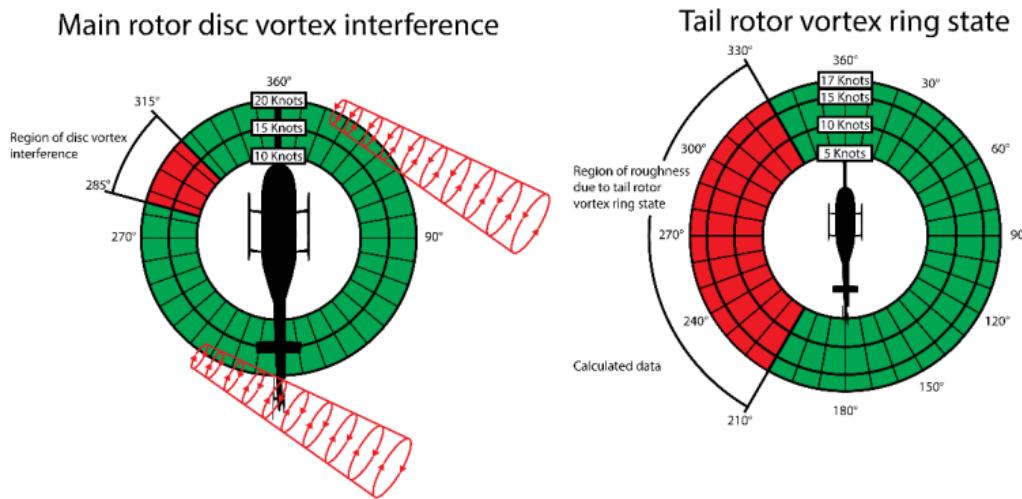
Figure 5. Main rotor disc vortex interference and tail rotor vortex ring state angle based on relative wind direction and speed (Source: TSB, based on figures included in Federal Aviation Administration, Advisory Circular 90-95: Unanticipated Right Yaw in Helicopters [1995])

Four relative wind⁵ azimuth regions can produce an environment that is conducive to LTE (Figure 5):

- main rotor disc vortex wind (winds from 285° to 315° relative to the helicopter);
- weathercock stability (winds from 120° to 240°);
- tail rotor vortex ring (winds from 210° to 330°); or
- loss of translational lift (winds from all directions).⁶

Certain helicopter operations, such as slow-speed wildlife survey flights, lend themselves to being more at risk of LTE than other operations. In addition to understanding the LTE characteristics of their specific helicopter type, pilots need to pay close attention to airspeed, height and relative wind to ensure that LTE conditions are either avoided, or recognized and responded to immediately.
