**MARINE INVESTIGATION REPORT**  
**M05C0033**

**COLLISION**

**BETWEEN THE TANKER *JO SPIRIT***  
**AND THE BULK CARRIER *ORLA***  
**SOUTH SHORE CANAL, ST. LAWRENCE SEAWAY, QUEBEC**  
**19 JULY 2005**

Report Number M05C0033

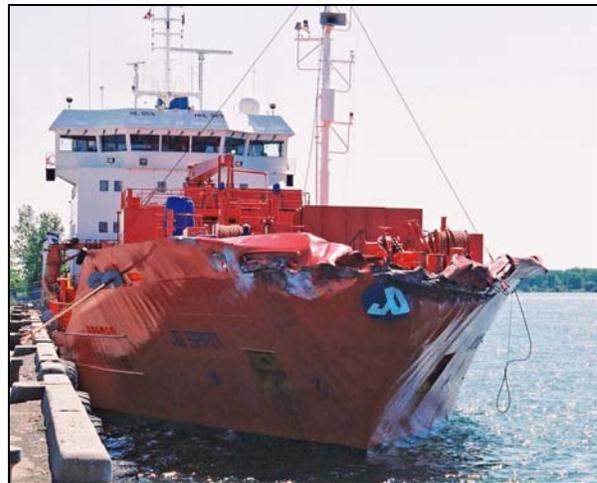
The side shell plating of the *Jo Spirit* in way of the forecastle was set in and gashed.

Photo 3. Bow damage on *Jo Spirit*

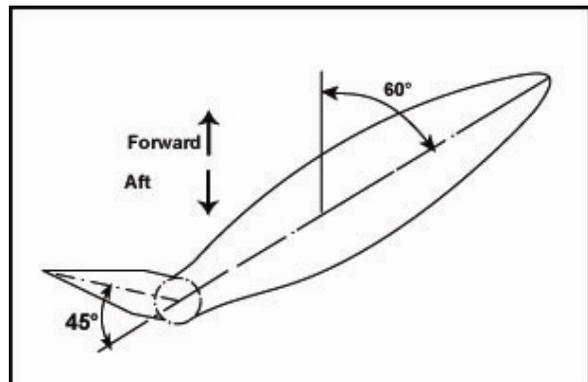
The *Jo Spirit* is equipped with a Becker rudder. When such a rudder is turned to any given angle up to a maximum of  $60^\circ$ , an articulated flap also moves in relation to the plane of the main blade up to an additional  $45^\circ$ . The ratio of flap angle to main rudder angle is variable, being greatest at small rudder angles and then diminishing. A  $5^\circ$  main rudder application, for example, will produce almost  $12^\circ$  of flap angle, while a  $45^\circ$  main rudder application will result in  $45^\circ$  of flap angle. This type of rudder has the effect of increasing the lift coefficient dramatically, and the resulting side force is almost 80 per cent greater than conventional rudders. Maximum side force of the Becker rudder is achieved at about  $34^\circ$  on the main rudder, with a corresponding flap angle of about  $43^\circ$ .

Figure 3. Becker rudder

Five minutes before the collision, the *Jo Spirit* was already very close to the channel's north bank and experiencing increased bank suction aft. More and more starboard helm was therefore necessary to maintain the required heading. Although the high side forces generated by the Becker rudder could counteract the increasing bank suction, they also allowed the situation to persist. As soon as the rudder was placed amidships, however, the counteracting forces generated by the rudder were lost and the vessel sheered to port.

Following the occurrence, the company conducted an in-house investigation. A new familiarization task was added to the checklist for deck officers and helmsmen. An information binder on the rudder and its performance characteristics was compiled and is now kept in the wheelhouse. Additionally, a small working model of the Becker rudder is mounted in the wheelhouse to demonstrate functionality.

Helmsmen are now instructed to put the rudder to 35° when "hard over" helm is requested (since maximum side thrust is achieved at this angle). If, during manoeuvring at slow speeds, rudder angles of 60° are needed so the rudder can act as a stern thruster, the order "full helm" is to be used.

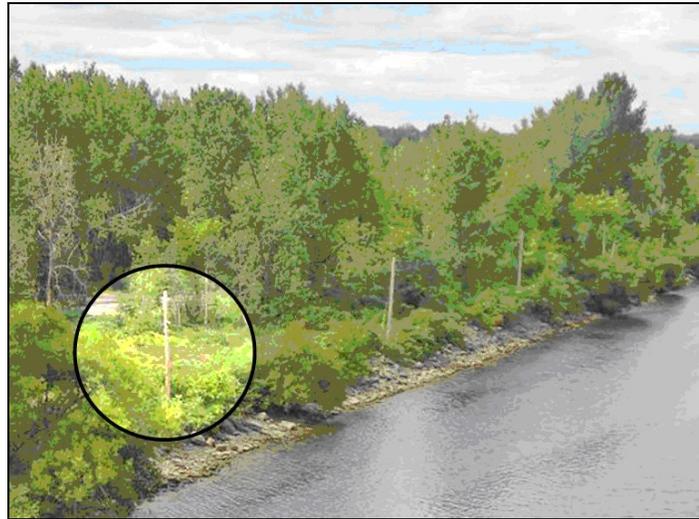
The South Shore Canal is fitted with variable-intensity lighting that outlines the banks of the canal.<sup>7</sup> The system extends from the Jacques Cartier Bridge in the east to the end of the dyke at Kahnawake (Lac Saint-Louis) in the west. Light intensity can be controlled from Côte-Sainte-Catherine and increased during periods of reduced visibility. Night navigation in the canal is essentially carried out using the visual cues taken from the lighting arrangements. Although the north shore light posts were, for the most part, easily visible and clear of any trees or other obstructions, those on the south side were not. Especially above Côte-Sainte-Catherine lock, many lamppost lights were extinguished, and had been for some time, while others were obstructed by trees and bushes.

**Photo 4.** Lamppost lights extinguished and/or obstructed

Night navigation within the South Shore Canal is primarily dependent on visual cues taken from lights mounted on wooden lampposts on either side of the channel (see Photo 4). Above Côte-Sainte-Catherine lock, many lights were extinguished, and had been for some time. Others were obstructed by trees and bushes, a situation that reduces the spatial orientation of the bridge team. The reduced shore-side lighting, therefore, may have hampered the ability of the pilots of both vessels to accurately assess their respective vessel’s position within the channel in the minutes leading up to the collision.

On 14 October 2005, Marine Safety Information Letter 04/05, *Less Than Adequate Visual Aids for Night Navigation in the South Shore Canal*, was sent to the St. Lawrence Seaway Management Corporation (SLSMC). The letter brought attention to the numerous non-functioning lights reported on the south side of the channel above Côte-Sainte-Catherine, as well as the growth of trees and shrubs that reduces the visibility of functioning lights.

In response, the SLSMC advised that work was completed by 31 October 2005 on bank lighting circuits 7, 8, and 10, as well as brushing and tree trimming along the channel above Côte-Sainte-Catherine lock, to improve the quality of visual aids for night navigation. Work on circuit 9 was completed in 2006. Additionally, the SLSMC has stated that the corporation will improve its water-side inspections to better target its tree-trimming/cutting program and thus ensure proper visibility of the canal bank sides and lights from vessels at night.

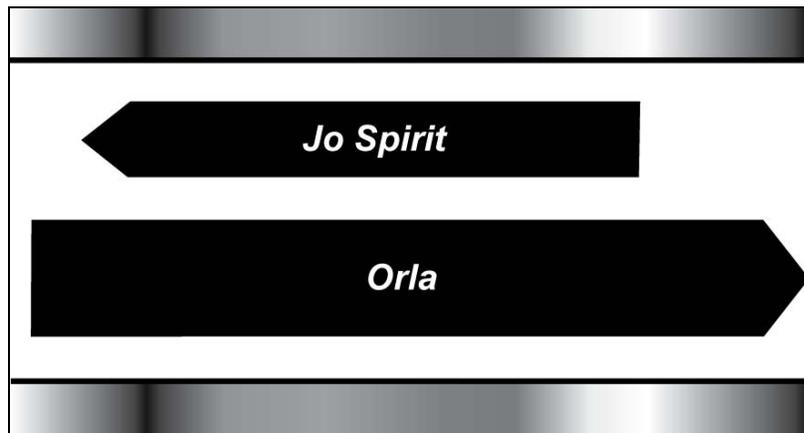
Given moulded breadths of 15.9 m and 23 m, respectively, the *Jo Spirit* and *Orla* would take up much of the available manoeuvring space in a channel only 70 m wide. Figure 4 shows a meeting between these two vessels in which maximum even space is maintained between the vessels, and also between each vessel and the channel bank. Even in this ideal case, however, only approximately 10 m would exist between the vessels and between each vessel and the bank – a tight fit given the size of the vessels.

Figure 4. Vessel template to scale with the channel bank profile

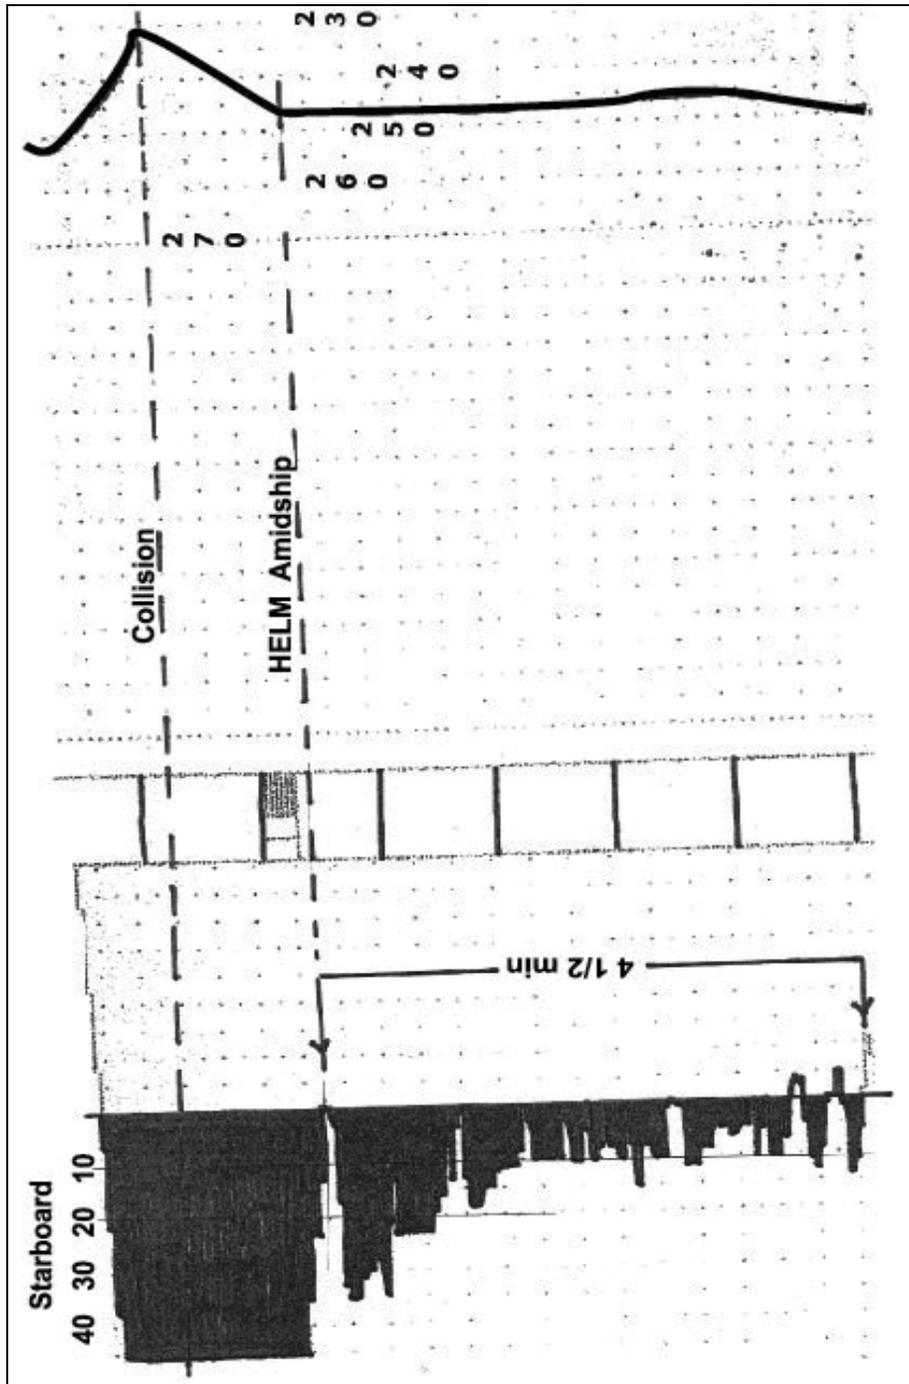
Appendix A – Jo Spirit: Course and Rudder Angle Recorder  
Printout. Helm Applications and Course Steered

Between 2239 and 2240, more than 10° starboard helm was applied to maintain the heading. By 2241, 20° to 30° starboard helm was necessary to steer 248° (G).<sup>3</sup> During this time, the pilot glanced at the rudder angle indicator from time to time, but there was no exchange of information among bridge team members. As the *Jo Spirit* made its way along the channel bank, the pilot gradually reduced the propeller pitch to slow the vessel down before the meeting. Since completing the final upbound bend at 7.6 knots,<sup>4</sup> the vessel was now making 5.7 knots.

There is conflicting information with respect to the helm orders given at about 2242. The navigation personnel of the *Jo Spirit* maintain that the pilot ordered the helm amidships, whereas the pilot does not recollect this order. The helm was nonetheless put to midships (see Appendix A), and the vessel immediately started to sheer to port. Full starboard helm was then applied, but the vessel's heading continued to swing to port. Starboard bow thrust was reportedly requested by the pilot, but was not applied.

The *Jo Spirit* is also equipped with a C. Plath rudder angle recorder (see Appendix A). Although the maximum rudder angle achievable is 60° (port or starboard), the rudder angle recorder in the wheelhouse is only capable of recording to a maximum of 45° (port and starboard). Any rudder angles used that are greater than 45° are also recorded as 45°. On the other hand, the rudder angle indicator used by the bridge team to view helm application is graduated to the full extent of rudder movement – that is, 60°.

During the several minutes preceding the sheer to port, increasing amounts of starboard helm were applied to steer the *Jo Spirit* parallel to the channel and counteract the bank suction effect. Given the high efficiency of a Becker rudder, using 30°, 20°, or even 10° of helm to steer a straight course is an unusual requirement. Nonetheless, neither the helmsman nor the OOW, who were closely monitoring the situation, communicated to the pilot the amount of helm action being used. The pilot of the *Jo Spirit* was not closely monitoring the rudder angle
