## **RAIL TRANSPORTATION SAFETY INVESTIGATION REPORT R17W0267**

### **EMPLOYEE FATALITY**

Canadian National Railway Company  
Remote control locomotive system  
Extra yard assignment Y1XS-01  
Melville, Saskatchewan  
22 December 2017

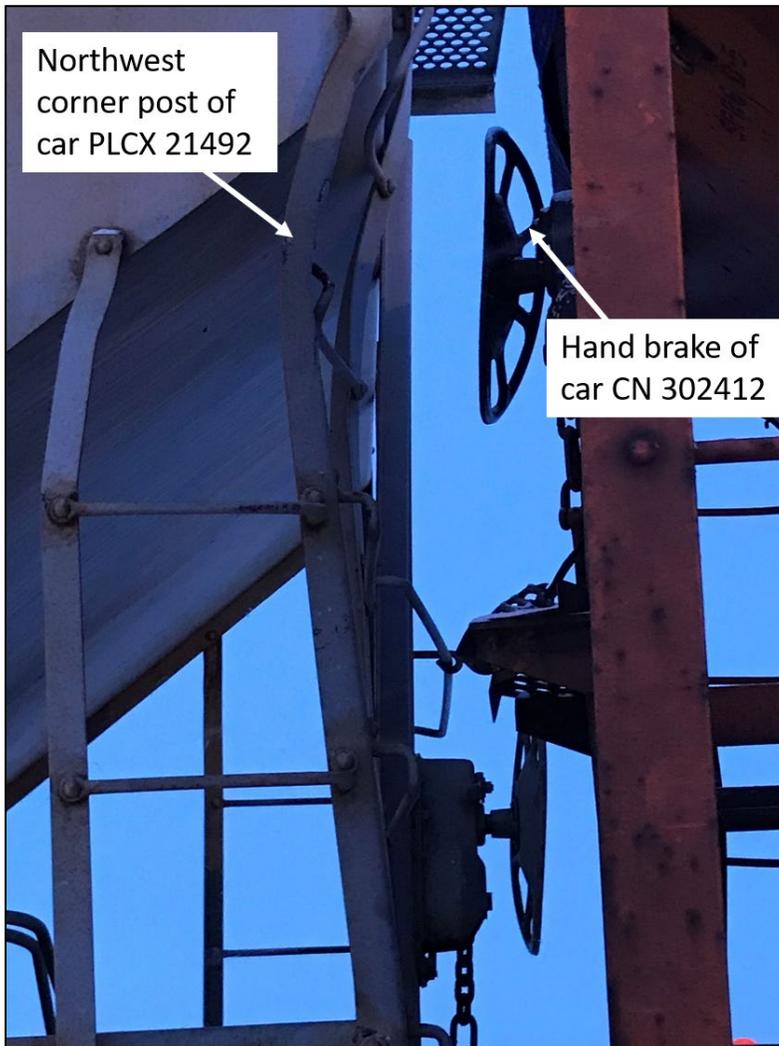
Figure 4. Estimate of how PLCX 21492 and CN 302412 came to rest, as staged the following day (Source: Canadian National Railway Company, with TSB annotations)

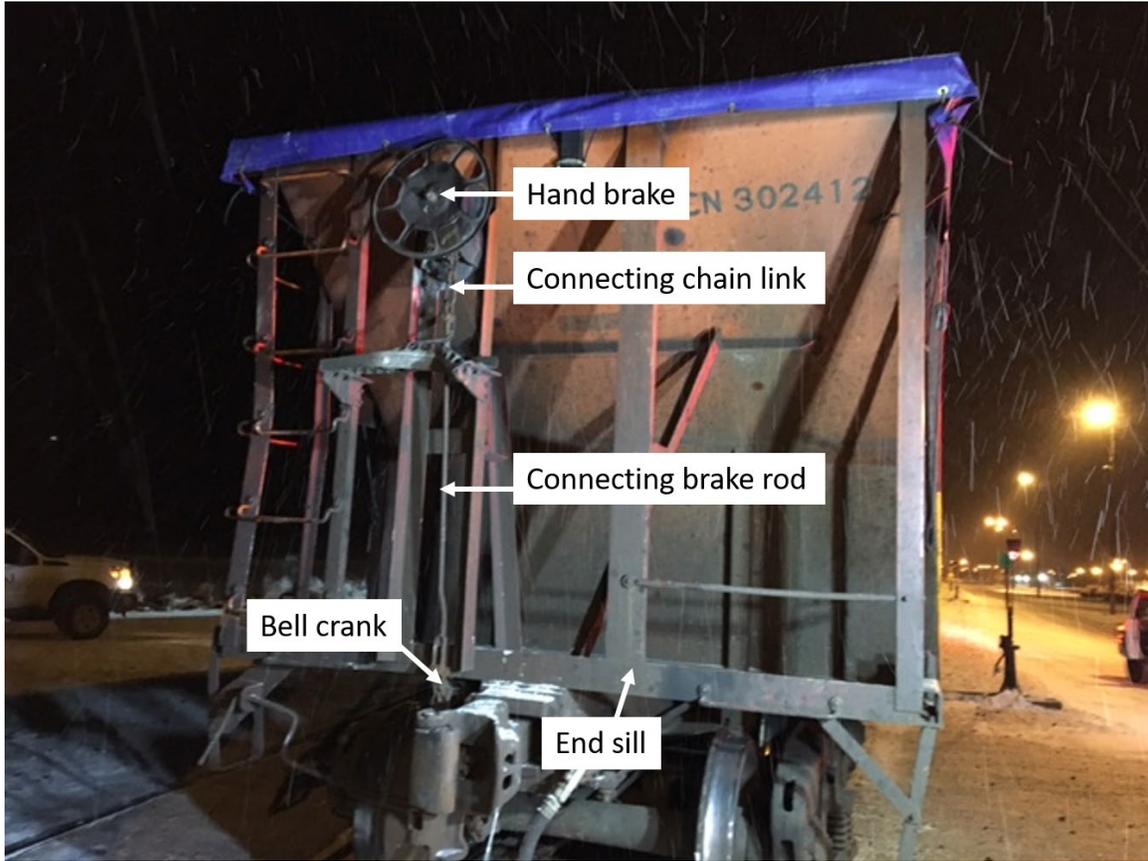
Once on the B-end platform, the foreman applied the high-mounted hand brake but could not stop the uncontrolled movement. Subsequently, the southeast corner of CN 302412 collided with the northwest corner of empty covered hopper car PLCX 21492, which was stationary and foul of the MR-lead track. The foreman became pinned between the corners of the cars (Figure 4) and received fatal injuries. There was no derailment and no dangerous goods were involved.

Figure 5. B end of CN 302412, as found about 30 minutes after the accident (Source: Canadian National Railway Company, with TSB annotations)

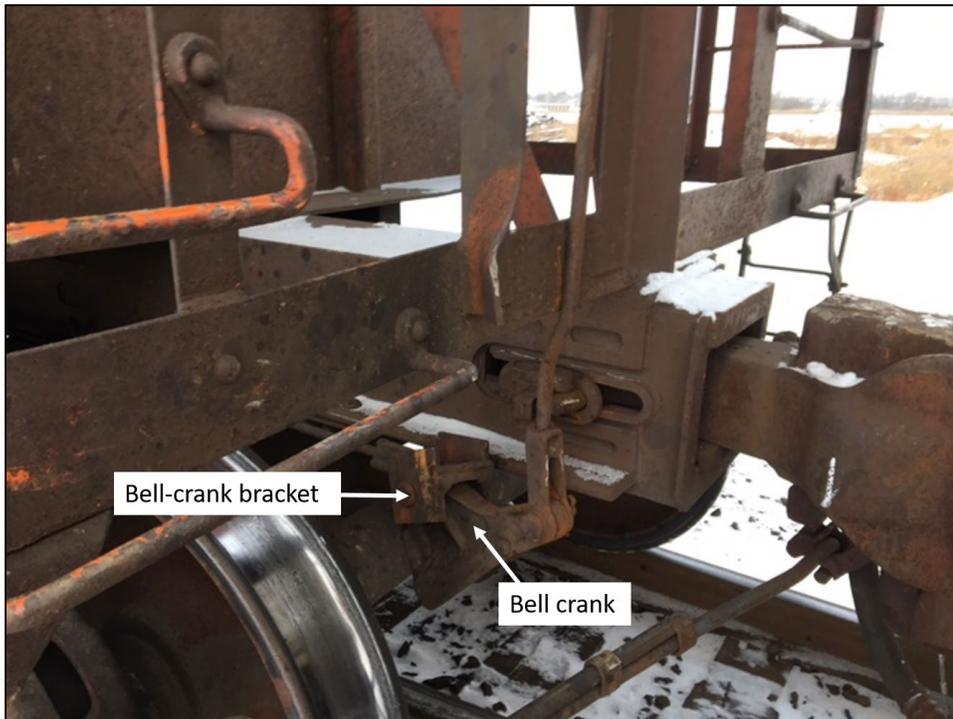
The 2 cars involved in the collision (PLCS 21492 and CN 302412) were photo-documented and examined more closely, which included documenting the broken bell-crank bracket (Figure 6).

Figure 6. Bell-crank bracket and bell crank separated from car CN 302412 (Source: Canadian National Railway Company, with TSB annotations)

Examination of the bell-crank bracket and the bell crank determined that the welds securing the bell-crank bracket to the underside of the CN 302412 B-end sill had failed, and the bracket fracture surface contained 2 small zones of fresh fracture (Figure 7).

Following the accident re-enactment, CN 302412 was sent for repairs, which included welding the bell-crank bracket back onto the end sill, installing a new bell crank, installing a new end platform, repairing various brake rigging components, and conducting a full single-car air-brake test while on a shop track. The hand brake wheel was replaced, but the hand brake itself did not require repair and remained with the car. After verifying that the car was safe to travel, it was sent to CN's Symington Yard car shop in Winnipeg, Manitoba.

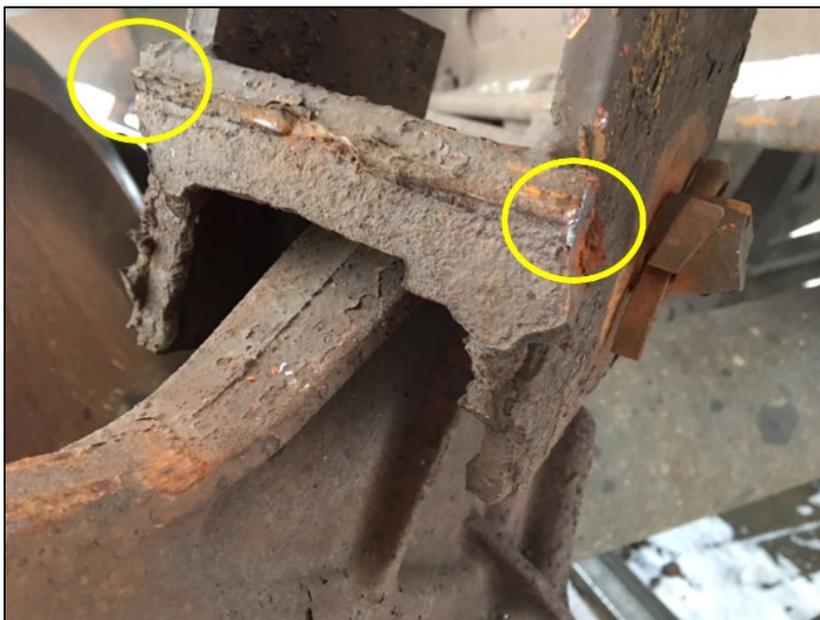
Figure 7. Bell-crank bracket fracture surface containing 2 small zones of fresh fracture (circled) (Source: Canadian National Railway Company, with TSB annotations)

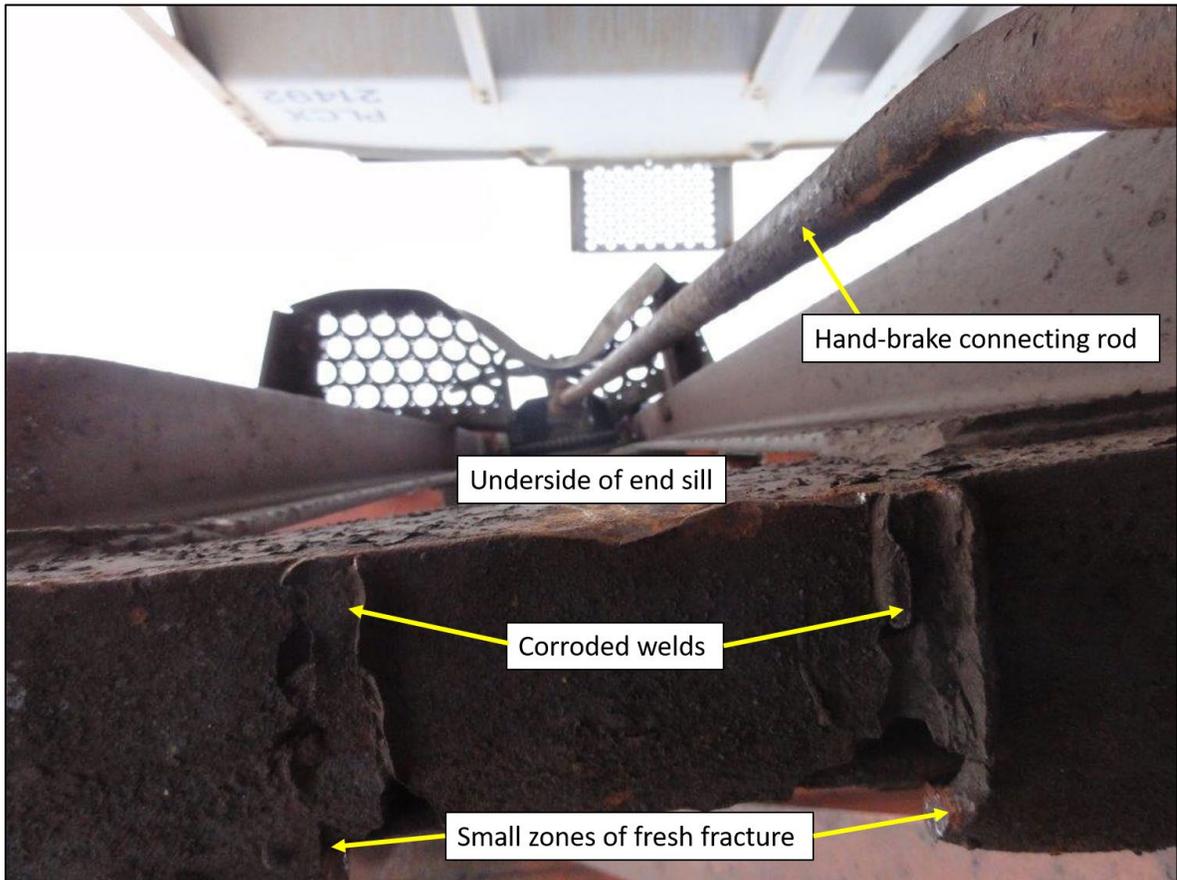
The fracture surfaces of the welds displayed heavy corrosion. The extent of the corrosion suggests that it had been present for an extended period of time. The rear of the 2 outboard welds each contained a small bright area, which was consistent with the 2 small zones of fresh fracture observed on the bell-crank bracket fracture surface (Figure 8).

Figure 8. Corroded welds securing the hand brake bell-crank bracket to the underside of CN 302412 with small zones of fresh fracture (Source: Canadian National Railway Company, with TSB annotations)

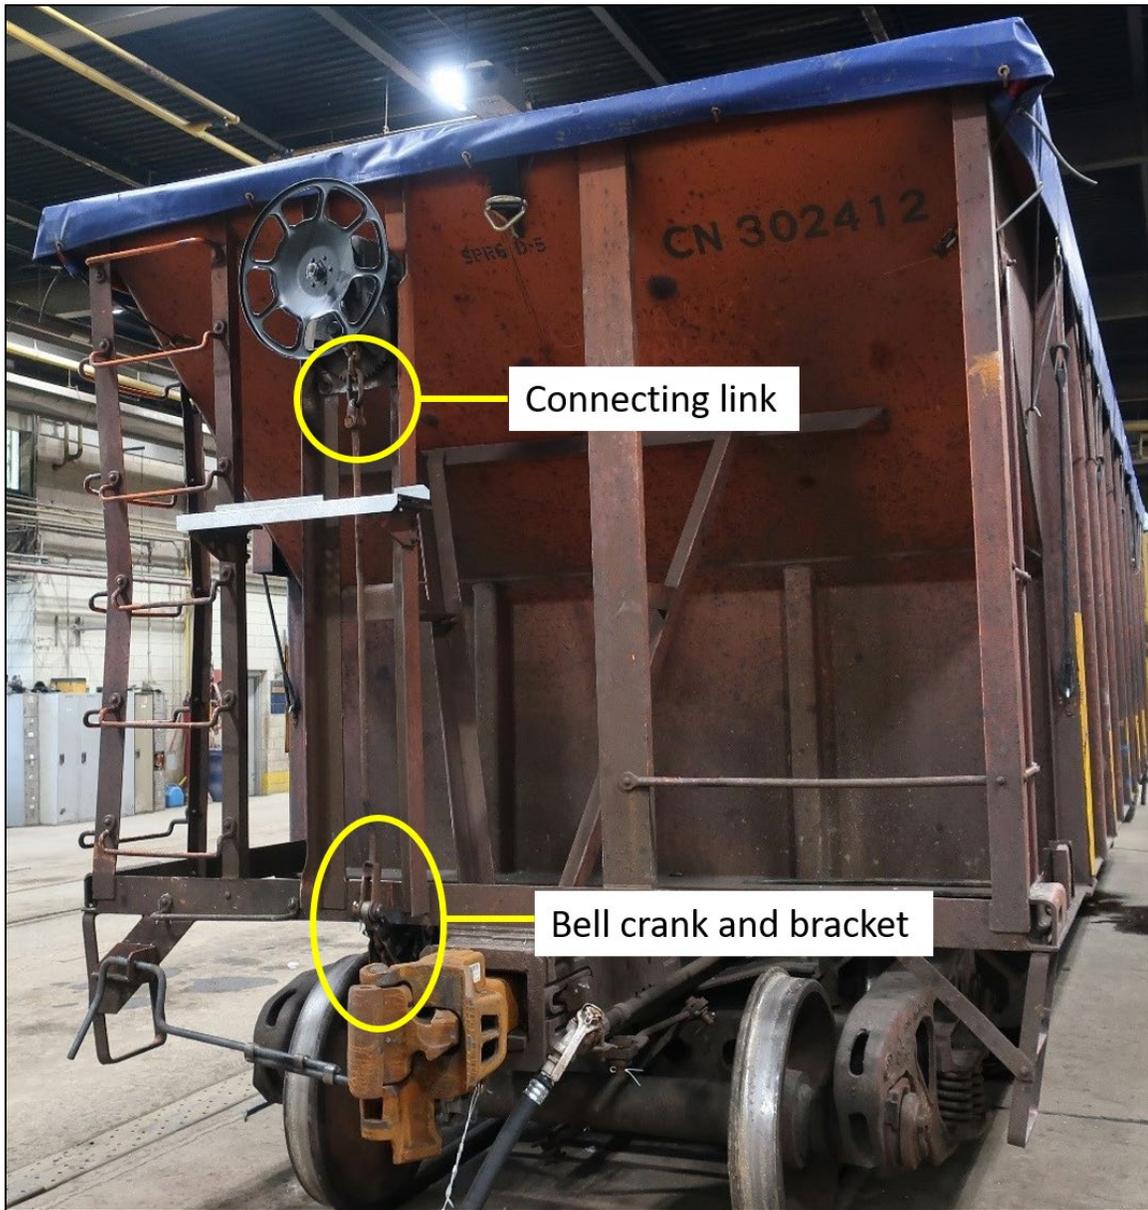
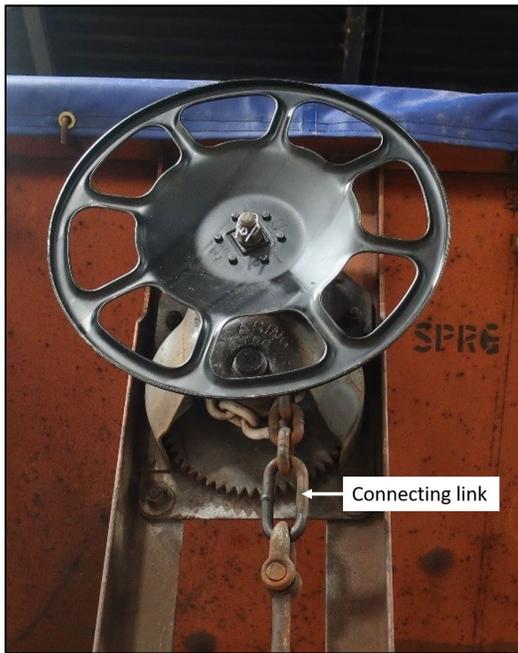
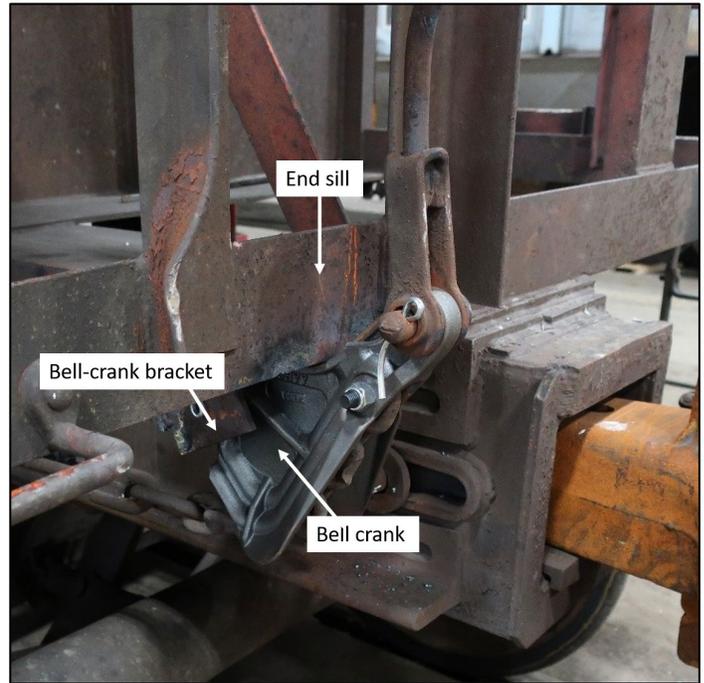
After cutting the bell-crank bracket from the B-end sill to simulate a broken condition, subsequent testing was conducted. The same brake shoe force tests were performed with the bell-crank bracket and the bell crank separated from the car body. When the hand brake was applied, these 2 components moved into almost the identical positions in which they were found at the accident site (Figures 11, 12, and 13). The highest NBR achieved for this test was 2.42%, which did not meet the minimum required NBR of 6.5%. This indicates that a hand brake with rigging in this condition is ineffective.

Figure 11. CN 302412 with hand brake applied and bell-crank bracket cut to simulate a broken condition (Source: TSB)

Figure 12. Position of connecting link with hand brake applied and bell-crank bracket cut (Source: TSB)

Figure 13. Position of bell crank and bracket with hand brake applied and bell-crank bracket cut (Source: TSB)

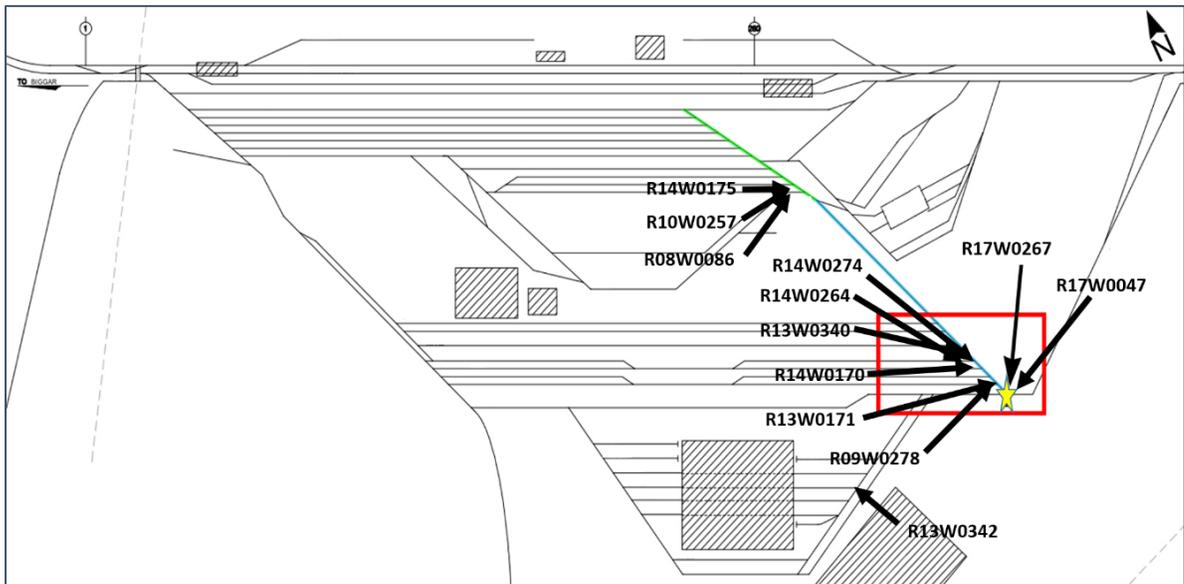
A review of the TSB Railway Occurrence Database System (RODS) for uncontrolled movements at Melville Yard from 2008 to 2017 revealed 11 previous uncontrolled movements (Appendix A). Of the 12 uncontrolled movements, including this occurrence, 8 had occurred along the MR-lead track between the MR13 and MR19 switches (Figure 14).

Figure 14. Melville Yard map showing location of previous uncontrolled movements (Source: Canadian National Railway Company, with TSB annotations)

Of the 11 previous occurrences, the most recent occurred on 26 February 2017 at the same location as the occurrence under investigation. At that time, the cars were being switched between track MR19 and the MR-lead track.

CN indicated that most of the previous uncontrolled-movement incidents in that area of the yard involved inadequate securement and operator errors. Corrective measures focused on employee education, clarification of instructions to the employee, increased employee monitoring, and disciplinary action (in some cases).
