RAIL TRANSPORTATION SAFETY INVESTIGATION REPORT R18H0105

MAIN-TRACK COLLISION BETWEEN TRAIN AND TRACK UNIT

Canadian National Railway Company
Freight train X 14921-01 and
Unimat tamper
Mile 84.27, Kingston Subdivision
Crysler, Ontario
02 October 2018

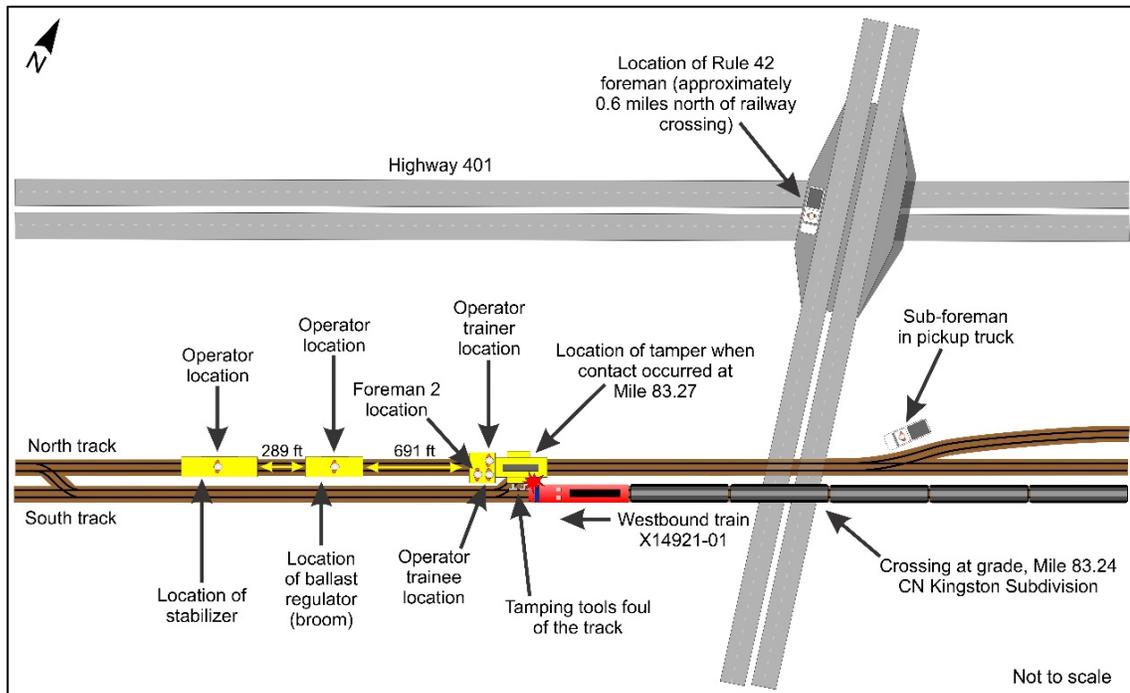
Figure 2. Occurrence site diagram showing the locations of the Rule 42 foreman, the sub-foreman, the operators, the operator trainer, and foreman 2 (Source: TSB)

At this location, there are 2 main tracks, designated as the north track and the south track (Figure 2). At the time of the occurrence, work was being conducted on the north track under the protection of *Canadian Rail Operating Rules* (CROR) Rule 42 (Planned Protection).⁴

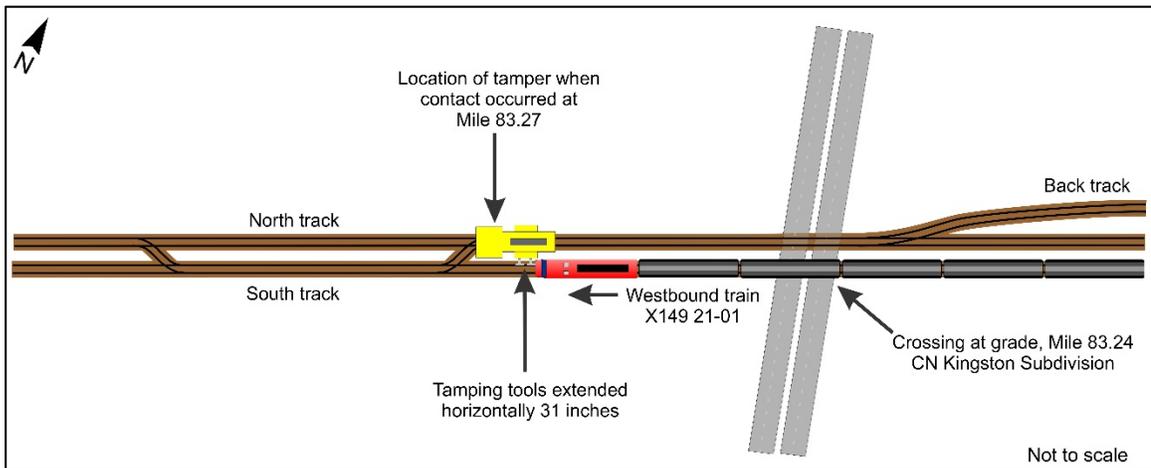
Figure 3. Close-up of occurrence site diagram prior to the collision (Source: TSB)

On 02 October 2018, at about 0010, with the westbound train travelling at about 48 mph on south track, the train crew observed that the tamping tools of the tamper were extended horizontally, foul of the south track (Figure 3). The train struck the tamping tools, and the crew applied the train brakes and brought the train to a controlled stop. There were no injuries. The tamper sustained damage to its tamping tools. The train sustained damage to safety appliances (ladders and sill steps) on both locomotives (IC 2721, CN 2679) and 3 cars. Seven other cars sustained minor damage (scrape marks).

The accident occurred when train 149 struck the Unimat tamper's tamping tools, which had been extended horizontally before the switch and were foul of the south track. The collision resulted in damage to safety appliances on both locomotives and 3 cars, and to the tamping tools on the tamper.

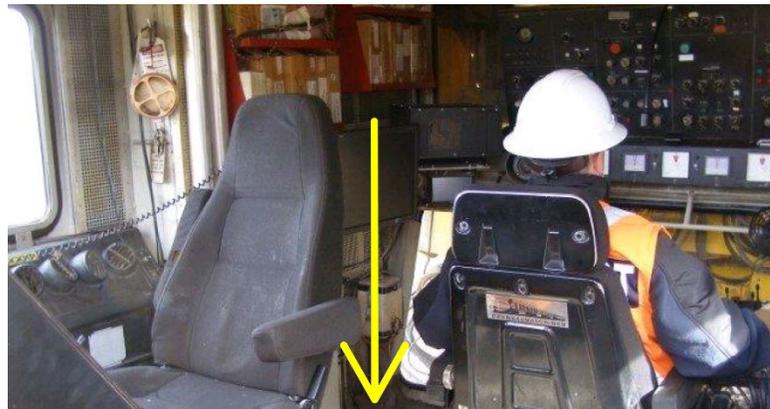
At the time of the occurrence, the operator trainer was in the cab of the Unimat tamper standing beside the operator trainee, facing west (Figure 4), in the opposite direction in which the machine was moving. The operator trainer was overseeing the operator trainee's manipulation of the machine controls and conversing with foreman 2. He was aware that the tamping tools, if lifted and extended horizontally when not in use, could extend far enough to foul an adjacent track. However, he was unaware that the train was on the approach and that the operator trainee had lifted the tamping tools horizontally toward the south track.

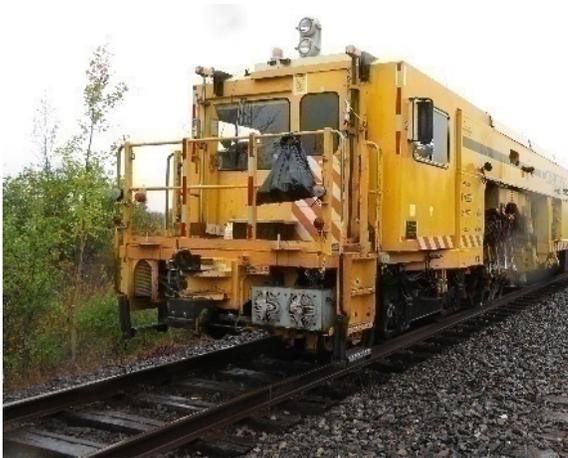
Figure 5. Unimat tamper with long nose leading (Source: TSB)

At the time of the occurrence, the Unimat tamper was being operated with its long nose leading (Figure 5). When seated at the operator workstation, the operator trainee could visually estimate how far the tamping tools were extended by leaning forward and looking through the viewing area (clear glass) located at the bottom of the workstation (Figure 6).

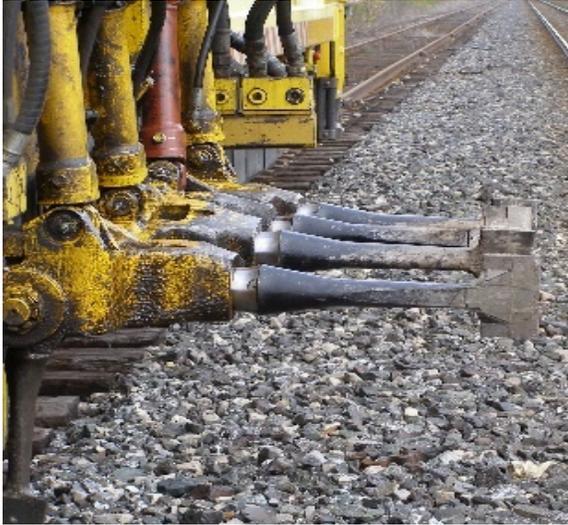
Figure 7. Tamping tools extended (Source: TSB)

The tamping tools could be extended to about 39 inches on both sides of the tamper (Figure 7). At the occurrence location, any tamping tools on the south side of the tamper that extended sideways beyond 31 inches would foul the adjacent track. At the time of the

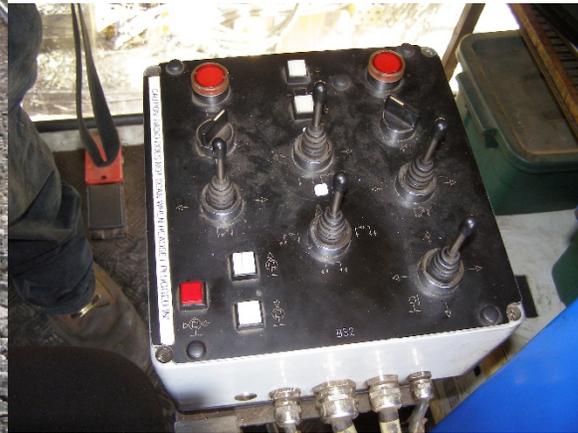
Figure 8. Rotary switches and joysticks in the cab of the tamper (Source: TSB)

The Unimat tamper crew must maintain awareness of the lateral extension of tamping tools, particularly when trains or vehicles have the authority to travel on an adjacent track. Control boxes for the tamping tools are located at the operator control stations on each side of the cab of the tamper. Each control box has 2 rotary switches and 2 joysticks for lateral movements (left and right in the horizontal plane) (Figure 8).

The Unimat tamper cab is a relatively dark work environment, and there are no brightly lit visual displays associated with the controls. Furthermore, there were no displays to specifically indicate if any of the tamping tools were in the horizontal position and extended.
