AIR TRANSPORTATION SAFETY INVESTIGATION A25O0021

PRELIMINARY REPORT

COLLISION WITH TERRAIN DURING LANDING

MHI RJ Aviation Group CL-600-2D24 (Regional Jet Series 900), N932XJ

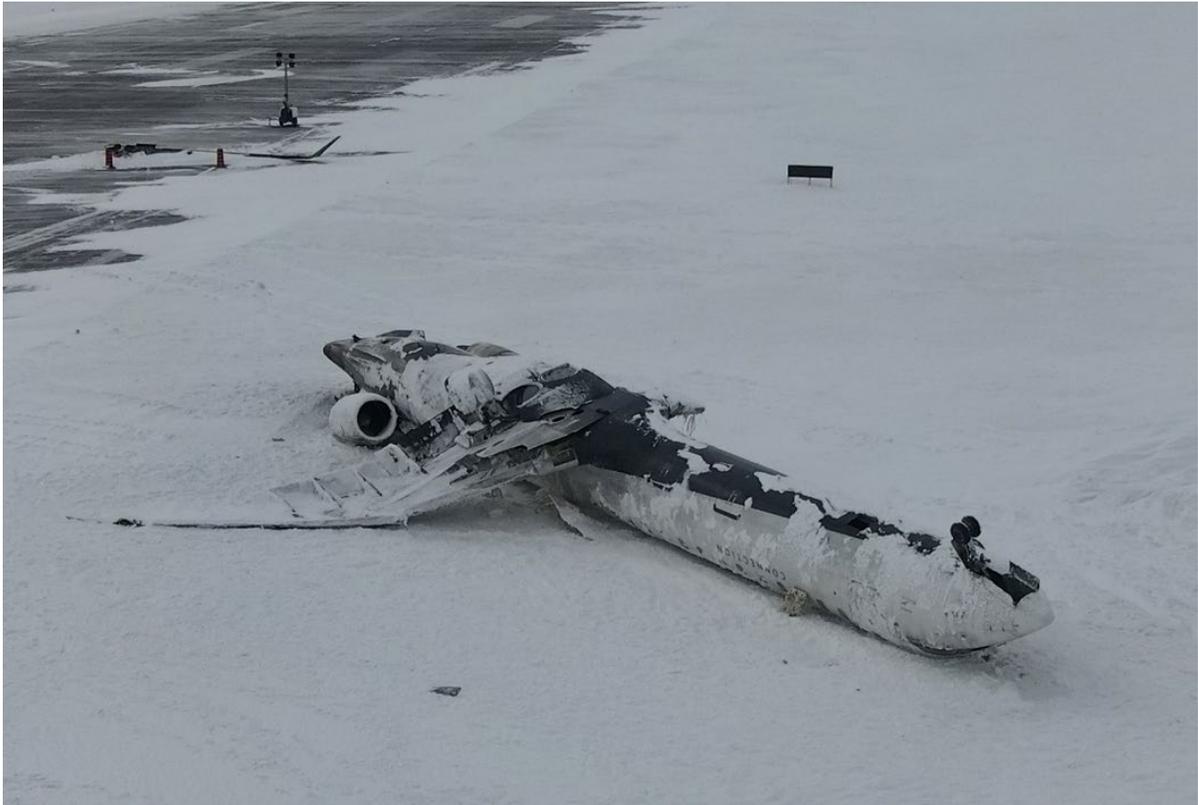
The aircraft went off the right side of the runway into the snow-covered grass area and came to a rest on Runway 15L, near the intersection with Runway 23, about 75 feet beyond the right edge of Runway 23 (Figure 1). The right wing, including the right MLG, became fully detached from the aircraft and slid approximately 215 feet further along Runway 23.

Figure 1. Aerial view of the aircraft wreckage resting on Runway 15L, with the detached wing in the background on Runway 23 (Source: Peel Regional Police)

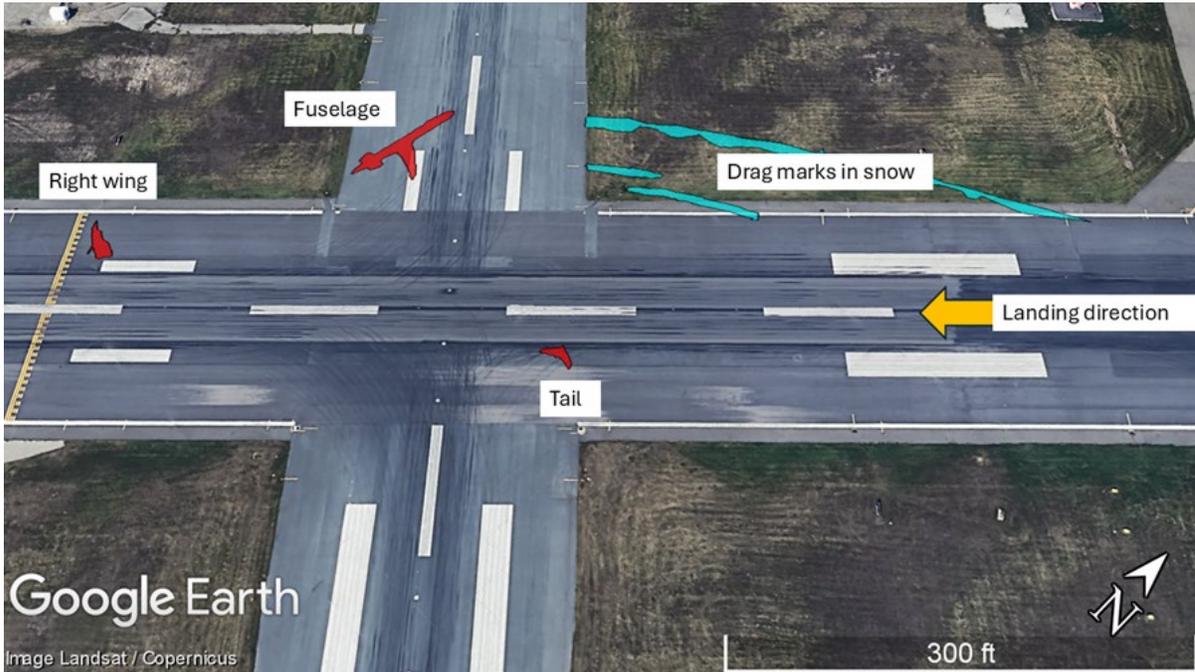
A large portion of the tail section was found on the runway, to the left of the centreline, about 1680 feet from the threshold and 235 feet from the main wreckage. The right wing came to a rest on Runway 23 about 215 feet beyond the main wreckage (figures 2 and 3).

Figure 2. Resting locations of the fuselage, the right wing, and the tail section, and aircraft marks left in the snow (Source: Google Earth, with TSB annotations)

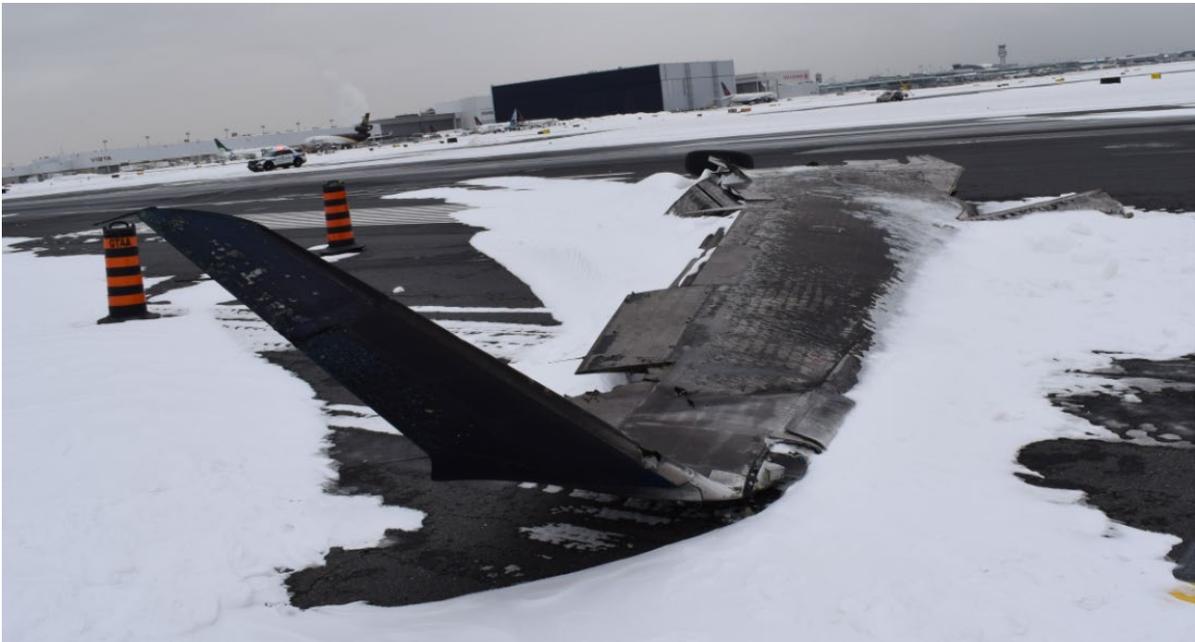
Figure 3. Aircraft's right wing resting on Runway 23 after it detached from the aircraft and slid along the runway (Source: TSB)

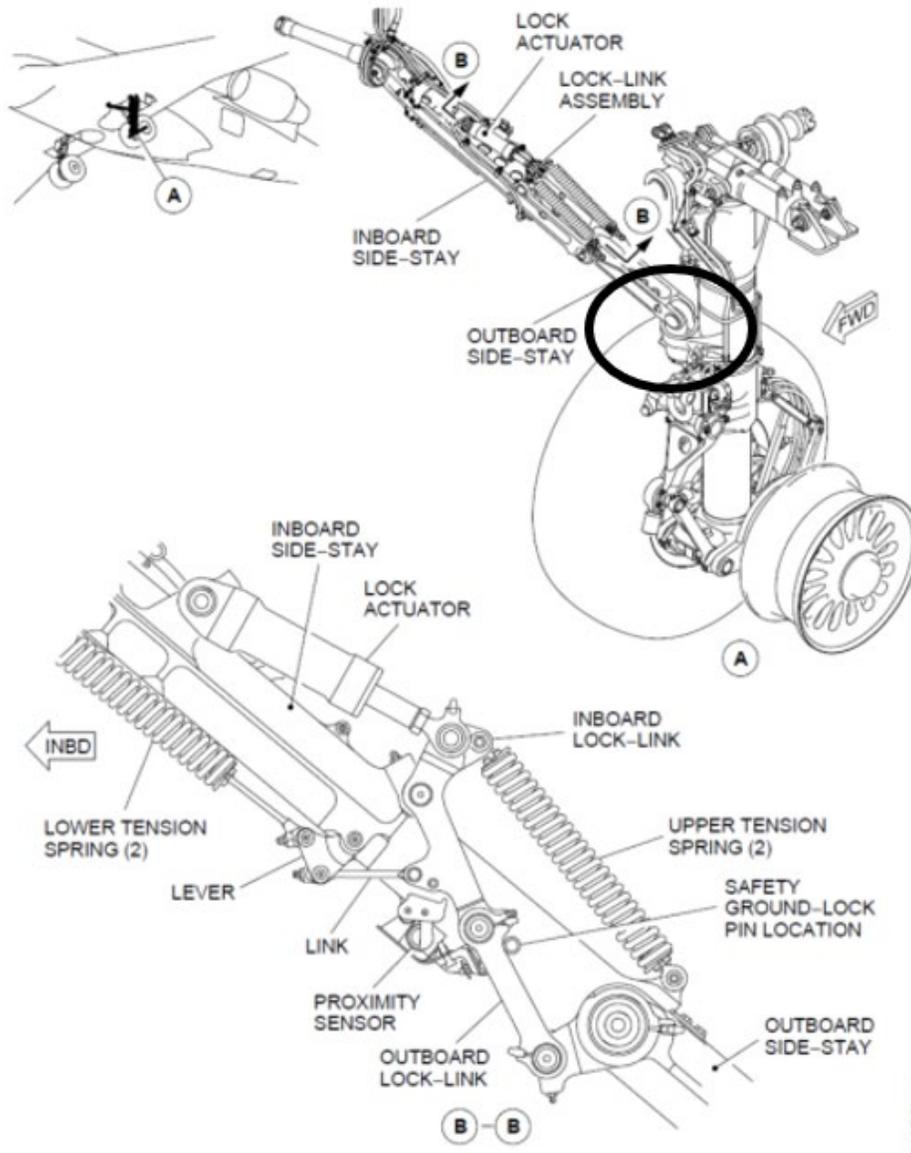
The right MLG outboard side-stay (Figure 4) locks the landing gear in place and prevents the landing gear from collapsing during normal operations.

Figure 4. Schematic of landing gear with side-stay and fracture location (Source: MHI RJ Aviation Group, with TSB annotations)

During the occurrence, the right MLG outboard side-stay fractured at the connection to the landing gear strut; the landing gear then folded inward. The side-stay remained in the down-and-locked position (Figure 5).

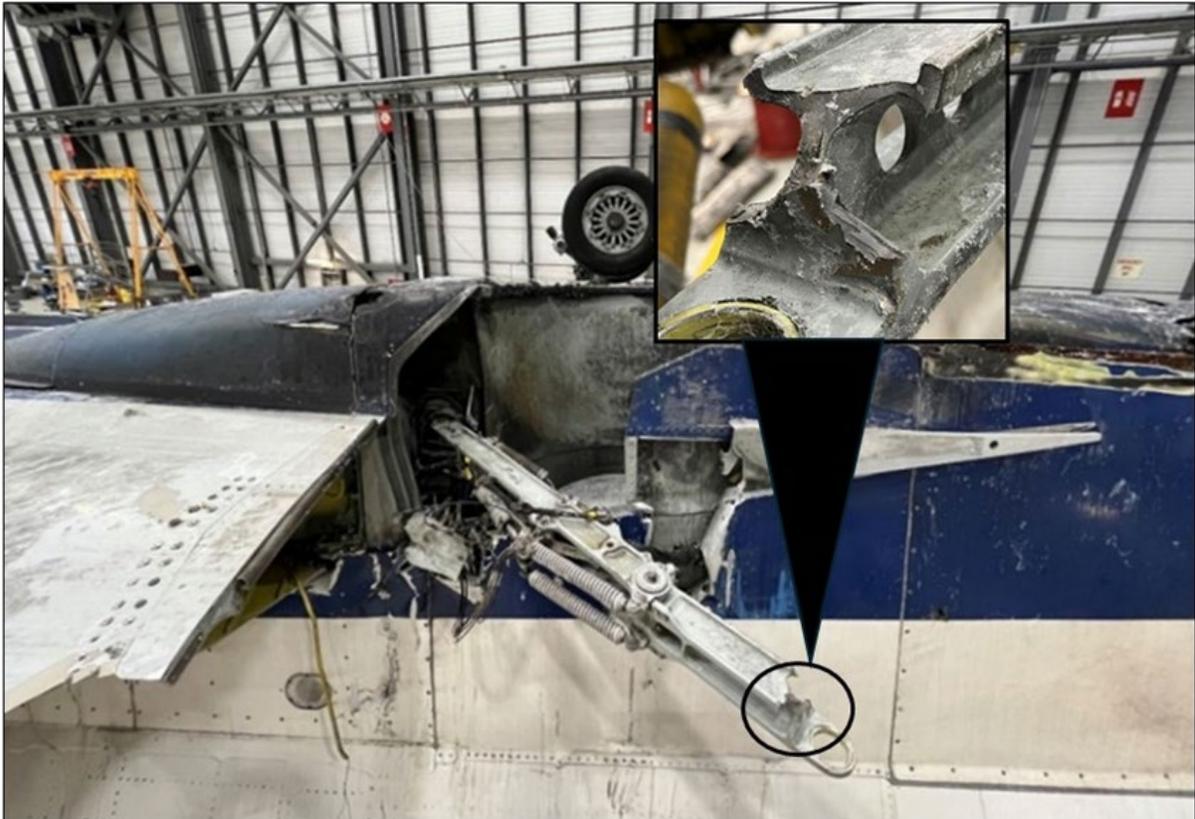
Figure 5. Occurrence aircraft resting inverted showing a close-up view of the fractured right main landing gear side-stay (Source: TSB)

The MLG shock struts on this aircraft are designed to absorb the energy of a 720 fpm (12 fps) descent velocity at the maximum landing weight.

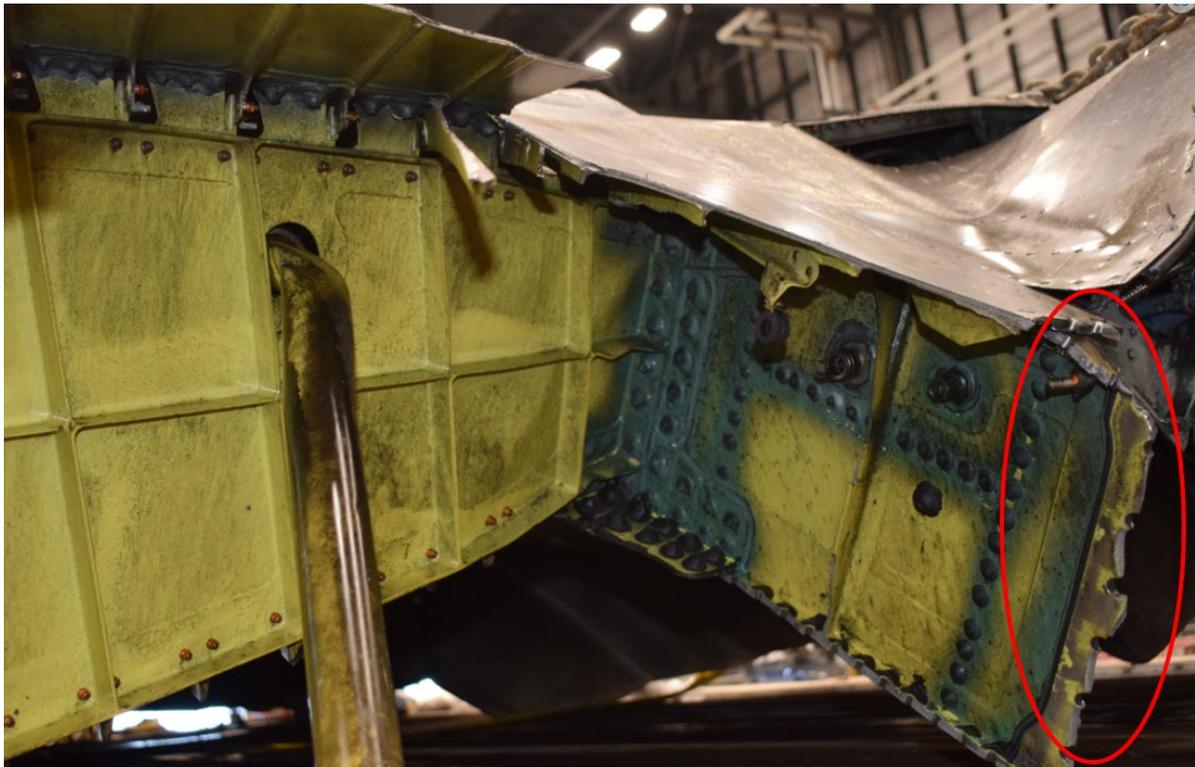
The right wing separated from the fuselage, and the left wing was severely damaged but remained attached to the fuselage. The right-wing main spar fractured at the fastener location to the fuselage, and the main spar was also bent significantly downward from the accident sequence (Figure 6). In addition, there was substantial damage to the right wing in the area surrounding the landing gear.

Figure 6. Right-wing rear spar, with fractured area (Source: TSB)

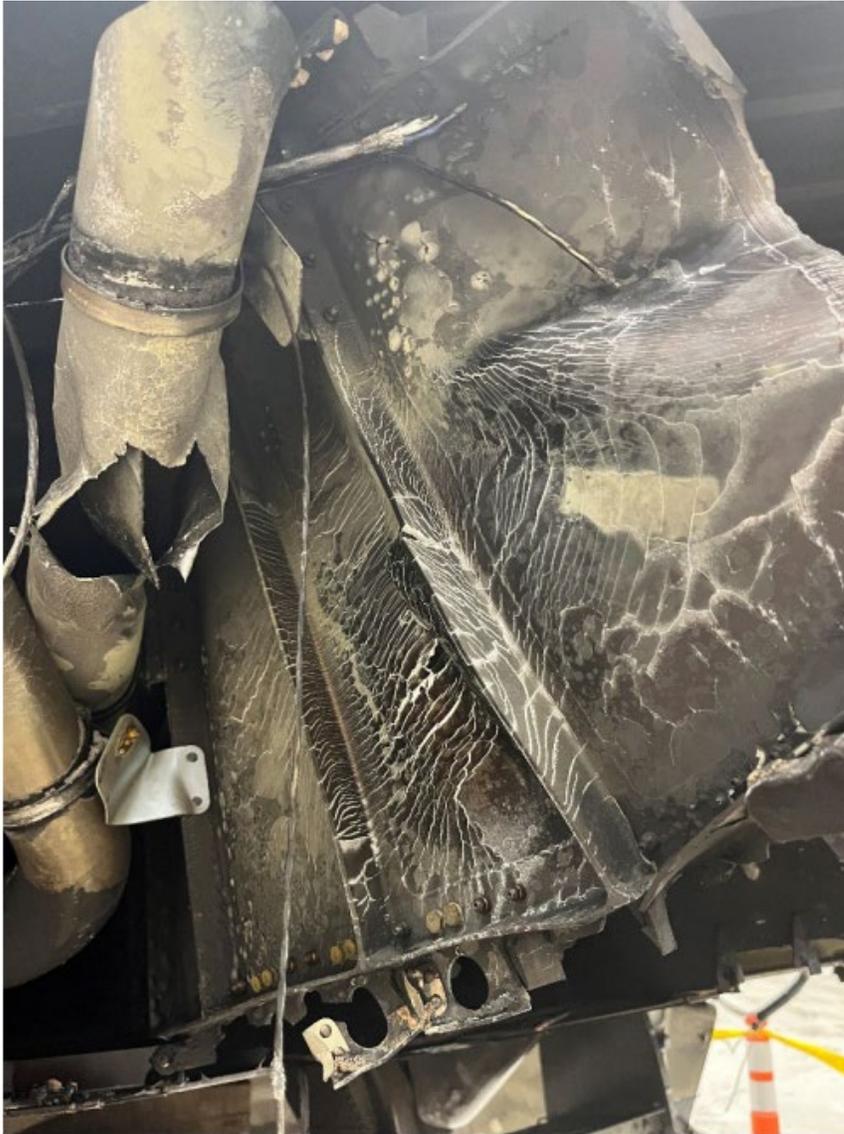
The fuel tank is integrated into the wing. As a result, when the right wing broke off, fuel spilled out of the wing and ignited. There was significant fire damage to the wing, and the right-wing fuel balance pipe, which is located inside the right wing, had a damaged sidewall that was deformed outwards (Figure 7).

Figure 7. Close-up view of the thermal damage to the right wing (Source: TSB)

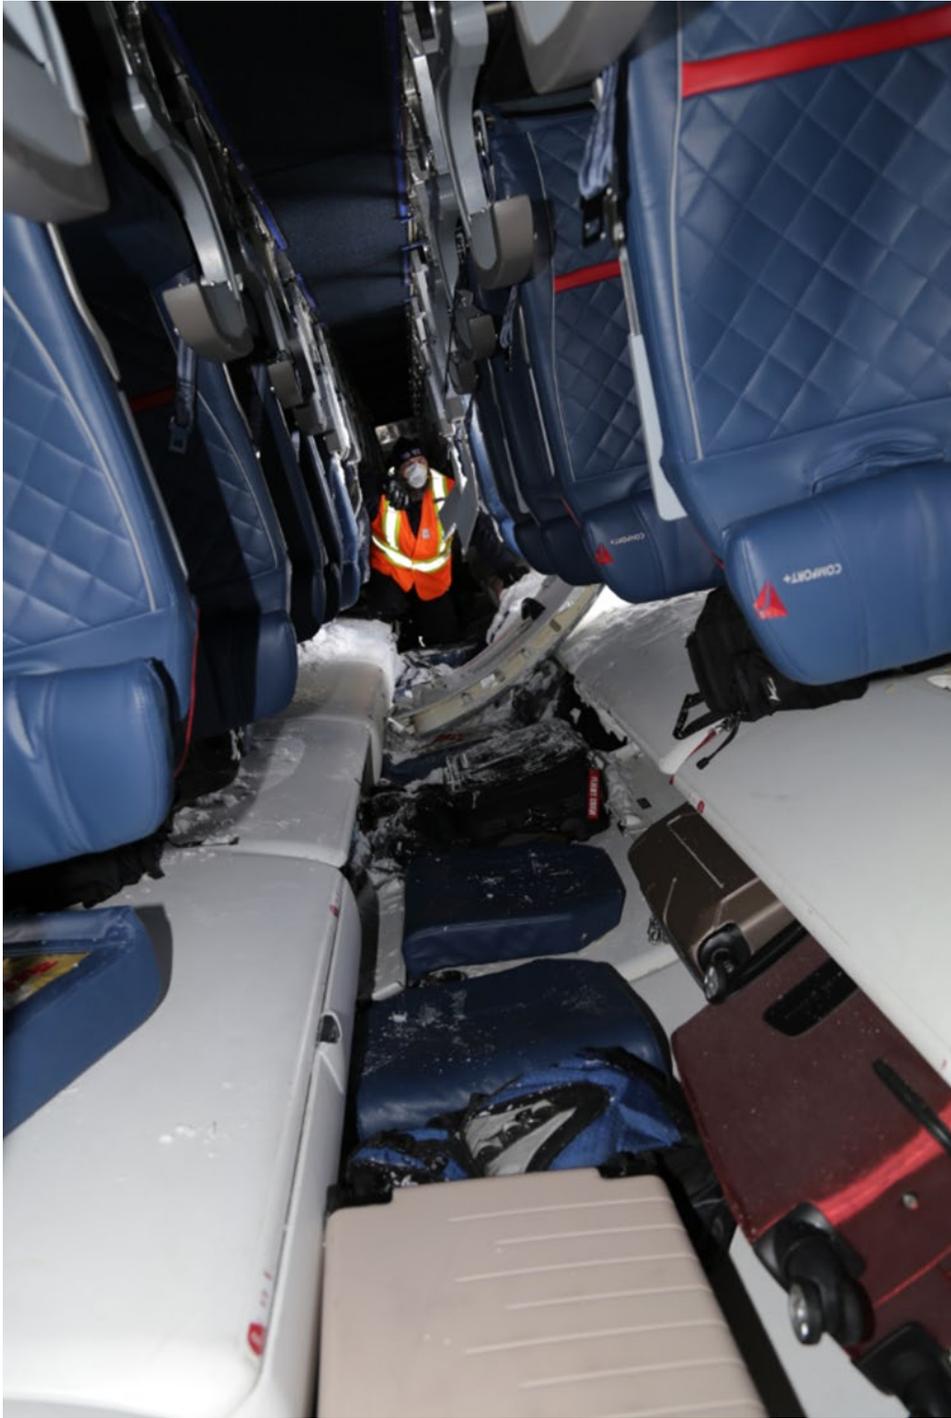
The aircraft came to rest inverted; as a result, passengers were hanging upside down in their seats, suspended by their safety belts, and many of the carry-on baggage and other items ended up on the aircraft ceiling (Figure 8). Some passengers had difficulty releasing the buckles on their safety belts due to being inverted. Some of the injuries sustained by the passengers occurred when they unbuckled their safety belts and fell to the ceiling. The TSB is not aware of any safety belt or seat failures occurring during the accident.

Figure 8. Interior of aircraft cabin at the occurrence site, looking aft (Source: TSB)

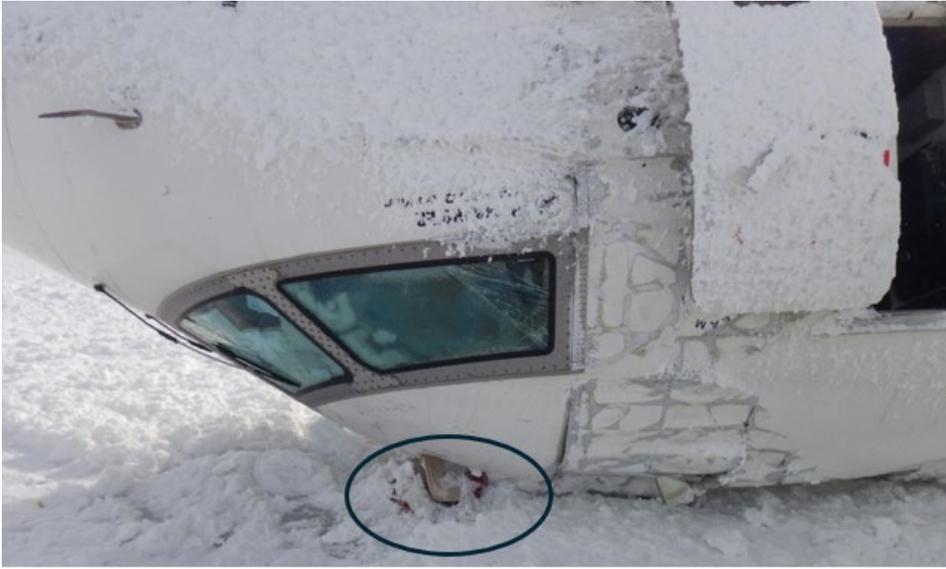
The crew and the passengers began evacuating; however, the deformation of the forward fuselage coupled with the flight attendant jump seat position prevented the flight deck door from opening after the accident. As a result, the pilots used the escape hatch on the cockpit ceiling (which was upside down) to evacuate. The hatch opening was close to the ground, which impeded the evacuation; however, with help from a passenger, the pilots were able to egress (Figure 9).

Figure 9. Location of escape hatch through which the pilots egressed (Source: TSB)

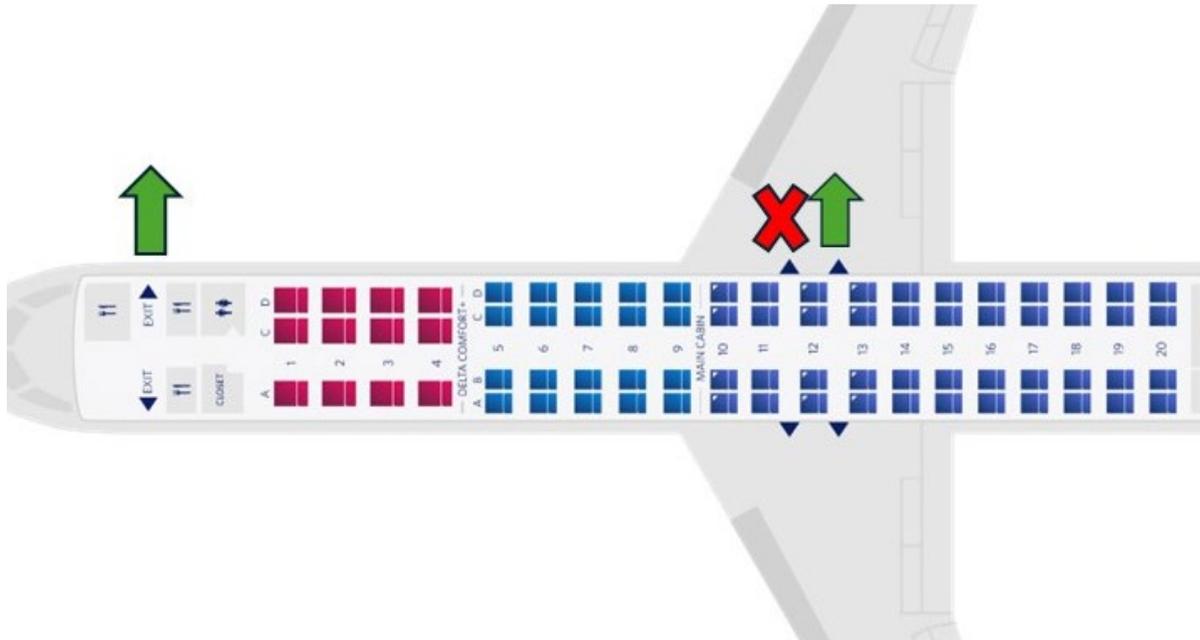
Aircraft rescue and fire fighting (ARFF) personnel arrived approximately 5 minutes after the accident. A passenger attempted to utilize the forward emergency overwing exit located on the starboard side of the fuselage at seat 12D; however, because fuel was flowing over that exit door, most rear-fuselage occupants evacuated via the overwing exit door at seat 13D (Figure 10), some of whom got covered in fuel. Several passengers exiting through the same exit were also sprayed by fire retardant foam from the ARFF vehicle.

Figure 10. Graphic of the emergency exits used for the evacuation (Source: Endeavor Air, with TSB annotations)
