# AIR TRANSPORTATION SAFETY INVESTIGATION REPORT A24C0057

## LOSS OF CONTROL AND COLLISION WITH TERRAIN

Canadian Fly-in Fishing (Red Lake) Ltd.  
De Havilland Aircraft of Canada Limited DHC-2 Mk. I, C-GBZH  
Red Lake (Howey Bay) Water Aerodrome (CKS4), Ontario, 2.2 NM SE  
16 June 2024

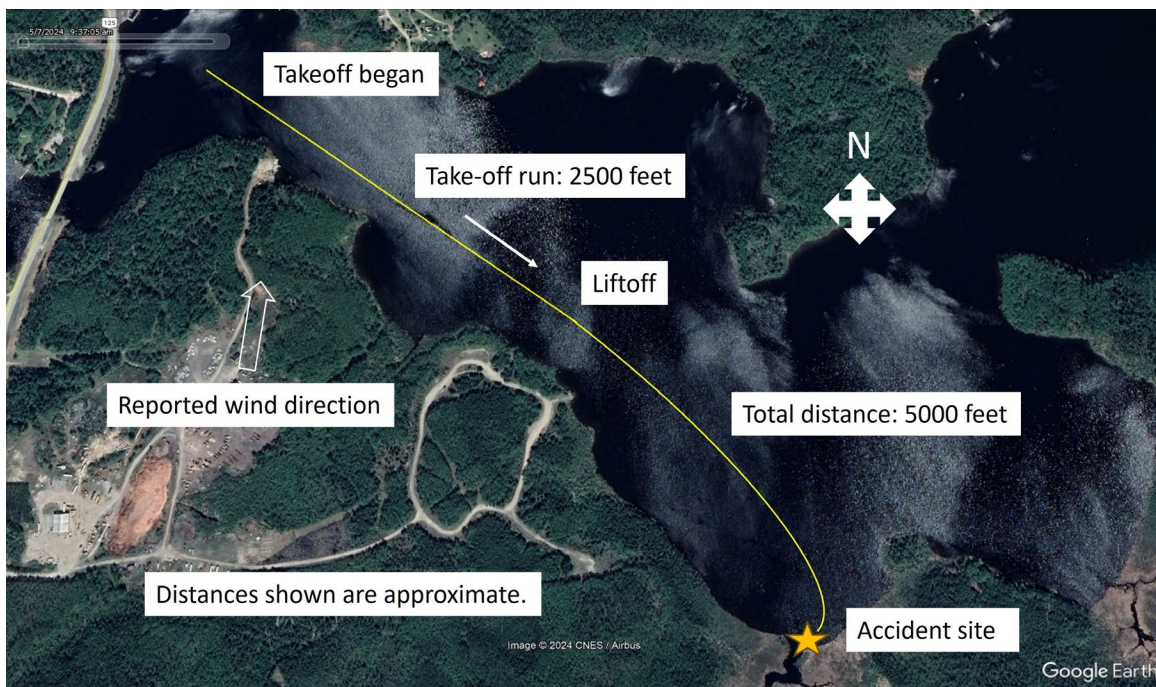
The aircraft's airspeed did not increase, and the pilot made a turn to the right, into the wind. At a height of approximately 80 feet above the water, the aircraft entered an aerodynamic stall, with a roll to the right.

Aircraft control was lost and, at 0655, the aircraft collided with the shoreline in a nose-down, banked attitude (Figure 1).

Figure 1. The occurrence flight take-off route and accident site (Source: Google Earth, with TSB annotations)

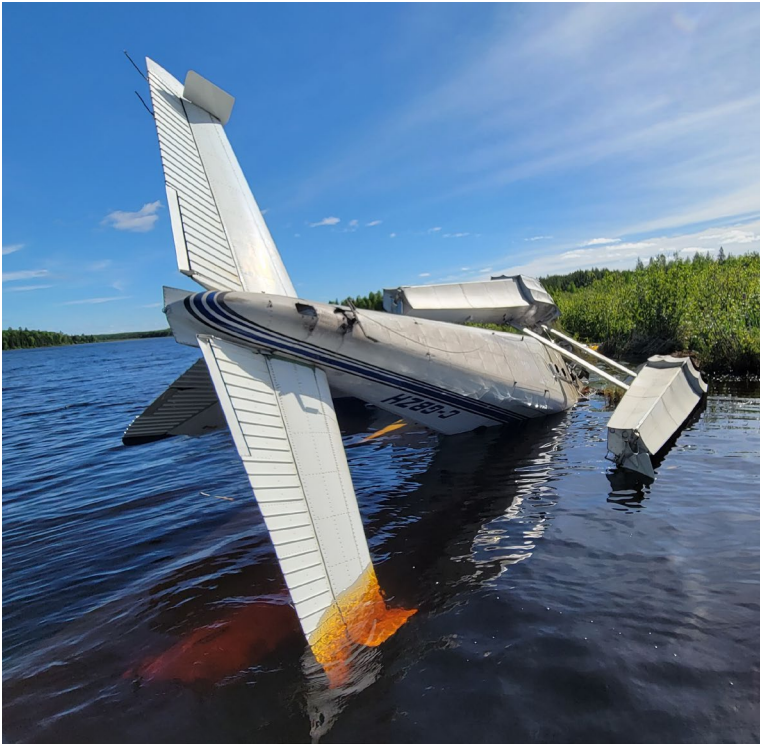
The aircraft came to rest on its left side, partially submerged in approximately 1.5 m of water, 5000 feet from the start of the take-off run (Figure 2).

Figure 2. The occurrence aircraft following impact with terrain (Source: TSB)

The aircraft was substantially damaged. There was no post-impact fire. The emergency locator transmitter activated.
