AIR TRANSPORTATION SAFETY INVESTIGATION REPORT A24Q0104

COLLISION WITH WATER

Privately registered
Airbus AS350 B2 (helicopter), C-GGLM
Lac d'Elvert, La Vérendrye Wildlife Reserve, Quebec
18 August 2024

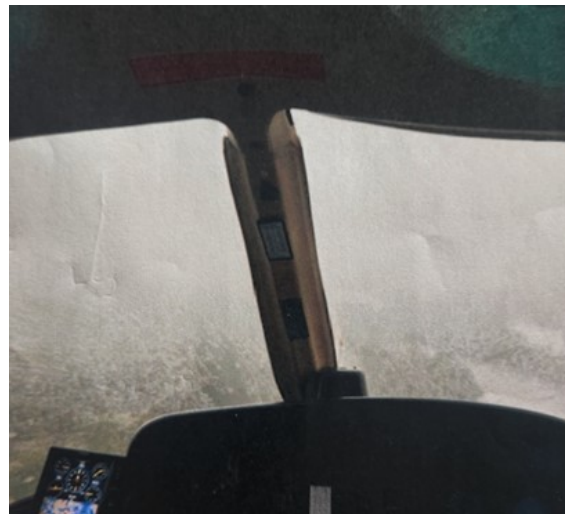
At approximately 1600, given the poor weather conditions, the pilot landed at Le Domaine, a rest area and lodging site for hunting and fishing enthusiasts owned by the Société des établissements de plein air du Québec. One of the passengers took a photo with their cellphone while in flight before landing at Le Domaine, which showed that forward visibility was very low due to heavy rain (Figure 1). Text messages exchanged between an individual on the ground and this passenger confirmed that weather conditions were poor during the flight.

Figure 1. Photo taken during the occurrence flight before landing at Le Domaine (Source: Third party, with permission)

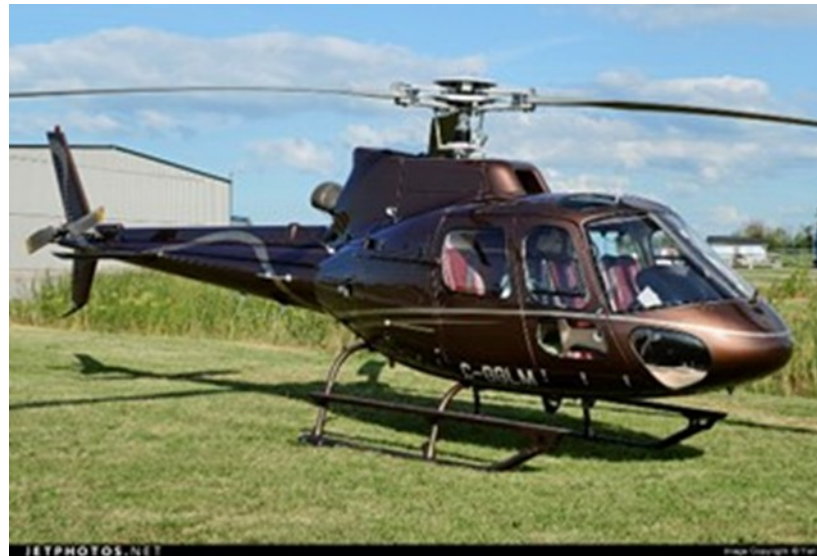
The occurrence AS350 B2 helicopter (Figure 2) was manufactured by Eurocopter (now Airbus Helicopters) in France in 2001 and imported into Canada in 2007. The helicopter was not equipped with a flight data recorder or a cockpit voice recorder, nor was either required by regulations.

Figure 2. Occurrence helicopter (Source: JetPhotos)

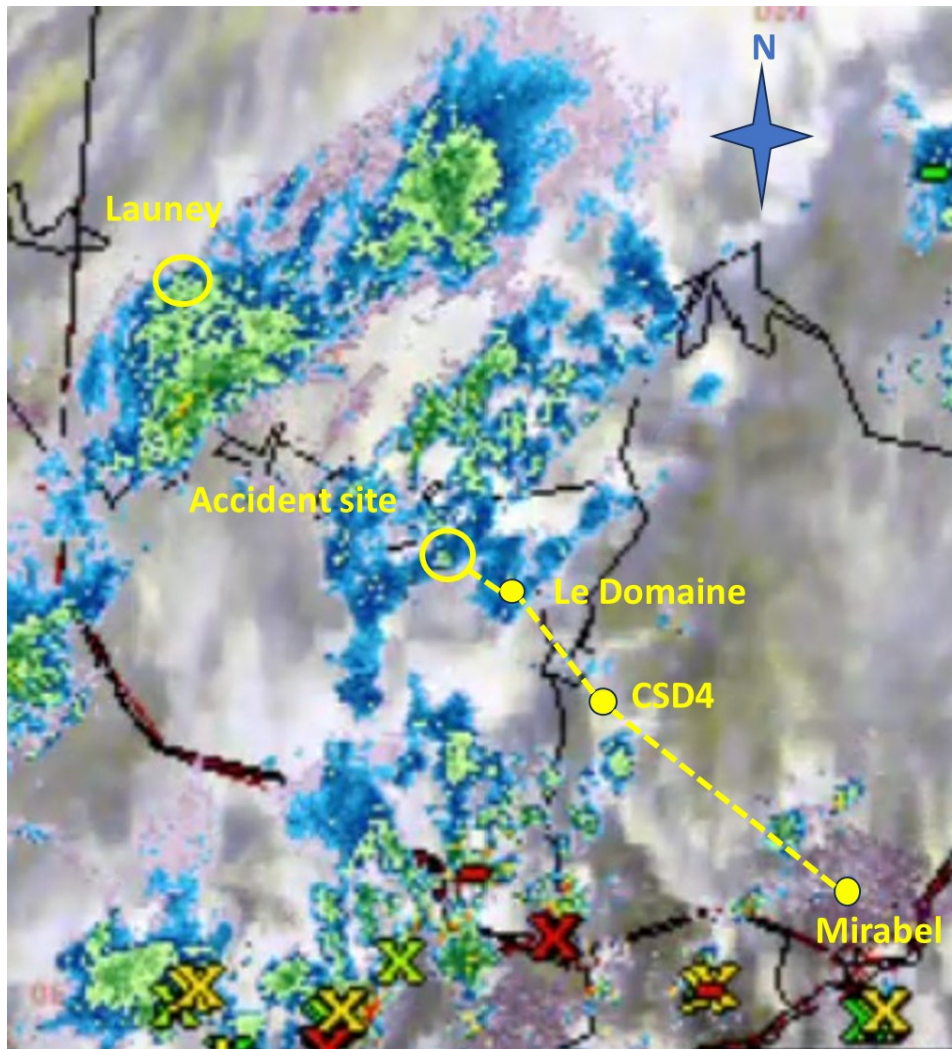
Figure 4. Radar image of lightning and precipitation at 1655 on 18 August 2024, with depiction of the occurrence flight. According to the image, rainfall intensity was between 0.7 and 2.7 mm/h at the accident site (Source: Environment and Climate Change Canada, with TSB annotations)
