MARINE TRANSPORTATION SAFETY INVESTIGATION REPORT M17C0179

BOTTOM CONTACT AND SUBSEQUENT FLOODING

Passenger vessel *Island Queen III*
Kingston, Ontario
08 August 2017

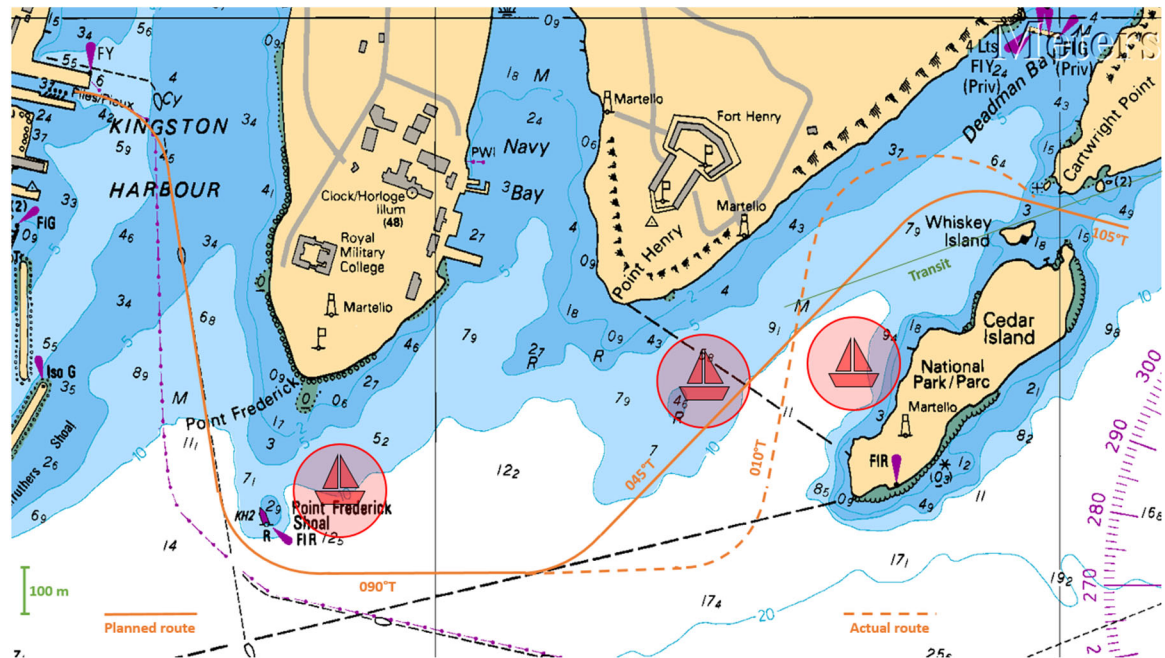
Figure 2. The *Island Queen III*'s track from Kingston Harbour to Cartwright Point (shown in orange) and the sailing school dinghies (indicated by red boats) (Source: Canadian Hydrographic Service Chart 2017, *Kingston Harbour and Approaches*, with TSB annotations)

At approximately 1240, as the vessel approached Point Frederick Shoal (Figure 2), the mate entered the wheelhouse. Both the mate and the master observed a fleet of sailing school dinghies (shown as red boats in Figure 2) to the vessel's port side and clear of the planned route.

After passing the Point Frederick Shoal buoy and the fleet of dinghies, the master turned the vessel to port to a heading of approximately 090° true (T). A second fleet of sailing school dinghies was training off Point Henry, near the master's planned route. To avoid the dinghies, the master continued past the planned alteration point and toward Cedar Island. A third fleet of sailing school dinghies was training off Cedar Island. Once the vessel was clear of the dinghies off Point Henry, at approximately 1243, the master turned to port to a new course of approximately 010°T, which gave a wide berth to the second and third fleets of dinghies as the vessel proceeded up Deadman Bay.

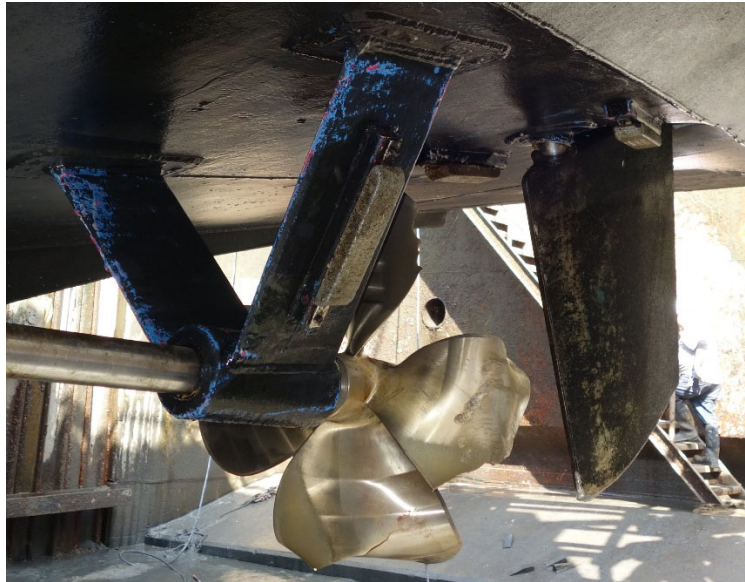
Figure 3. Damage to port propeller and rudder (Source: TSB)

The grounding deformed the vessel's keel from amidships to the stern, with tearing near amidships. The port propeller was damaged (Figure 3), as well as its tail shaft and shaft strut. The port rudder was pushed aft, bending the port rudder stock and deforming the hull surrounding the rudder stock. The top of the port rudder also punctured the hull at the steering compartment, creating an L-shaped opening measuring approximately 20 cm by 40 cm and pushing the shell plating upward approximately 15 cm (Figure 4). Nearby hull stiffeners and the bulkhead separating the steering compartment and stern storage were also damaged.

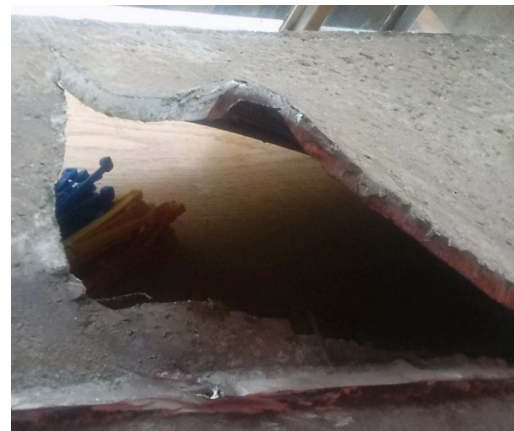
Figure 4. Section of bottom shell plate punctured by rudder (Source: TSB)

Once the master observed that the vessel was north of the planned route, he made a series of small corrections to return the vessel to the centre of the channel; however, there was limited time and distance to correct the vessel's course. When the master applied corrections to the vessel's course, they were not early enough or significant enough to return the vessel to its intended track. As the vessel's bow swung toward the centre of Whiskey Cut, the vessel's stern made contact with the bottom on the north side of Whiskey Cut, near Cartwright Point, puncturing the bottom shell plating.
