# AIR TRANSPORTATION SAFETY INVESTIGATION REPORT A23Q0143

## NEAR COLLISION WITH TERRAIN ON FINAL INSTRUMENT APPROACH

Boeing of Canada Ltd. De Havilland Division DHC-8-106, C-FLSX

Val-d'Or Airport (CYVO), Quebec

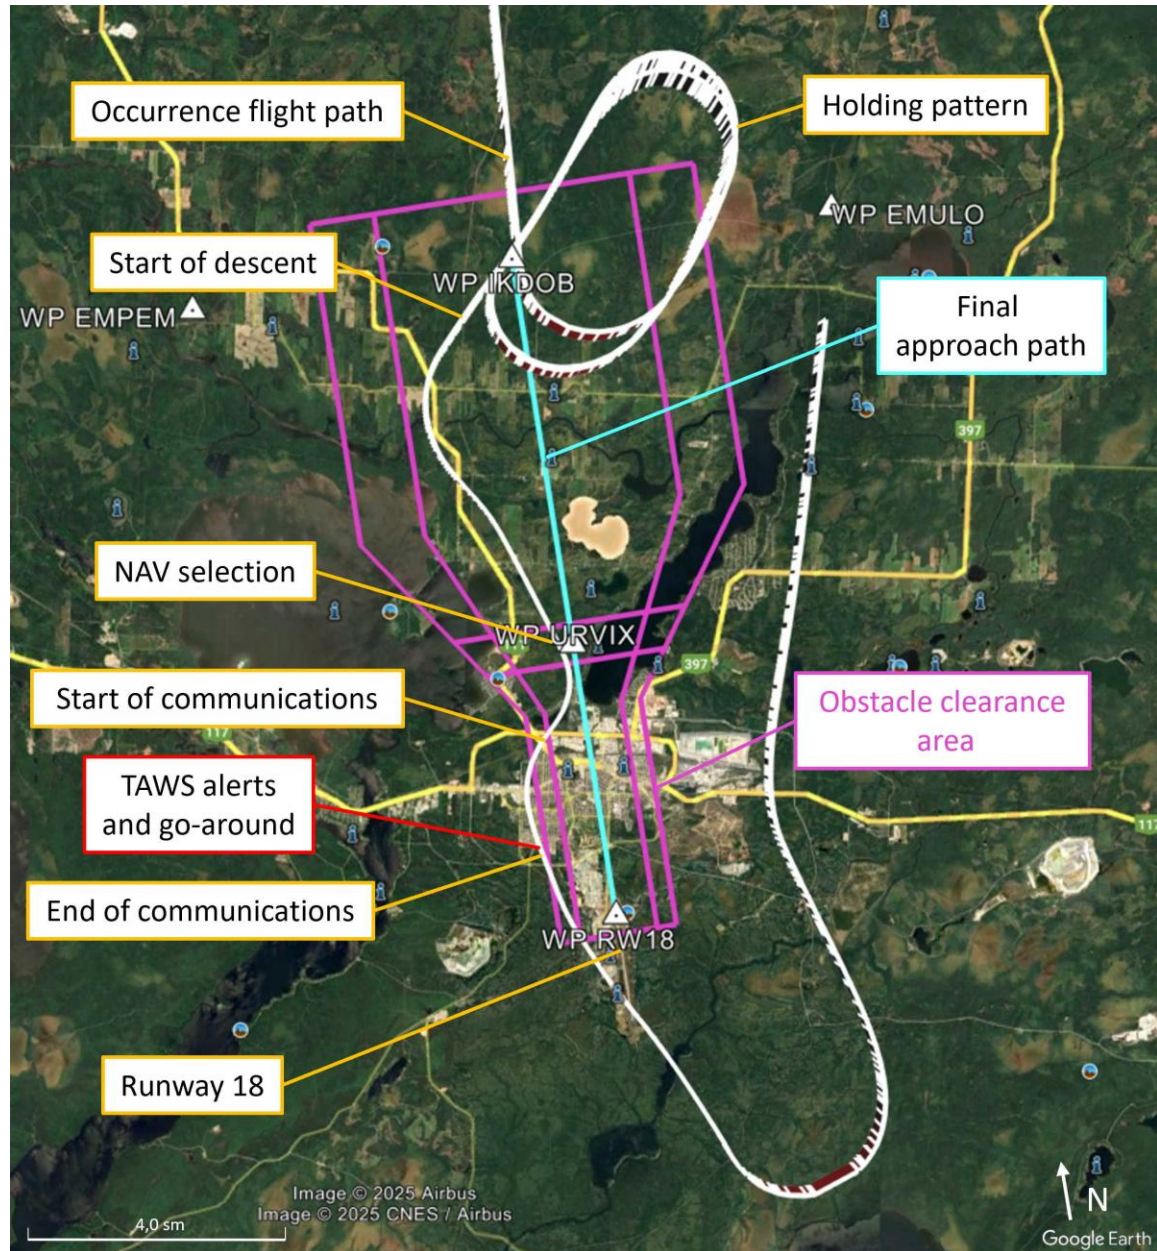
Figure 1. Map of the area of the occurrence, showing the occurrence flight path, Runway 18, the final approach path, the obstacle clearance areas, the holding pattern, the start of the descent, the point where NAV mode was selected, the point where the TAWS alerts were generated and the go-around conducted, and the point where communications ended (Source: Google Earth, with TSB annotations. Obstacle clearance area information provided by NAV CANADA.)

According to the flight data, the aircraft descended to 405 feet AGL when it was 0.96 NM to the right of the final approach path and 1.03 NM from the runway threshold, while still in a clean configuration and at 192 KIAS. The flight crew did not notice how close the aircraft was to the ground. The flight crew began the missed approach procedure and was cleared to

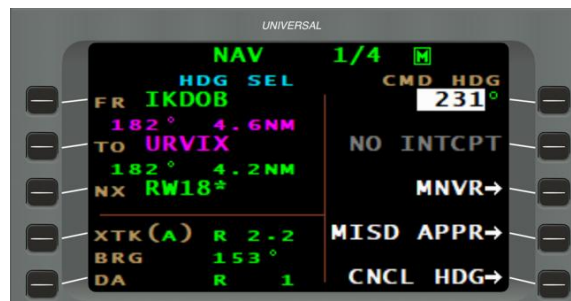
Figure 14. Navigation page in HDG SEL [heading selected] mode, after activation of the approach (Source: Universal Avionics, FMS Trainer v4.1.0.600)

(the 1st button on the right in Figure 14), and all that is left to do is to confirm the heading entered. On the occurrence flight, the aircraft's heading when the approach was activated, as the aircraft was exiting the hold, did not intercept the final approach path. In that case, NO INTCPT replaced the INTERCEPT function (the 2nd button on the right in Figure 14).

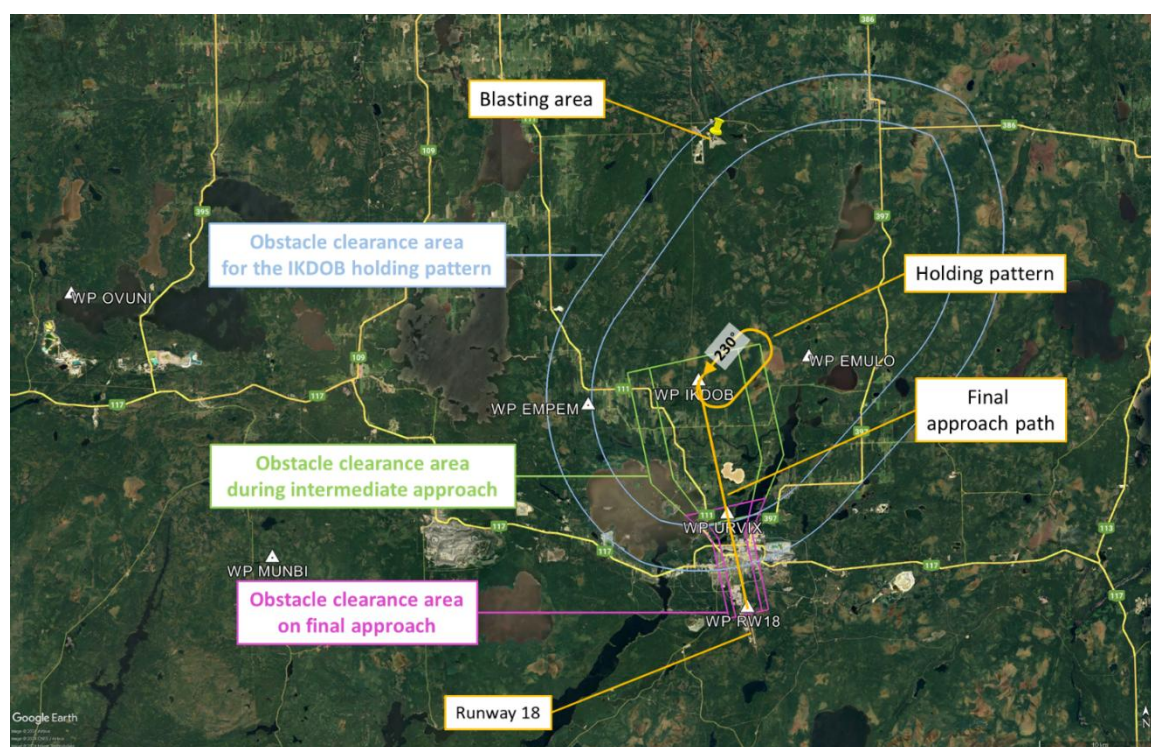
Figure 15. Map of the area of the occurrence showing the holding pattern at IKDOB on the RNAV (GNSS) RWY 18 approach to Val-d'Or Airport (Source: Google Earth, with TSB annotations. Information on obstacle clearance areas provided by NAV CANADA.)

When the RNAV (GNSS) RWY 18 approach to CYVO (Appendix B) was designed, the holding pattern at IKDOB was oriented 48° from the final approach path because of a blasting area north of IKDOB. Given this unusual orientation, when an aircraft exits the holding pattern, it must manoeuvre to get established on the final approach path (Figure 16).

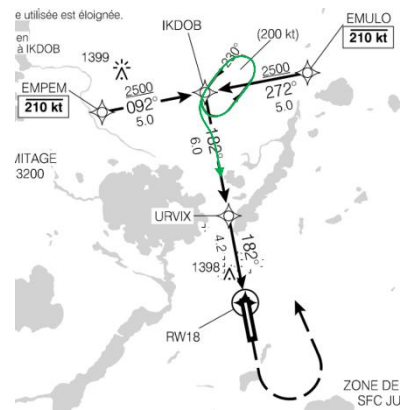
Figure 16. Diagram showing the flight path as the aircraft was exiting the holding pattern at IKDOB (Source: NAV CANADA, *Canada Air Pilot* [CAP], CAP 6: Quebec [effective 05 October 2023], with TSB annotations)

The aircraft was being guided by the flight management system (FMS) when it exited the holding pattern at initial approach waypoint IKDOB. At that point, the aircraft was above the approach slope and maintained a track that was divergent both laterally and vertically from the final approach trajectory. The flight crew attempted to recover the approach, but when the aircraft was near the ground, the terrain awareness and warning system (TAWS) generated alerts. The analysis will therefore focus on programming the FMS and the issues related to recovering an approach in high-workload conditions.

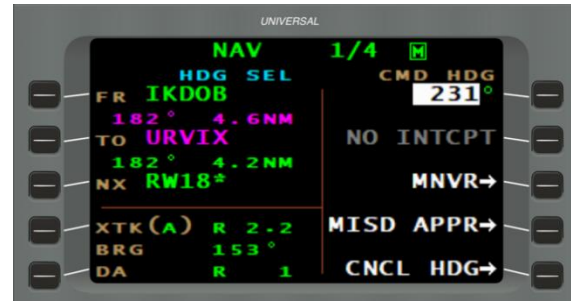
Figure 17. Navigation page in HDG SEL [heading selected] mode, after activation of the approach  
(Source: Universal Avionics, FMS Trainer v4.1.0.600)

The aircraft's heading is automatically proposed and highlighted in the entry field of the CMD HDG function in the FMS when the approach is activated. Therefore, as was the case for the occurrence aircraft, if the aircraft's heading diverges from the final approach path when the approach is activated, the proposed heading will not make it possible to intercept the final approach path, and NO INTCP [no intercept] will replace the INTERCEPT function (Figure 17).

In such a situation, the pilot must calculate and manually enter a heading that will enable interception of the final approach path so that the INTERCEPT function will be displayed. There is a high risk of error in calculating the new intercept heading and in entering the heading in the FMS because these tasks increase the workload at a critical point in a flight when the workload is already heavy.

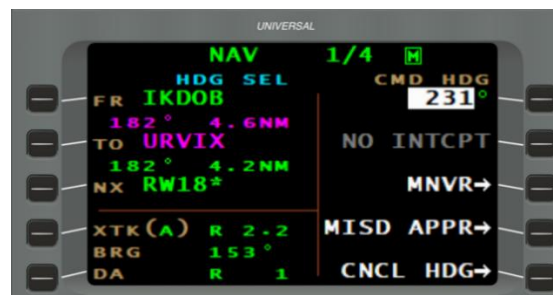
Then, as the flight crew flew toward final approach waypoint URVIX, given all the information displayed on navigation page NAV 1/4 (Figure 18), the flight crew did not notice that the FMS was still in HDG SEL mode and that NO INTCPT was displayed in grey. Consequently, the flight crew did not realize that the final approach path would not be intercepted once the autopilot NAV mode was selected. The flight crew members were not expecting the aircraft to turn right on the heading of 231° entered using the CMD HDG function, and deviate from the final approach path.

Figure 18. Navigation page in HDG SEL [heading selected] mode, as the aircraft flew toward waypoint URVIX (Source: Universal Avionics, FMS Trainer v4.1.0.600)

In this occurrence, the flight crew had to deal with the unexpected behaviour of the FMS, which required a number of actions to attempt to recover the final approach path. These actions delayed the coordination and completion of other actions that were critical to the flight, such as re-intercepting the approach slope, reducing speed, and configuring the aircraft for landing. A thorough understanding of the indications on the FMS pages, which are at times subtle, is important to cut down on the time needed to interpret the displayed indications, especially in a situation where there is a heavy workload.
