PIPELINE TRANSPORTATION SAFETY INVESTIGATION REPORT P24H0018

PIPELINE RUPTURE AND FIRE

NOVA Gas Transmission Ltd.
36-inch Grande Prairie Mainline
Near Edson, Alberta
16 April 2024

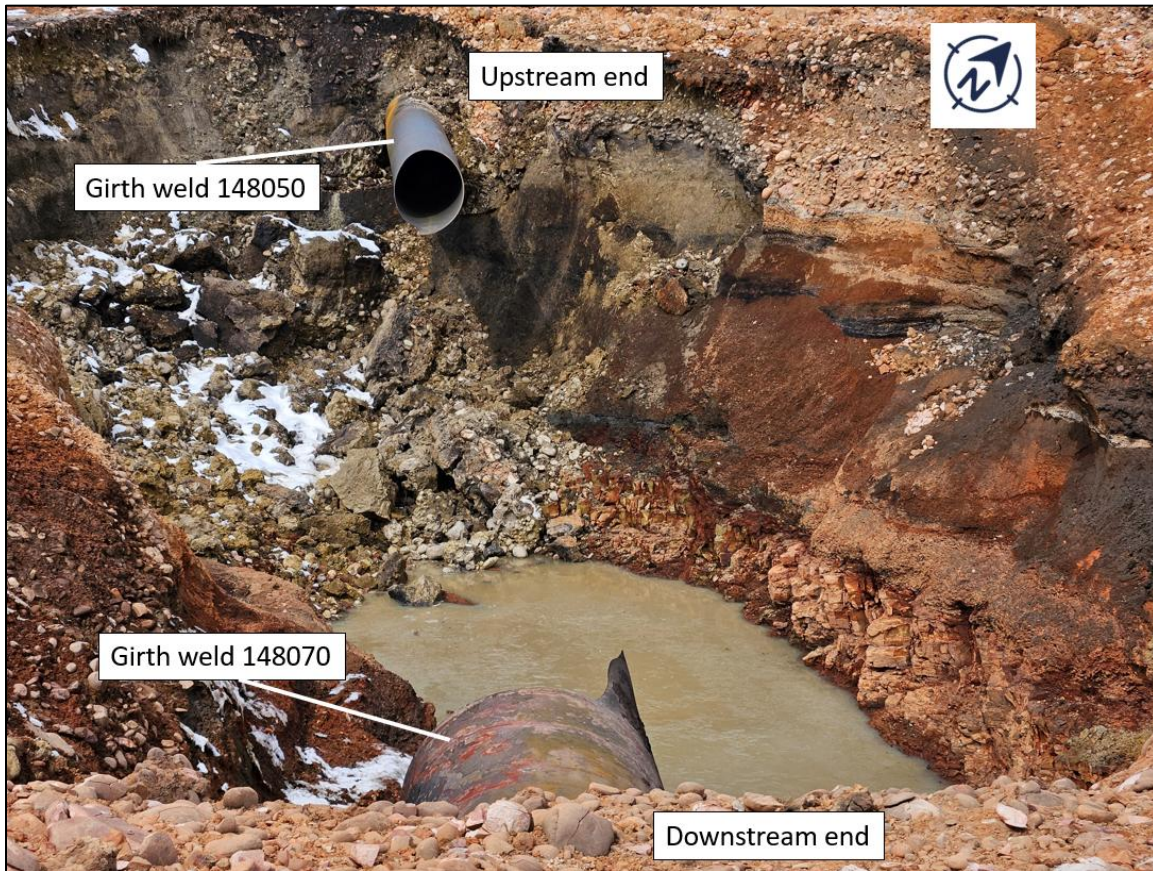
Figure 3. Crater created by rupture and explosion (Source: TSB)

The rupture and explosion created a 7 m-deep crater approximately 40 m by 20 m (Figure 3). The occurrence area is on a gradual southeastern slope on a grassy right-of-way surrounded by coniferous forest. The surface soil is mineral/organic with mineral subsoil consisting of fine and coarse particle size. The material from within the crater consisted of small pebbles and rocks ranging in diameter from 1 to 5 cm, boulders, clay, and shale rock from depths below 5 m.

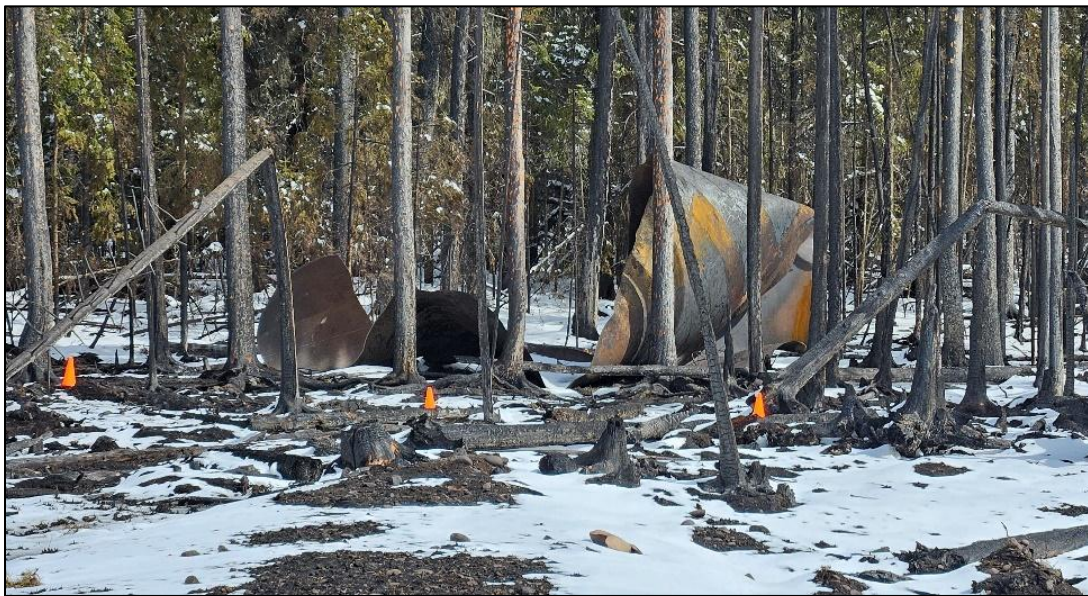
Figure 5. Piece 1 as found 200 m east of the occurrence location (Source: TSB)

The NPS 36 Grande Prairie Mainline was exposed at both the upstream and downstream ends of the ruptured section. Three large pipe pieces⁷ that were ejected during the rupture were located in the vicinity of the crater (Figure 4). All of the ejected pipeline material, approximately 20 m, was recovered. The largest piece, which included the rupture origin, was located 200 m east of the occurrence location (Figure 5). No damage to other nearby NGTL or third-party infrastructure was reported.

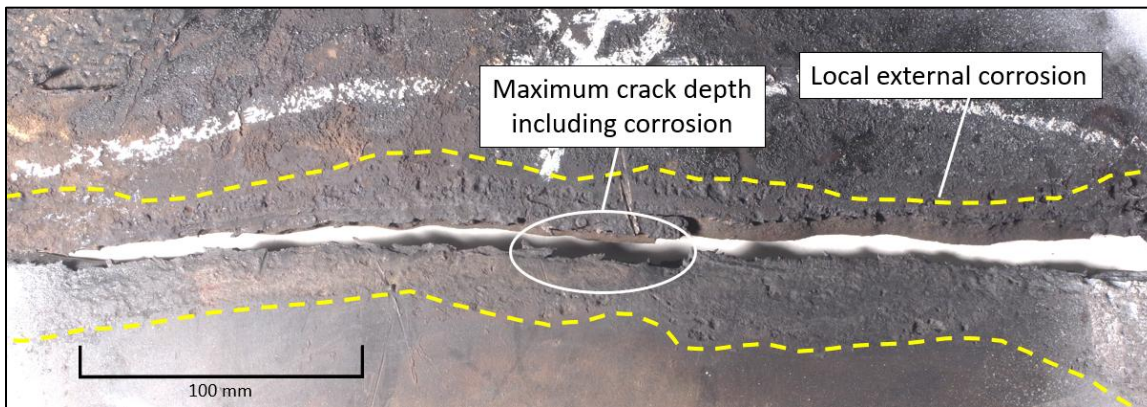
Figure 8. Re-assembled fracture surfaces showing local external corrosion at rupture location (Source: Acuren with TSB annotations)

The examined pipe components revealed the presence of general corrosion and stress corrosion cracking. The laboratory analysis determined the failure of the NPS 36 Grande Prairie Mainline to be the result of axially oriented near-neutral pH stress corrosion cracking. The crack at the rupture location was between 8.96 m and 9.33 m downstream of girth weld 148050. All other fractures were ductile fractures resulting from the force of the pipe rupture. External corrosion was present in the local area around the rupture location (Figure 8).

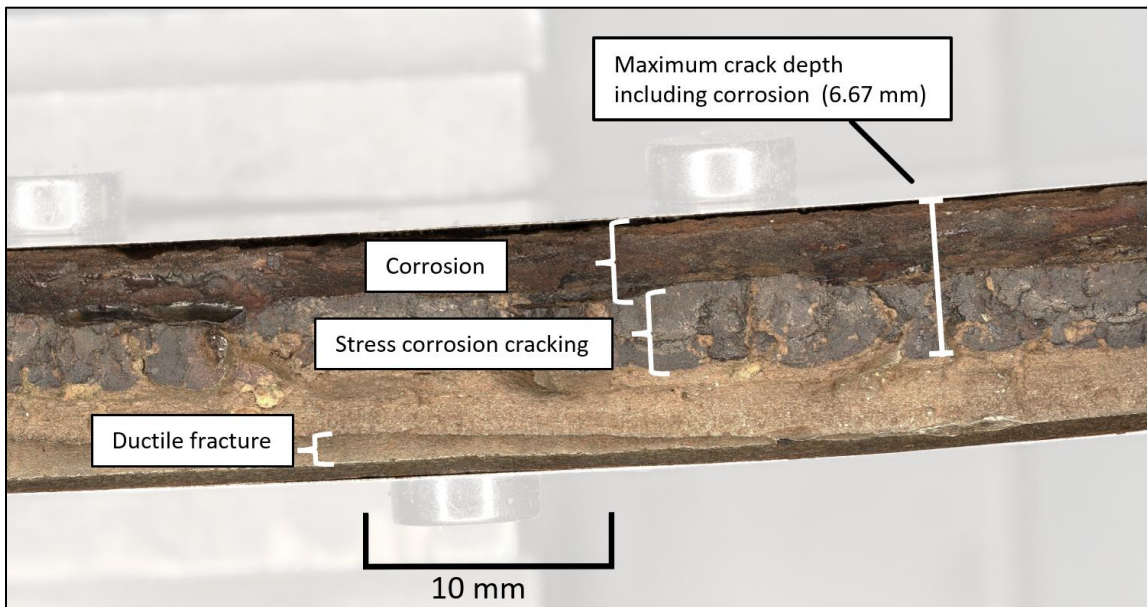
Figure 9. Crack profile between 9.02 m and 9.07 m downstream of girth weld 148050 (Source: Acuren with TSB annotations)

The maximum crack depth, including corrosion,¹⁶ at the rupture location was 6.67 mm, or 67% of the pipe wall thickness (Figure 9).¹⁷ The next deepest cracks on joint 148050 were found to be at maximum depths of 3.86 mm and 2.02 mm, respectively. Cracks on joint 148070 had maximum depths from 1.03 mm to 1.25 mm; otherwise all other measured crack depths were less than 1.00 mm.

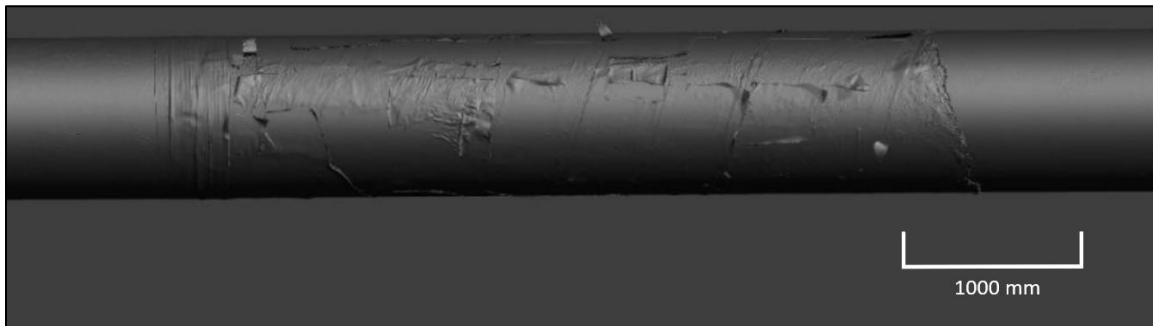
Figure 10. Example of coating assessment (Source: Acuren)

The pipe coating was analyzed¹⁸ and determined to be high-density polyethylene tape coating. The double-layer tape coating was initially bonded with polyisobutylene and silicate minerals. The tape coating was assessed with the use of 3-dimensional laser scanning. The pipe was scanned with the remaining tape coating still in place, followed by a scan with the disbonded tape removed. A final scan was conducted after the pipe was sandblasted to remove all remaining tape coating and reveal the corroded pipe surface. An example coating assessment scan is presented in Figure 10. Where tape remained on the recovered pipe sections, a considerable area was found to be disbonded. Corrosion, where present, tended to follow areas of coating disbondment and tape wrap lines.
