Transportation  
Safety Board  
of Canada

# MARINE TRANSPORTATION SAFETY INVESTIGATION REPORT M23P0235

## ACCIDENTAL RELEASE OF FREE-FALL LIFEBOAT AND CREW INJURY

Bulk carrier *Golden Zhejiang*  
Trincomali Channel, British Columbia  
02 September 2023

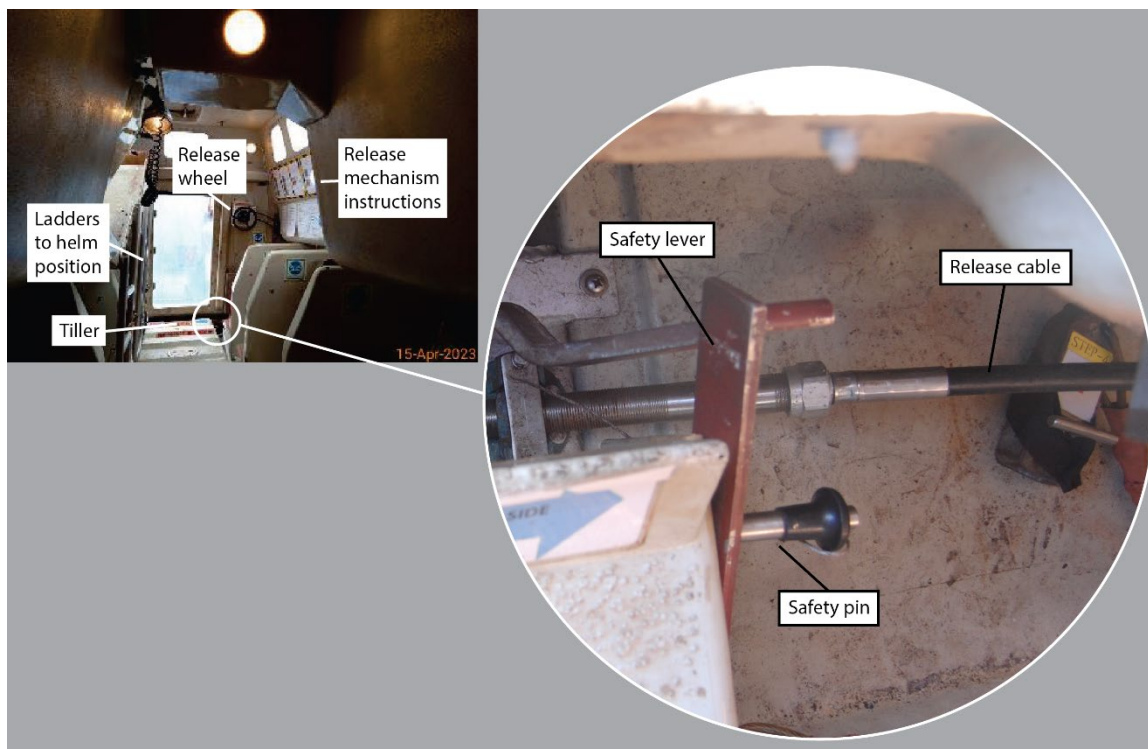
Figure 4. The interior of the lifeboat, facing aft. Inset shows the release cable, safety lever, and safety pin (Source of main image: Columbia Shipmanagement Ltd., with TSB annotations; Source of inset: TSB)

The first seat on the lifeboat's port side is the release station, with the release wheel in front of the seat (Figure 4) and the safety pin and safety lever to 1 side of the seat (Figure 4, inset). The helm station is accessed by ladders slightly forward and on the lifeboat's starboard side.

The *Golden Zhejiang's* crew reported that after the occurrence, the lifeboat was found with the safety pin removed and the safety lever in the forward position. The investigation found no records confirming that the release mechanism was in place beyond general reference in the weekly safety checks and the monthly safety meeting minutes. The last recorded release

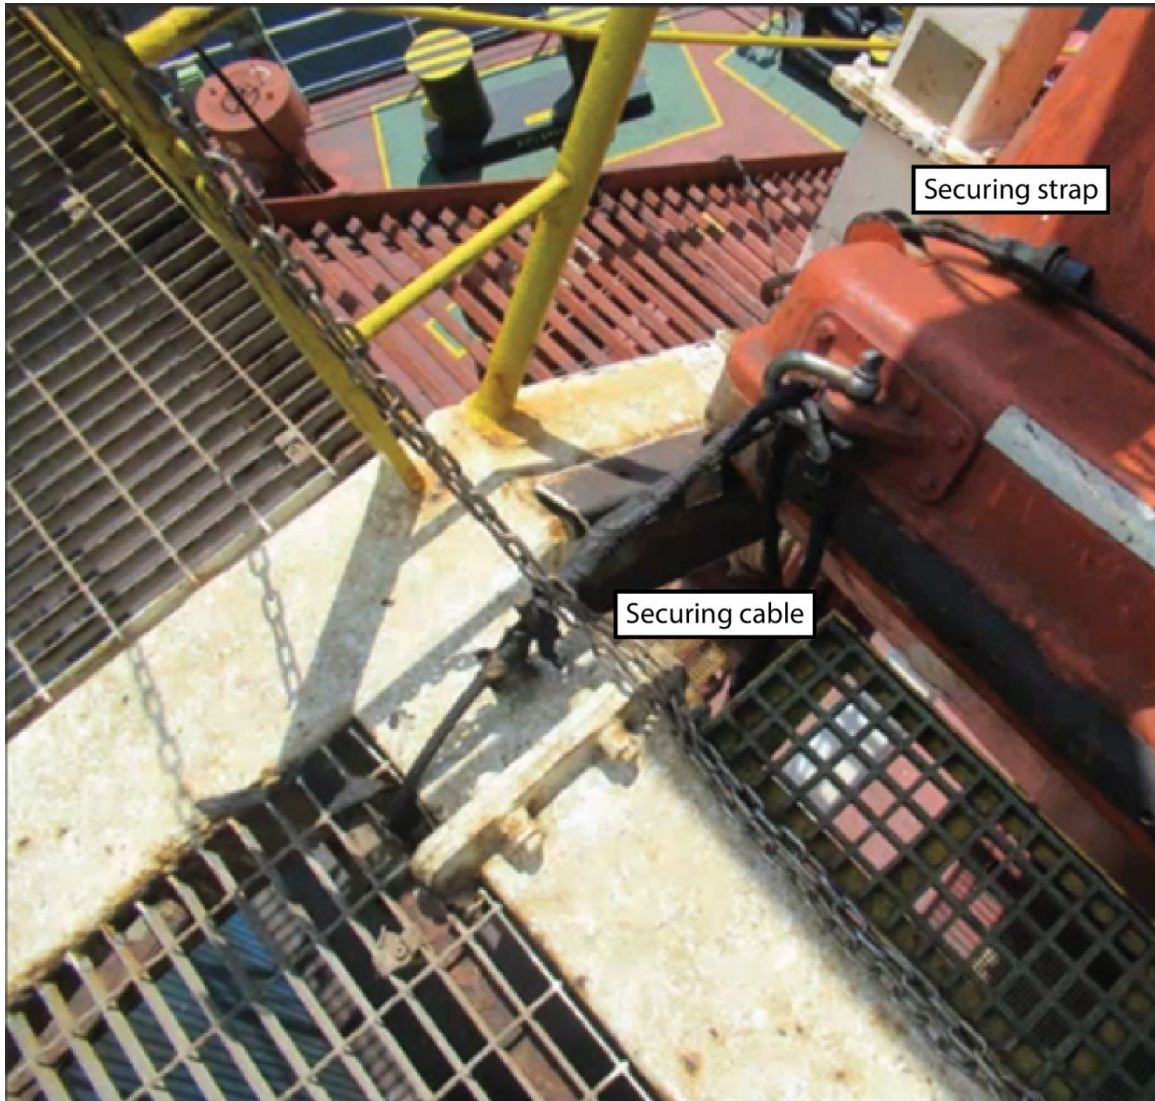
Figure 9. The free-fall lifeboat securing arrangements, with securing cables and a securing strap, before the occurrence (lifeboat port side) (Source: Columbia Shipmanagement Ltd.)

When the *Golden Zhejiang* was at anchor, in addition to the at-sea securing arrangements, the lifeboat was lashed to the launching structure by 2 cables (securing cables), 1 on each side of the lifeboat (Figure 9). At the time of the occurrence, the cables were in place.

The investigation could not obtain any load test certificates, purchase records, maintenance documents, or other certifications for these 2 cables. For other load-bearing cables on the *Golden Zhejiang*, the safety officer maintained such records. The securing cables were not listed in the deck equipment certifications, where items such as gangway, crane, and davit wires were listed.

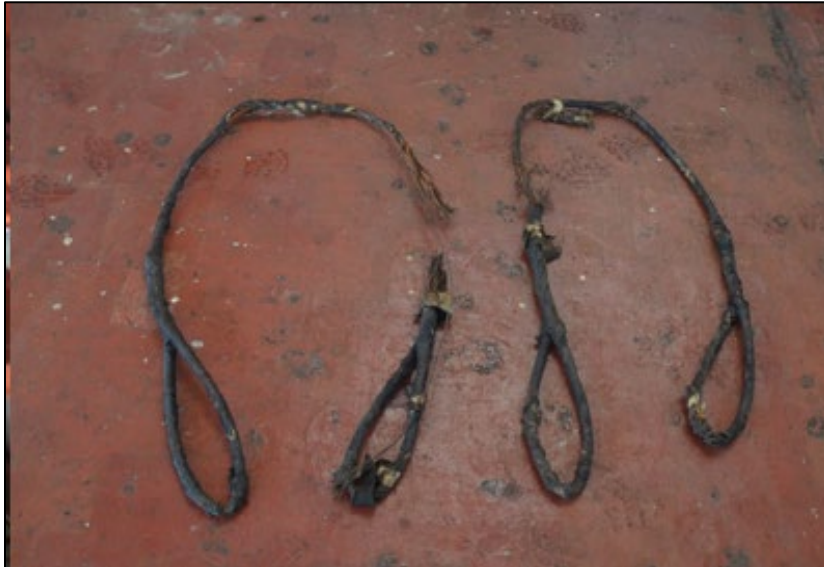
Figure 10. The 2 failed cables, post-occurrence (Source: TSB)

The TSB laboratory examined the cables used to secure the lifeboat (Figure 10) and performed calculations to estimate the dynamic load that would have been exerted on the 2 cables when the lifeboat was released. It was concluded that as installed, with visible slack, this kind of cable was inadequate for securing the lifeboat. It was also concluded that the cables failed likely because of the high shock loads to which they were subjected.

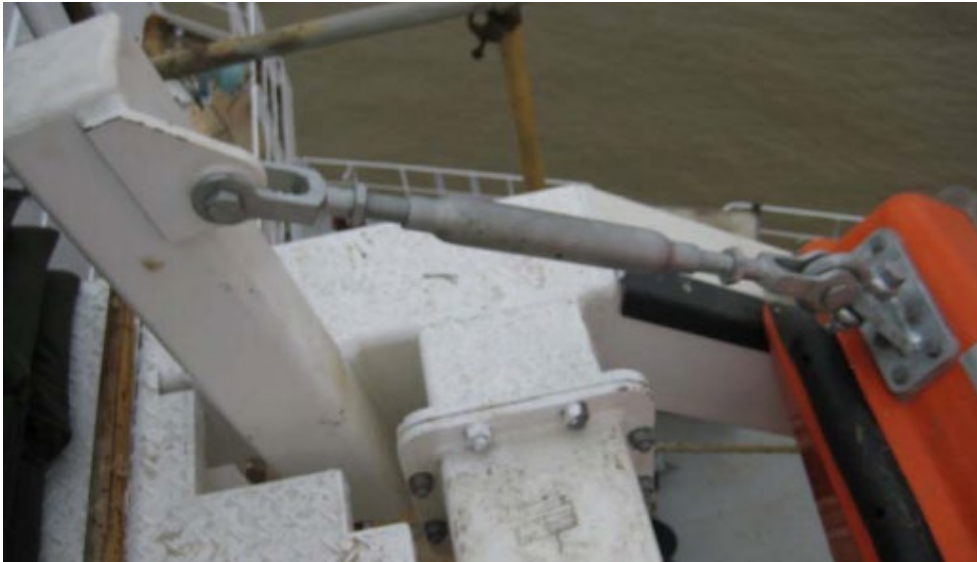
Figure 11: Turnbuckles to secure the lifeboat during training and maintenance, as recommended by the manufacturer (Source: Viking-Norsafe AS)

In the 2008 version of the lifeboat manual held on board, the lifeboat manufacturer recommended the use of turnbuckles on both sides of the lifeboat (Figure 11) to secure the lifeboat to the vessel during free-fall training. The 2020 version of the manual added that the turnbuckles should also be used for maintenance. At the time of the occurrence, CSM was not aware of or in possession of the 2020 version of the manual, and such turnbuckles were not in use on the *Golden Zhejiang* lifeboat.

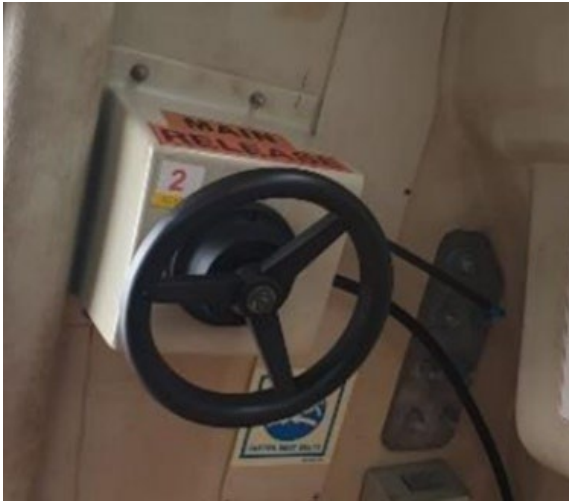
Figure 12. The release wheel on the lifeboat (Source: Columbia Shipmanagement Ltd.)

In the *Golden Zhejiang's* lifeboat, the release wheel (Figure 12) was identical to the steering wheel at the helm station. In 2012, the IMO published guidelines<sup>8</sup> that recommended that the lifeboat release control should be on the right side of the helm and have a shape and operation that cannot be easily confused with other controls.<sup>9</sup> Like the IMO circulars about fall preventer devices for securing lifeboats, these guidelines excluded free-fall lifeboats.

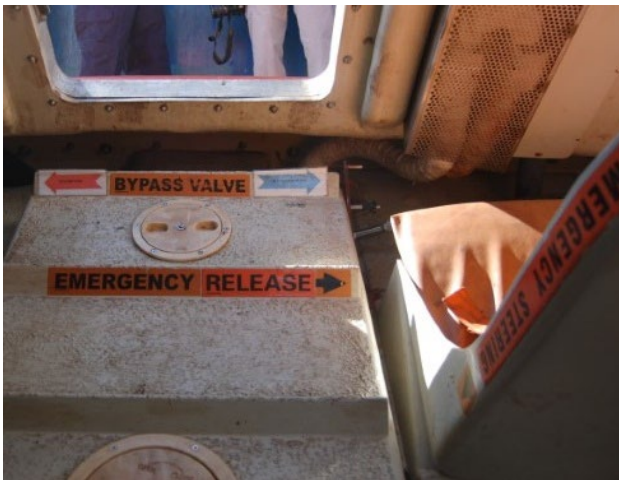
Figure 13. The release station, viewed from within the lifeboat and facing the door, showing labels in place at the time of the occurrence (Source: TSB)

At the time of the occurrence, the labelling inside the lifeboat at the release station was missing or unclear:

- The labels for the release mechanism were the same colours and font as the labels for other controls and positions throughout the lifeboat.
