AIR TRANSPORTATION SAFETY INVESTIGATION REPORT A23P0153

COLLISION WITH TERRAIN

Wilderness Seaplanes Ltd.

Grumman G-21A, C-GDDJ

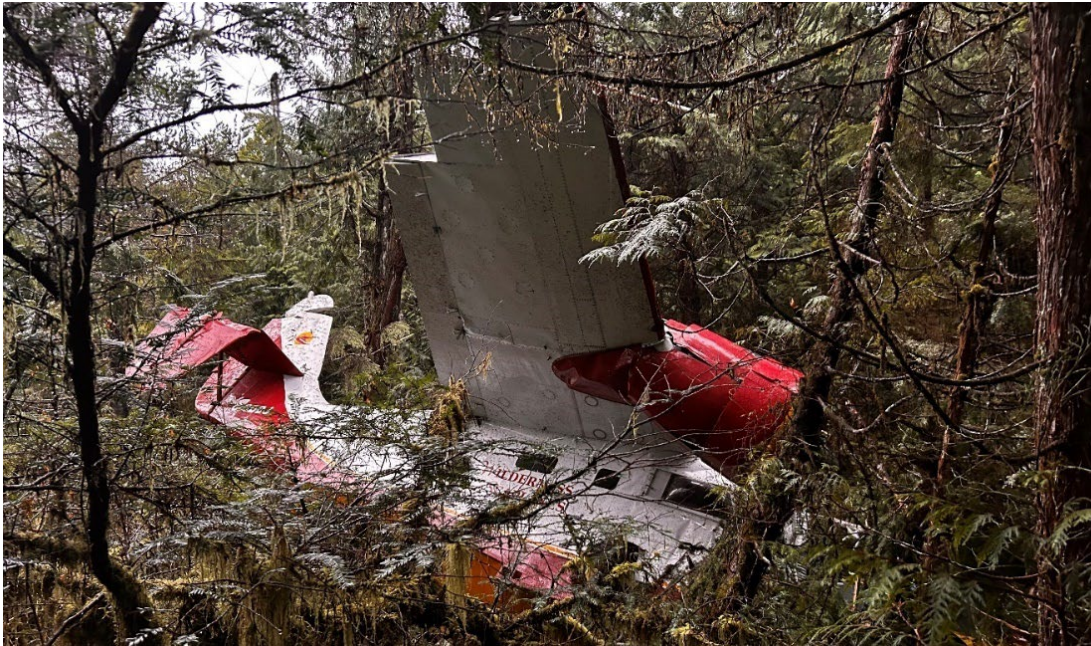
Figure 3. Occurrence wreckage (Source: RCMP)

The leading edge of each wing showed signs of impacting trees, and the outer portion of each wing was separated from the aircraft. The right engine nacelle and nose of the aircraft exhibited significant deformation. The right horizontal stabilizer was broken downward at a 90° angle. Both propellers appeared undamaged, indicating no propeller rotation at the time of the collision. The propellers were found unfeathered with the cockpit controls in the full fine position.

The occupiable space within the cockpit was partially compromised, with terrain intruding into the footwell area of the cockpit. The occupiable space within the passenger cabin was uncompromised.

The aircraft landing gear was found partially extended post-impact.

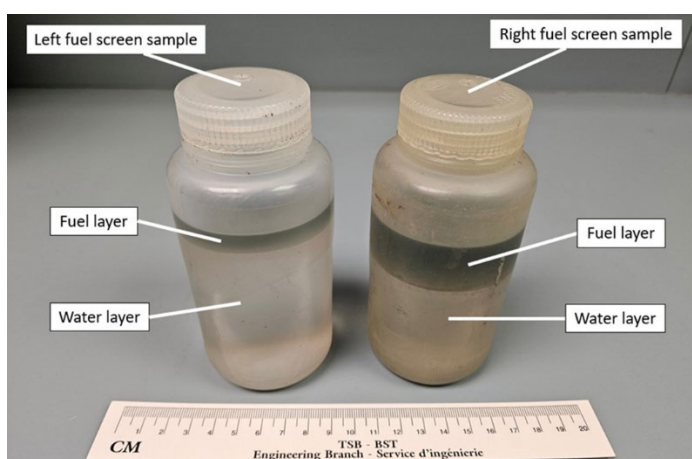
Each fuel sample exhibited the presence of water and failed all 3 parameters²⁴ of the American Society for Testing and Materials (ASTM) D4176 visual test. Aircraft engines may continue to run with up to a maximum of 30 parts per million (ppm) of non-dissolved water, provided it is uniformly dispersed within the fuel.²⁵ With the exception of the fuel layer collected from the left wing fuel sump during the

2nd sample collection, all samples had more than 30 ppm of water content, with the majority of samples in excess of 25 000 ppm²⁶ (Table 4). The highest concentrations of water were measured in wing fuel sump locations, or in the lower settled layer of fuel samples.

Figure 4. The 2 fuel samples taken from the occurrence aircraft's engine fuel screens (Source: TSB)

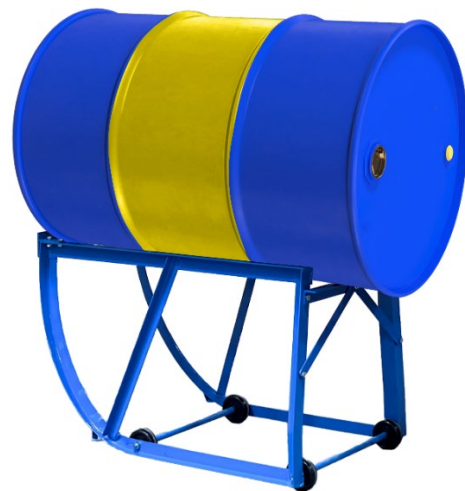
Figure 5. A fuel drum stored horizontally with the vent and bung at the 3 o’clock and 9 o’clock positions, respectively (Source: TSB).

bung of the drum was reinserted. The plastic seal that covers the bung, once removed, cannot be reinstalled. The drum was not marked or labelled as having been opened and was returned to storage rather than isolated or quarantined as an unsealed drum. When the drum was opened by the occurrence pilot on the day of the occurrence, the threaded bung was found to be only finger tight.

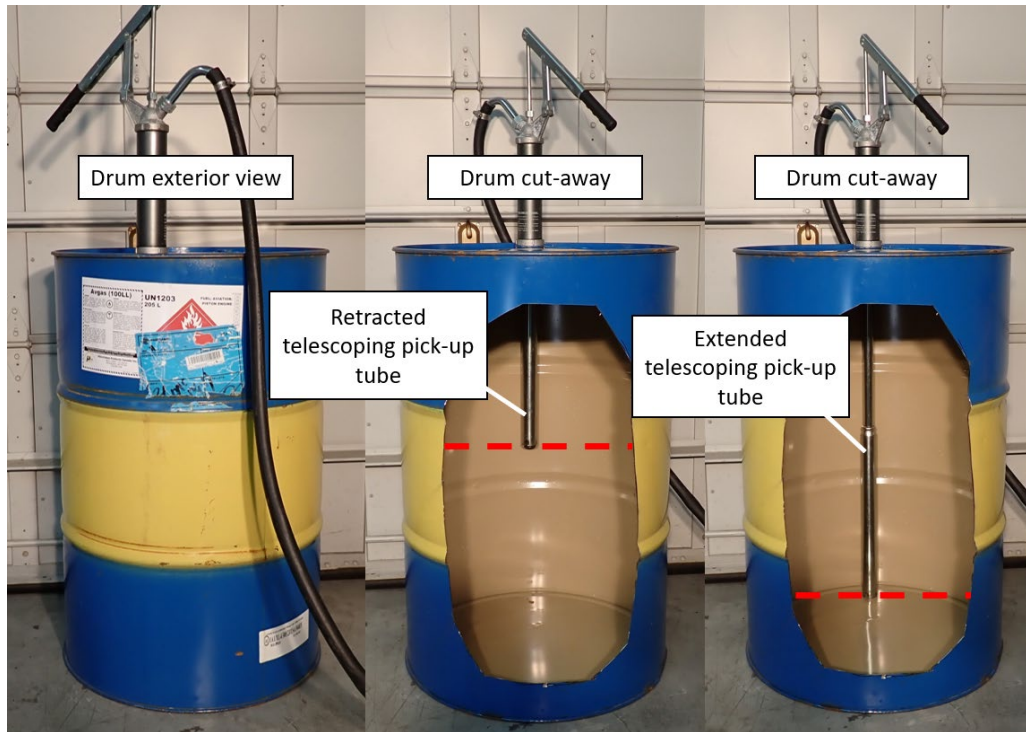
The hand pump provided for drum fuelling leaked fuel from its top while in use, and the pump was not a model that was suitable for use with fuel, including 100LL Avgas with which the occurrence aircraft was fuelled. After the hand pump was used for the 1st time,²⁹ the operator decided to replace it with an electric pump because the hand pump leaked and transferred fuel at a slow rate. It was planned to introduce the electric pump to service by the end of December 2023. On the day of the occurrence, the replacement pump was not yet available, and the hand pump was still in service.

Figure 6. The hand pump and fuel drum used to fuel the occurrence aircraft. Left: Drum exterior. Middle: Drum cut-away showing the retracted telescoping pick-up tube. Right: Drum cut-away showing the extended telescoping pick-up tube. The approximate fuel pick-up point is indicated by a red dashed line. (Source: TSB)

After fuelling of the Beaver was completed, the occurrence pilot fuelled the occurrence aircraft while the Beaver pilot operated the hand pump. Because the telescoping pick-up tube of the hand pump had not been fully extended, the flow of fuel stopped once it was drawn down to the approximate halfway point of the drum. The Beaver pilot then uninstalled the hand pump and extended the telescoping pick-up tube before reinstalling the pump and resuming fuelling. The remaining contents of the drum accessible by the fully extended telescoping pick-up tube was pumped into the occurrence aircraft. A fuel sample from the lower portion of the drum was not taken or examined.
