# AIR TRANSPORTATION SAFETY INVESTIGATION REPORT A25P0041

## COLLISION WITH TERRAIN

Chinook Helicopters (1982) Ltd.

Cessna 172S, C-GHCC

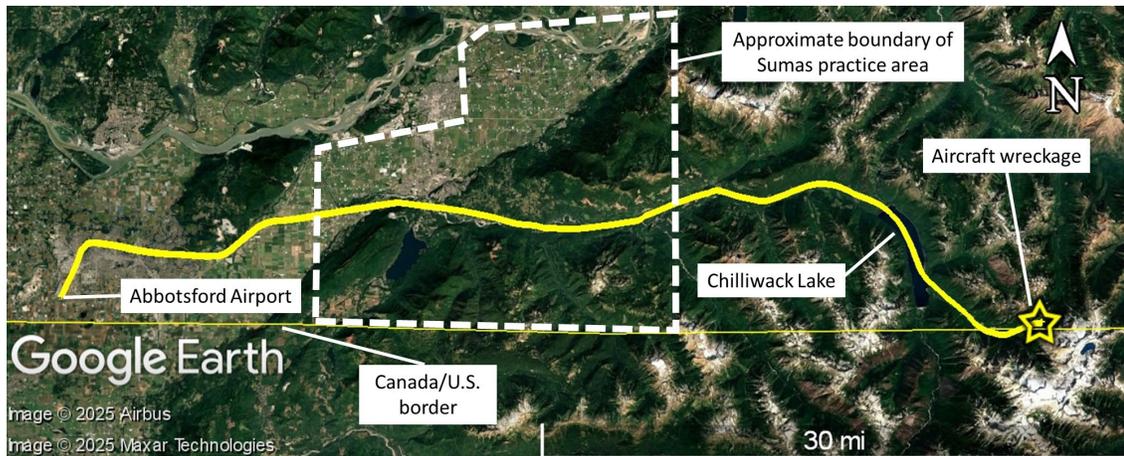
The aircraft departed from Runway 01 at CYXX at approximately 1228<sup>3</sup> and proceeded east. Approximately 34 nautical miles (NM) east of CYXX, the aircraft turned southeast and began climbing at 175 fpm while flying over Chilliwack Lake (Figure 1).

Figure 1. Map showing the complete track of the occurrence flight with the approximate boundary of the Sumas practice area indicated by the dashed line (Source: Google Earth, with TSB annotations)

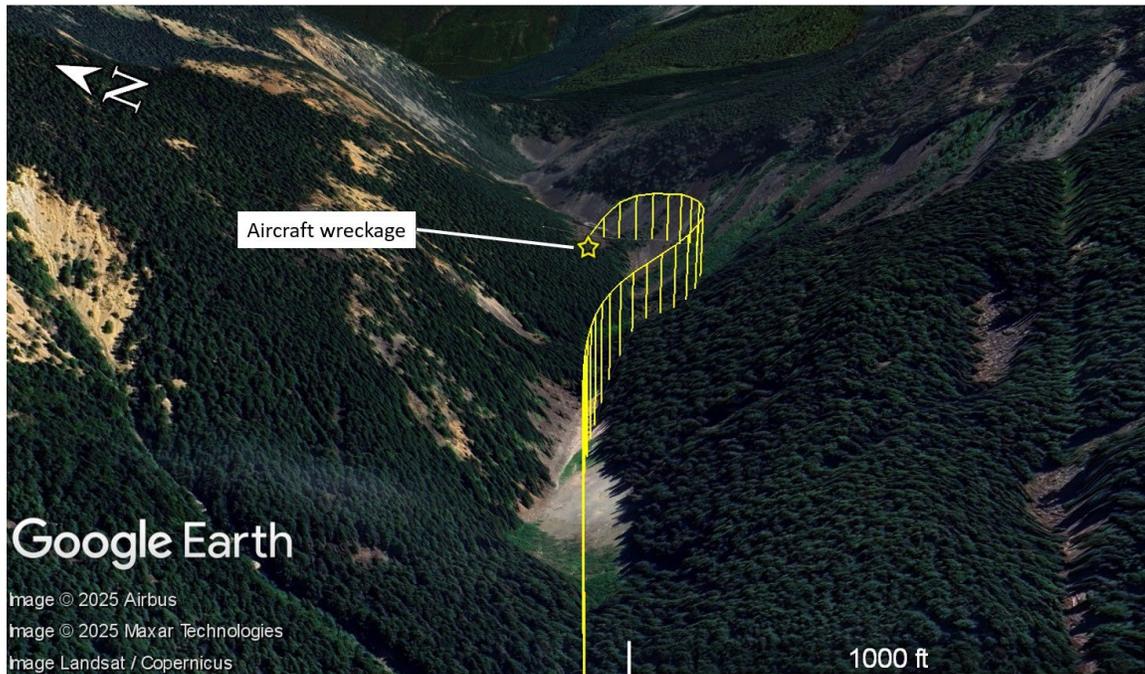
Over a span of 8 seconds the aircraft descended approximately 350 feet, while slowing from 72 knots to 45 knots ground speed in a left turn. The aircraft then began to accelerate while continuing to descend. At 1300, the aircraft impacted terrain at approximately 4000 feet ASL while heading northwest (Figure 2). Both occupants of the aircraft were fatally injured.

Figure 2. Map showing the last portion of the occurrence flight (Source: Google Earth, with TSB annotations)

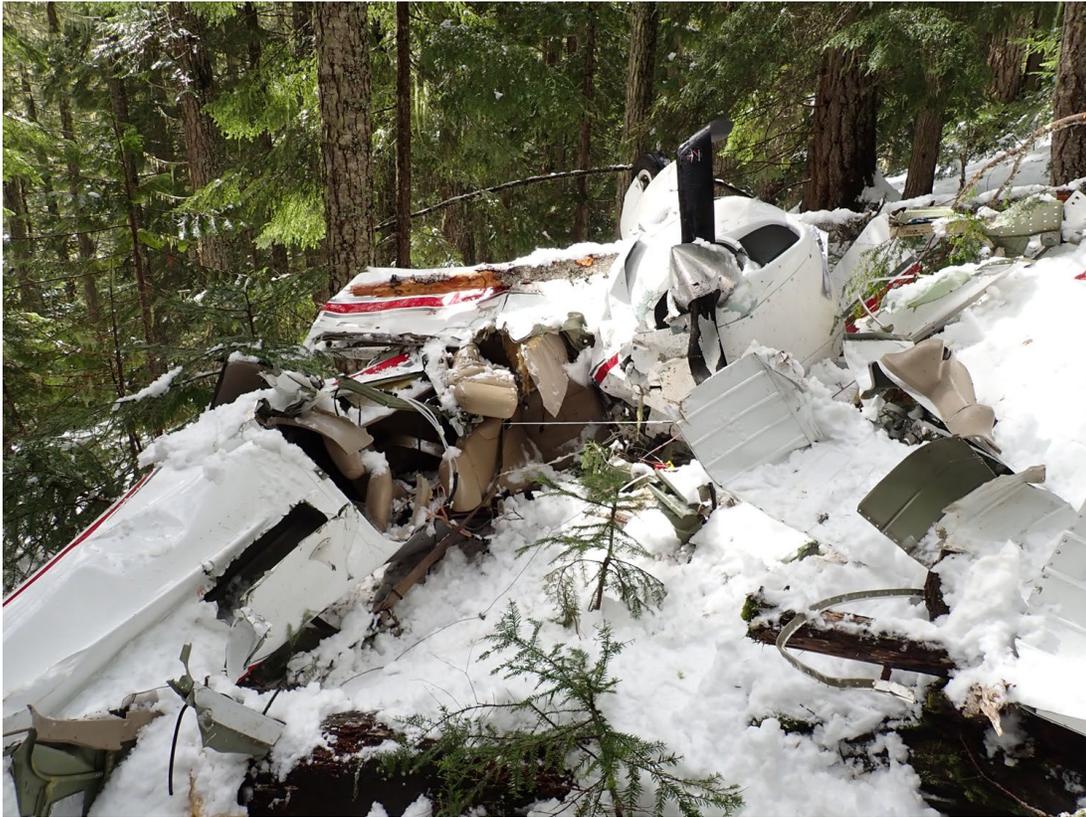
The aircraft wreckage was found in a forested area on a mountain side, at approximately 4000 feet ASL (Figure 4). The accident site was characteristic of a high-energy impact with a linear debris trail. The aircraft came to rest west of its 1st point of contact with trees and terrain.

Figure 4. Aircraft wreckage (Source: TSB)

The investigation determined that the aircraft was intact before the collision, and all aircraft components were accounted for at the accident site. The damage to the leading edges of the aircraft wings and horizontal stabilizer was consistent with impacting trees. The flaps, flap selector lever, and flap position indicator were all found in the up position.

The aircraft wings, vertical stabilizer, and right horizontal stabilizer were found separated from the fuselage. The occupiable space within the aircraft cabin was compromised and the ceiling of the cabin was separated from the fuselage.
