RAIL TRANSPORTATION SAFETY INVESTIGATION REPORT R25T0177

CROSSING COLLISION

Canadian Pacific Railway Company, doing business as CPKC
Intermodal train 113-13
Mile 115.64, CPKC Belleville Subdivision
Township of Cramahe, Ontario
14 July 2025

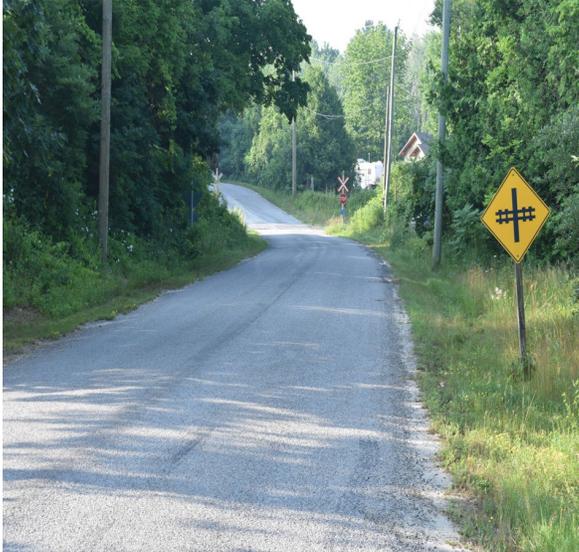
The CPKC crossing further south (the occurrence crossing) is a passive public crossing equipped with a standard retroreflective crossing sign (SRCS) and a stop sign. In the final approach to the crossing from the southbound direction, the road curves gently to the left, on a 5° downgrade, and crosses the Belleville Subdivision at an 85° angle (figures 2 and 3). The surface of the public roadway is paved and, at the time of the occurrence, the pavement was dry.

Figure 2. Southbound approach to the CPKC Hunt Road grade crossing (Source: TSB; photo taken on 16 July 2025 in environmental conditions similar to the conditions at the time of the occurrence)

On 15 July 2025, CPKC performed localized brush cutting activities to improve sightlines in the vicinity of Mile 115.64 of the Belleville Subdivision. The railway also cleared brush partially obstructing northward and southward advance warning signs for this crossing.

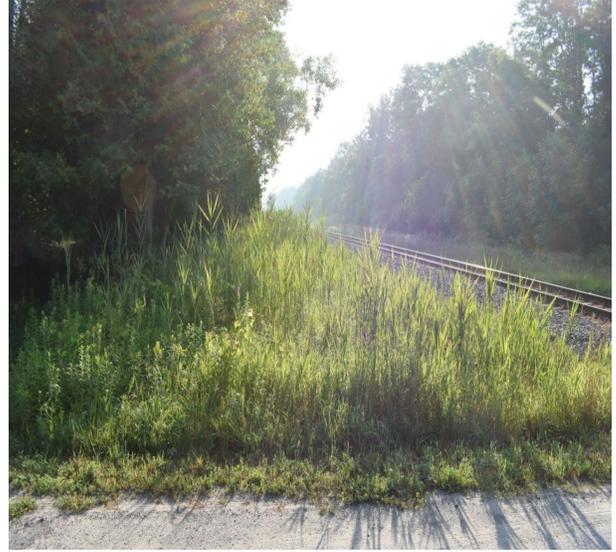
Figure 3. View to the southeast of the CPKC Hunt Road grade crossing, from a position approximating that of a driver of a southbound vehicle (Source: TSB; photo taken on 16 July 2025 in environmental conditions similar to the conditions at the time of the occurrence)

The day after the occurrence, Transport Canada (TC) inspected the crossing and found non-compliances with the *Grade Crossings Regulations*. The TC inspection expressed concern about the sightlines from the stopping sight distance, indicating that they "may not be adequate for the grades as well as current road use."⁶ Furthermore, TC indicated that "vegetation management [was] required along all approaches of the crossing to ensure that all warning signs are visible to road users."

On 24 July 2025, following its 15 July inspection of the crossing at Hunt Road crossing, TC issued a Letter of Non-Compliance to the Township of Cramahe describing the non-compliances and concern noted at the crossing. The non-compliances were related to signage and crossing surface conditions, and a concern was also noted for sightlines at the crossing. TC conducted a follow-up inspection on 24 August 2025 during which it identified that no visible change in the conditions noted in the Letter of Non-Compliance had taken place. Therefore, TC sent a Letter of Insufficient Action to the Township of Cramahe highlighting the items that required its further attention. On 12 September 2025, the Township of Cramahe indicated to TC that the vegetation had been cleared. On 16 October 2025, the Township finished the pavement markings at the crossing.
