MARINE TRANSPORTATION SAFETY INVESTIGATION REPORT M24C0142

COLLISION

Passenger vessel *Navark Faucon Millenium* and pleasure craft
St. Lawrence River
Longueuil, Quebec
27 June 2024

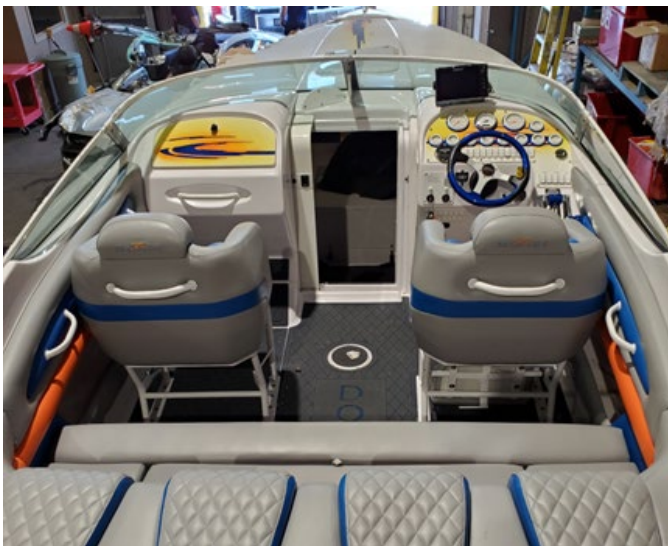
Figure 3. The cockpit of pleasure craft 59E53608 after the occurrence (Source: TSB)

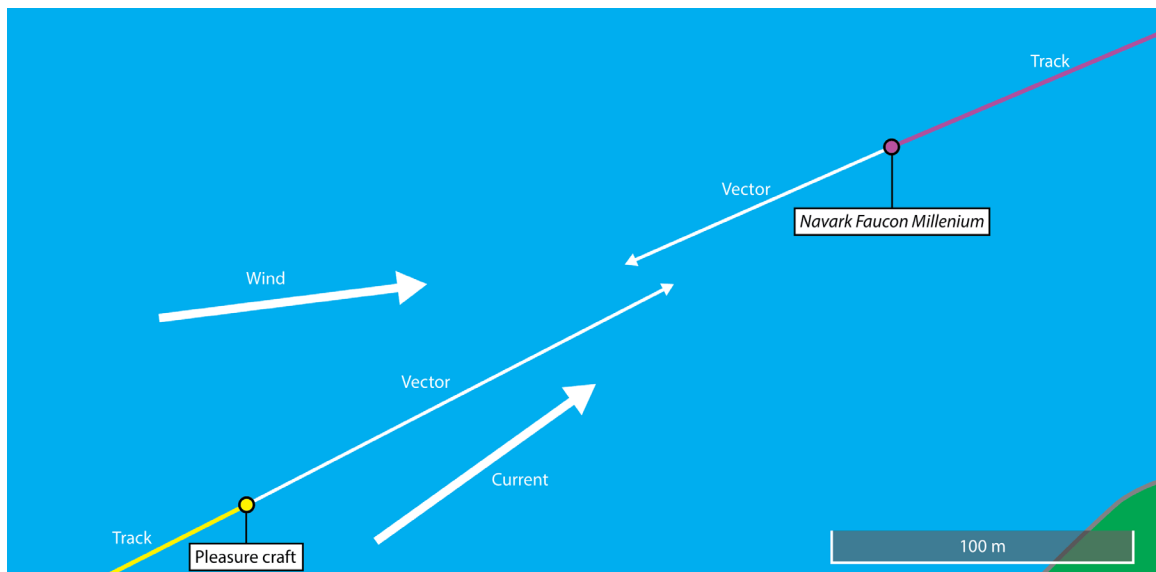
At approximately 1455, the pleasure craft operator saw the *Navark Faucon Millenium*. He visually estimated that the craft and passenger vessel would pass each other port-to-port at a distance of approximately 7 m. He maintained an average course of 060°T and a speed of 32 knots. At 1455:40, 15 seconds before the collision, the pleasure craft and passenger vessel were 0.12 NM (225 m) away and were maintaining their courses to pass clear of each other (Figure 5).

Figure 5. Diagram showing the pleasure craft's and the *Navark Faucon Millenium*'s positions at 1455:40, the charted track for the *Navark Faucon Millenium*, the predicted course vectors for the *Navark Faucon Millenium* and the pleasure craft, and the directions of the wind and current (Source: TSB, using data derived from the TSB's Marine Accident Data Analysis Suite)

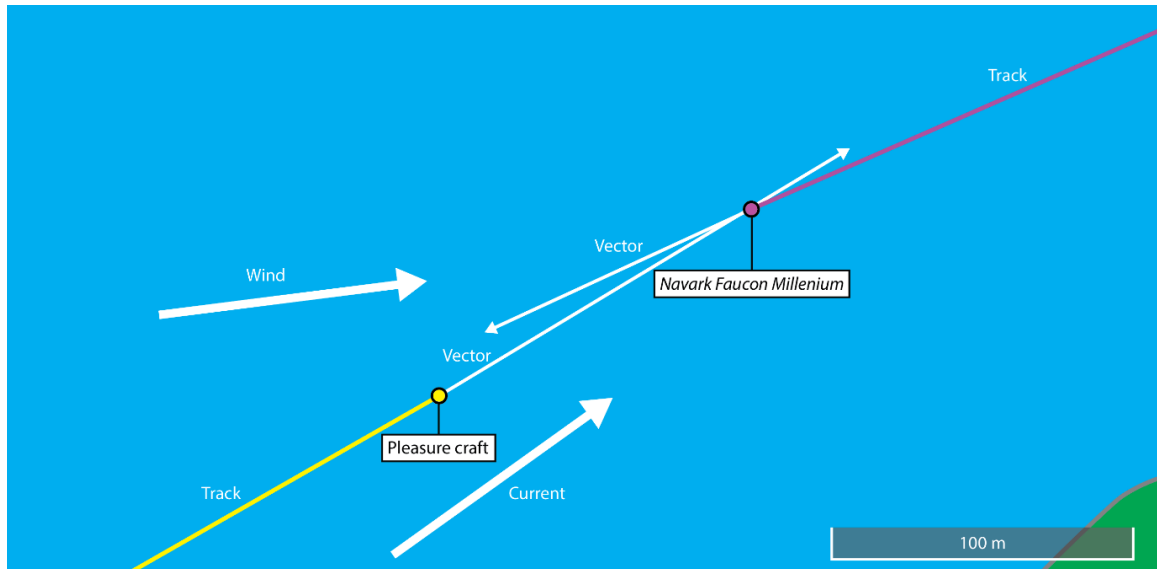
At 1455:45, when the distance between the vessels was approximately 0.06 NM (110 m), the pleasure craft's course suddenly changed by 4° to port, directly into the path of the *Navark Faucon Millenium* (Figure 6). The investigation found no evidence that operator input caused the unexpected alteration to port.

Figure 6. Diagram showing the pleasure craft's and the *Navark Faucon Millenium*'s positions at 1455:45 (Source: TSB, using data derived from the TSB's Marine Accident Data Analysis Suite)

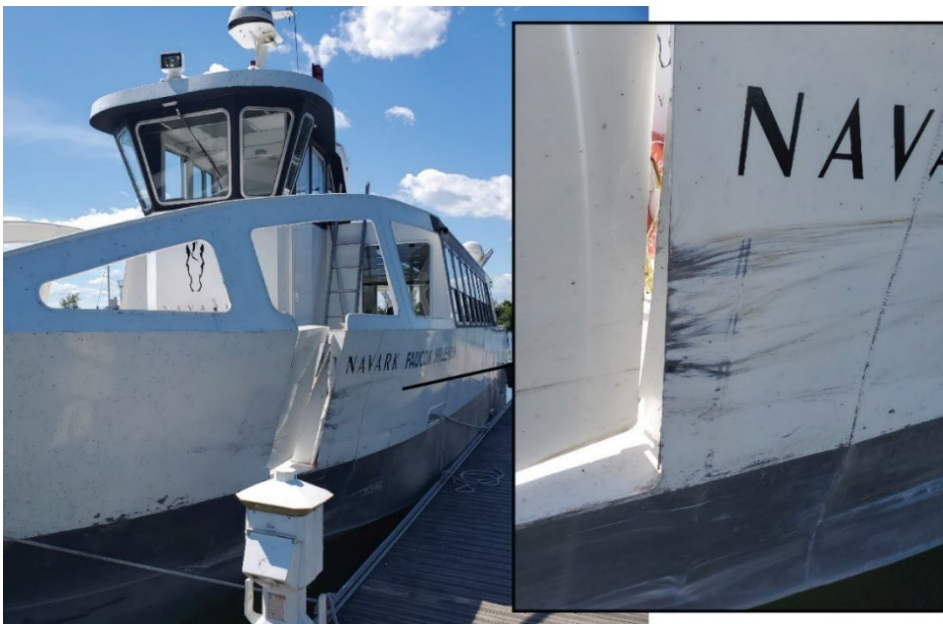
The *Navark Faucon Millenium* sustained minor damage near its port forward access gate (Figure 7) and inside its bulwark.

Figure 7. Damage near the *Navark Faucon Millenium*'s forward access gate (Source: TSB)

Transport Canada conducted an inspection of the hull, during which damage was found. A periodic inspection validated the temporary repairs to the hull, and a new deadline was set for permanent repairs to be made.

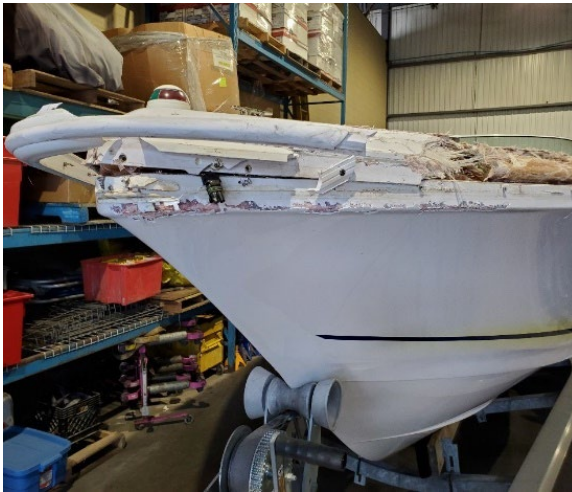
The pleasure craft was declared a constructive total loss, sustaining major damage to the bow (Figure 8), compression fractures along the port side from bow to stern, and damage below the waterline (Figure 9).

Figure 8. Damage to the pleasure craft's bow and port side (Source: TSB)

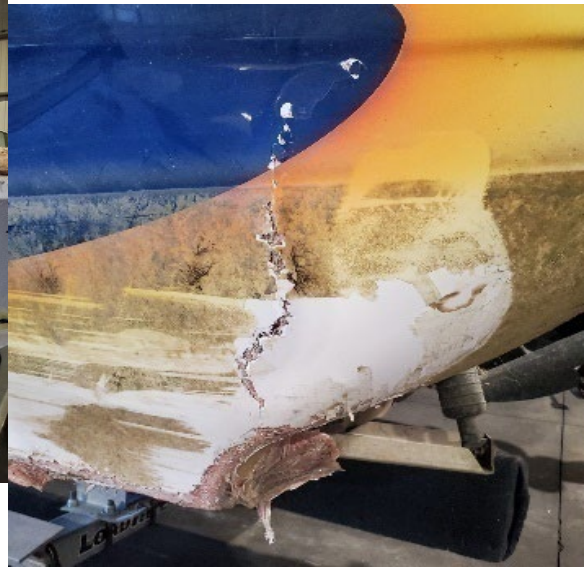
Figure 9. Damage to the pleasure craft's stern (Source: TSB)

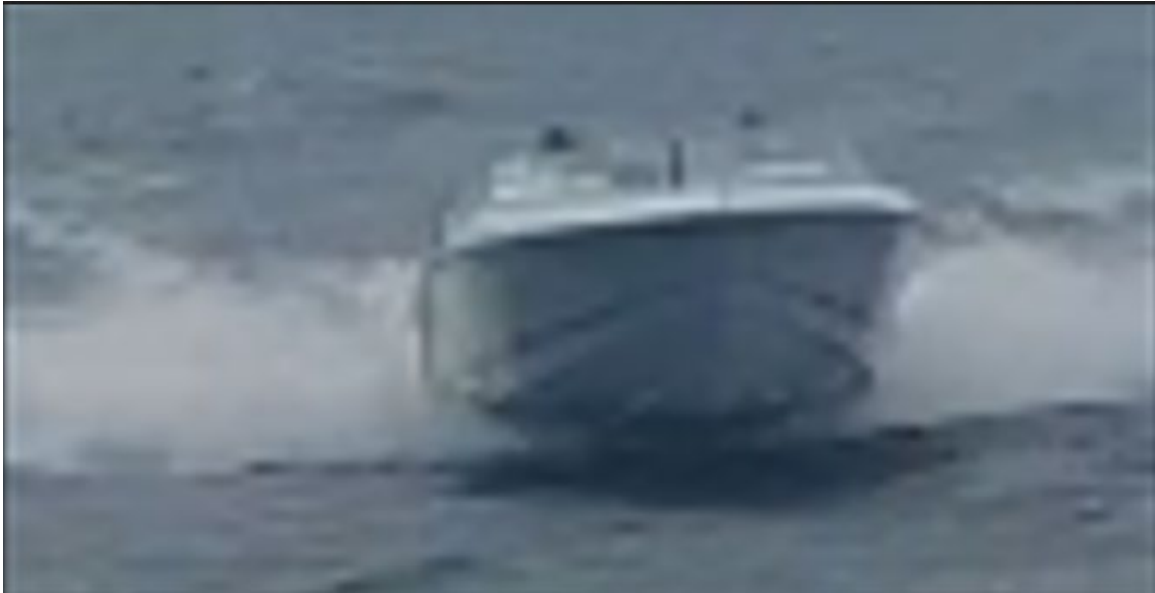
Figure 10. Still image from a video showing the occurrence pleasure craft planing (Source: Third party, with permission)

Because the pleasure craft operator had likely underestimated the speed of travel, he was not aware that the vessel was planing. Planing, combined with the high speed at which the pleasure craft was travelling, caused it to experience numerous uncontrolled dynamic motions, including yawing and broaching. These uncontrolled motions were observed in video recordings of the pleasure craft taken in the seconds before the collision.
