# AIR TRANSPORTATION SAFETY INVESTIGATION REPORT A24P0107

## LOSS OF CONTROL AND COLLISION WITH WATER

Cessna A185F, C-GBTJ

02 October 2024

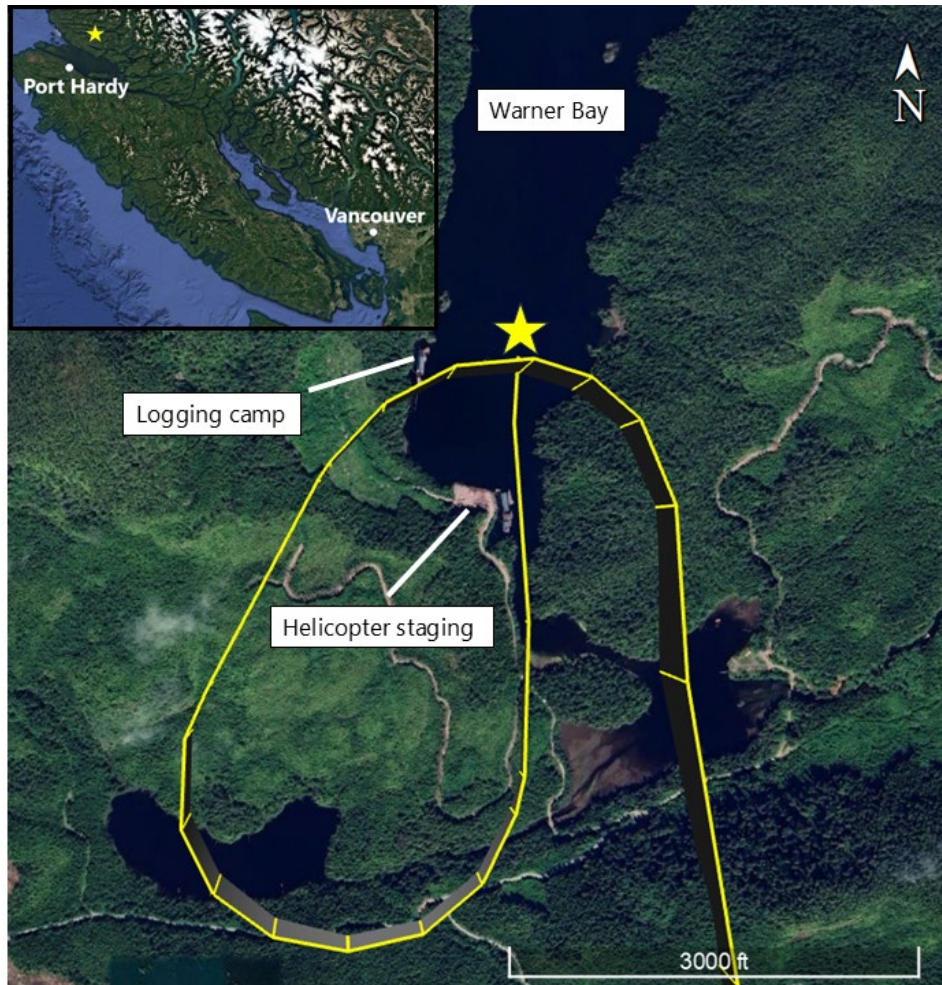
The occurrence flight was the pilot's 2nd flight of the day to Warner Bay, and the same north-northeast route across Johnstone Strait toward the mainland was flown on both flights. While crossing the strait, the pilot noted a northwest wind that had a direction similar to the wind during the 1st flight but with less speed. As a result, the pilot flew to the southern end of Warner Bay to conduct a landing approach in a northbound direction, similar to the 1st flight (Figure 1).

Figure 1. The approximate location of the occurrence (inset) and the approach path of the occurrence aircraft into Warner Bay with the point of impact indicated with a star) (Source: Google Earth, with TSB annotations)

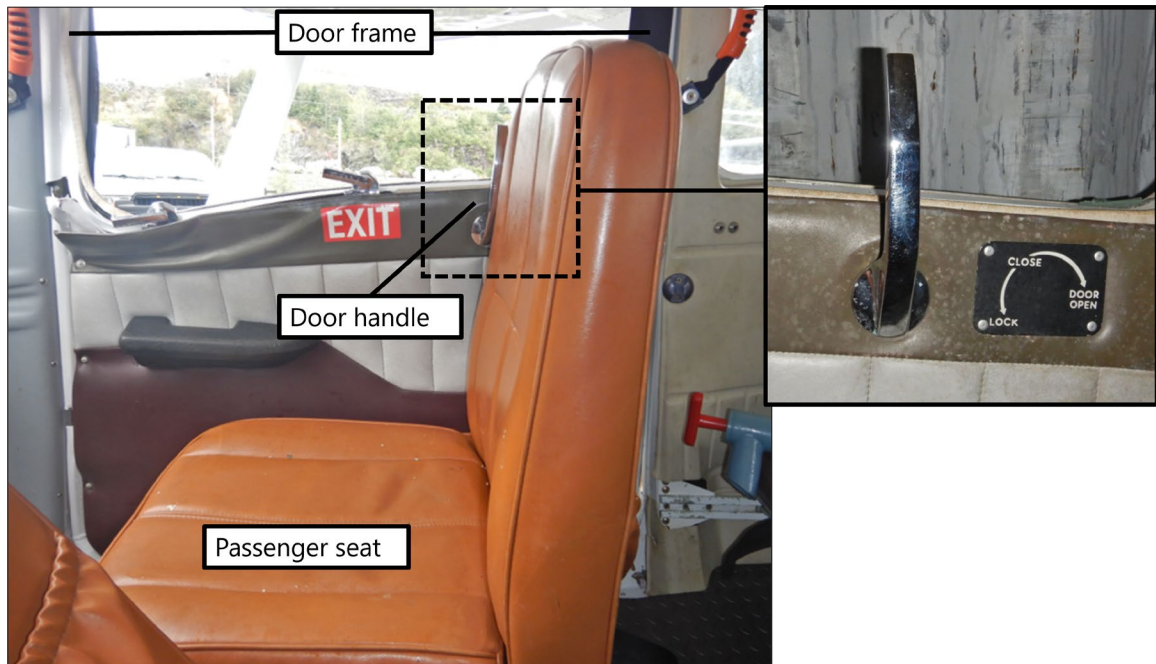
The interior door handles were located beside and behind the front seats. To open the door from the adjacent seat, the front seat occupants had to reach directly behind their shoulder and rotate the levers up and aft to the open position. With the front passenger seat being adjusted aft, the seatback lined up with the right door handle and provided approximately 2.5 cm between the seat and the handle (Figure 2).

Figure 2. Front passenger seat position, showing the seat back aligned with the right interior door handle, and a close-up view of the interior door handle (inset) in the closed position with the placard showing the 3 handle positions (lock, close, door open) (Source: TSB)\*

\* The visible damage on the door was caused during the recovery of the aircraft.

Although the right interior door handle was found in the closed position and the left door had been opened, the investigation could not determine if either front occupant was able to rotate the door handle to the open position and thus release the latch for their respective door.

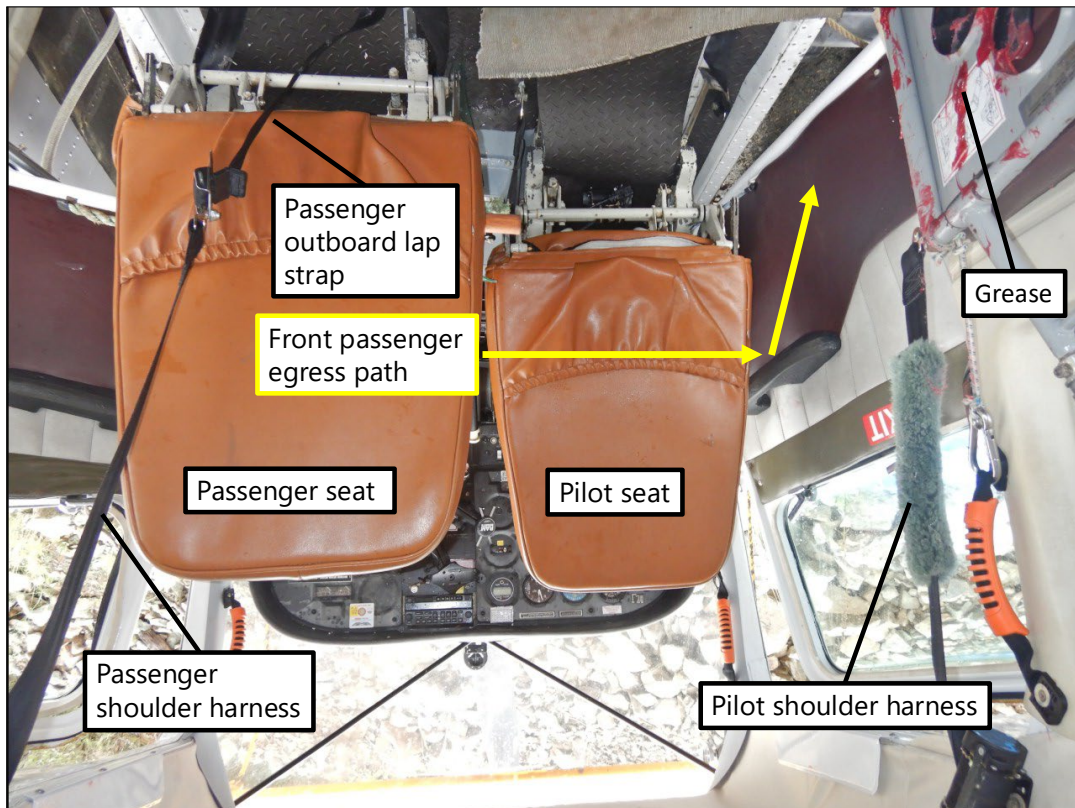
The front passenger crossed the cabin to exit through the left door (Figure 3). Based on the pilot seat position, the front passenger had to move past the pilot seatback and the safety belts in dark and cold water to reach the door. During the egress, the passenger's left leg likely became entangled in a loop created by the front passenger seat's shoulder harness and lap strap and, even though the straps were fully extended, they prevented the passenger from completely surfacing.

Figure 3. The inverted occurrence aircraft cockpit illustrating the egress route of the front passenger with the passenger shoulder harness connected to the outboard lap strap and the pilot shoulder harness disconnected from the outboard lap strap. The red grease was part of the cargo being transported to the logging camp. (Source: TSB)
