AVIATION INVESTIGATION REPORT

A14Q0155

Runway excursion

Airbus A330-343, C-GFAF

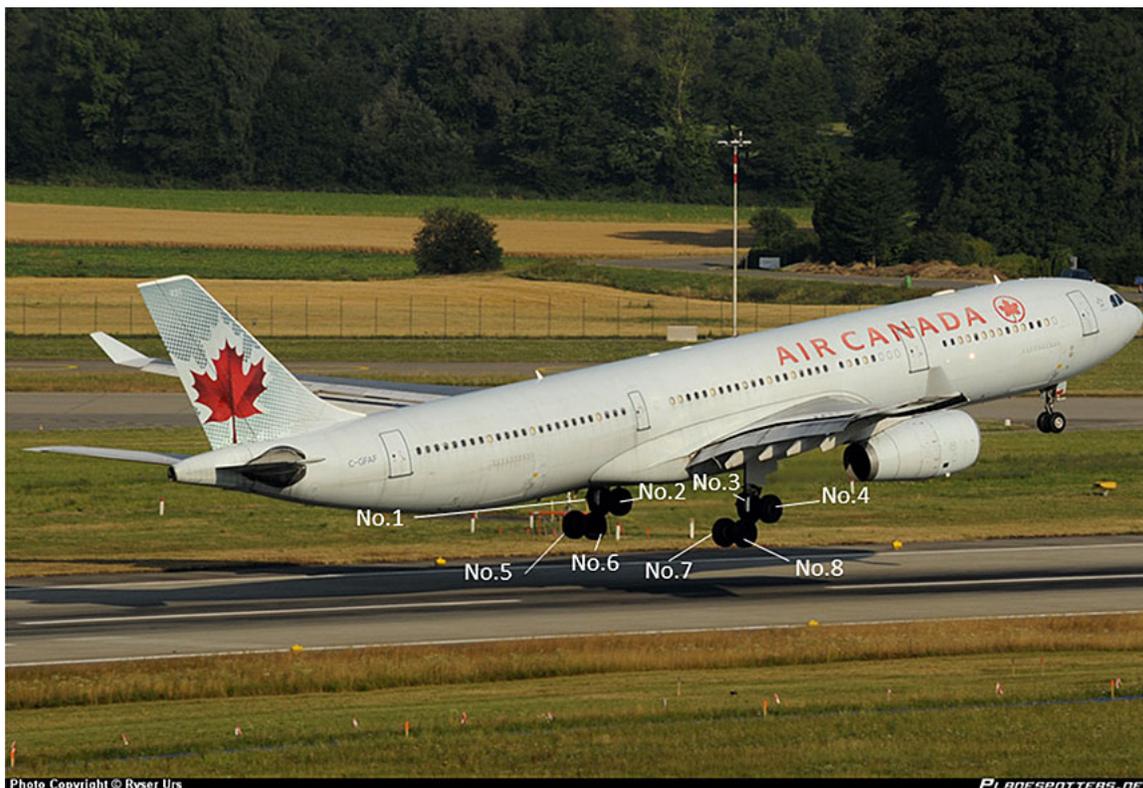
Figure 2. Numbering of the main landing gear tires on the A330 (Source: Ryser Urs, with TSB annotations)

The aircraft was not damaged. The left main landing gear sprayed mud onto the left side of the fuselage during the runway excursion. The rear tires of the left main landing gear (No. 5 and No. 6 tires) were replaced due to lacerations incurred when they struck the runway edge lights.

The landing gear on the A330 is made up of 1 nose gear with 2 wheels, and 2 main landing gear assemblies with 4 wheels each in a double tandem configuration. In flight, the bogies are inclined such that the back tires touch the runway first. The wheels are numbered 1 to 8, from left to right, starting from the front (Figure 2).

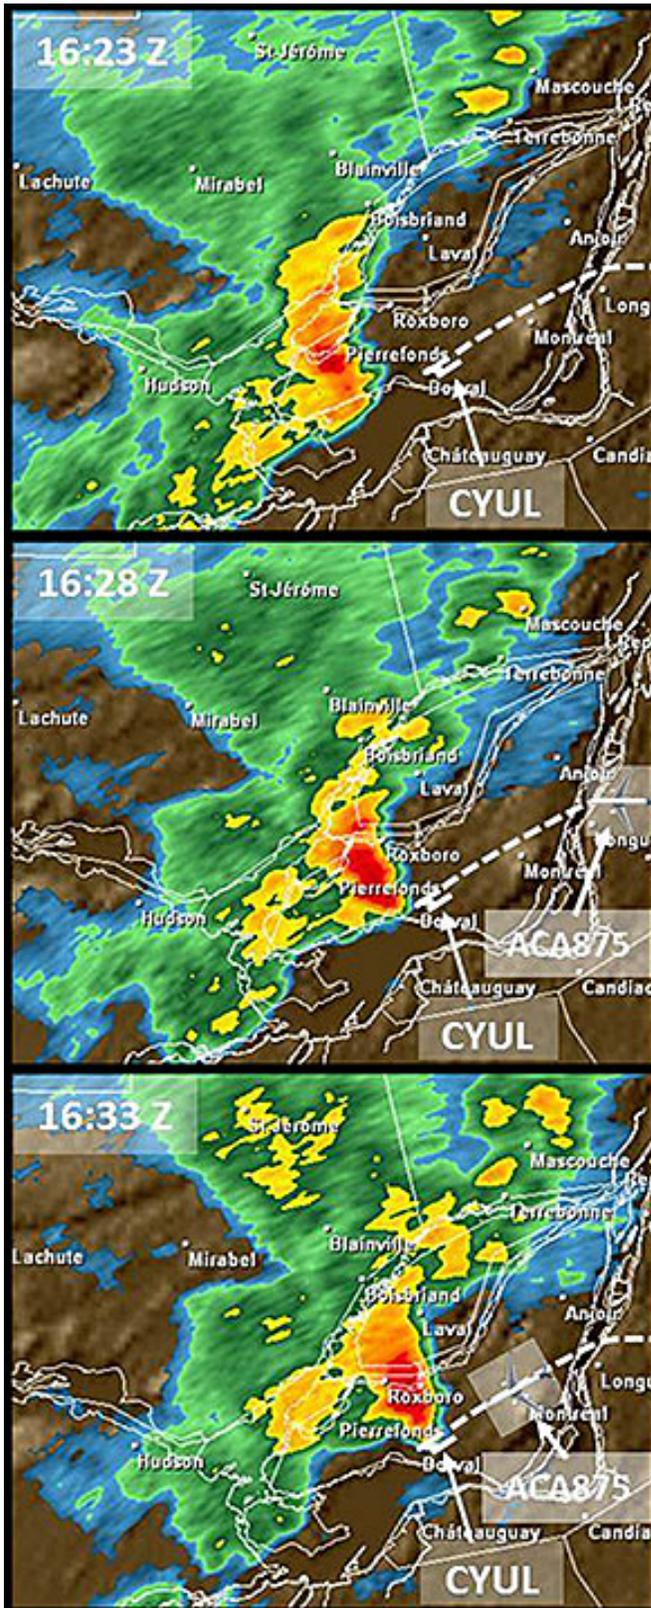
Figure 5. Movement of the thunderstorm shown on the Burlington Radar (Source: Environment Canada, with TSB annotations)

The strong precipitation to the north of the runway, the temporary drop in ground temperature, and the change in wind direction and strength all tend to confirm the presence of a downburst to the north of the runway at the time ACA875 was landing (Figure 5).

- A thunderstorm from the southwest of Montréal Island moved to just north of CYUL while intensifying between 1200 and 1300.
- The strong precipitation associated with the thunderstorm led to downbursts of wind that reached the ground, resulting in the strong gusts observed in the western sector.
- At 1234, the thunderstorm was located approximately 1 nm north of Runway 24R.

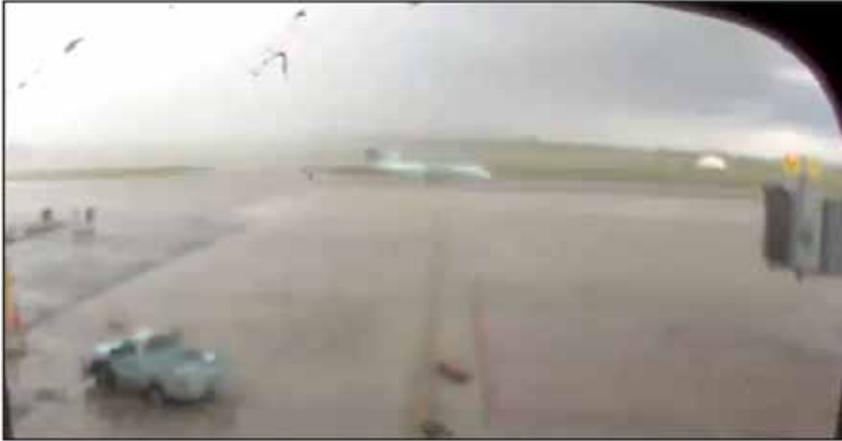
Figure 7. Weather conditions over Runway 24R at 1232:23 (Source: Aéroports de Montréal)

Figure 7 shows the weather conditions at 1232:23, i.e. 2.5 minutes before the landing; Figure 8 shows the weather conditions at 1233:56, i.e. 1 minute before the landing. The rain shower can be observed to have moved toward the threshold of the runway. Figure 9 shows the weather conditions at the time of the landing. Note that the aircraft is creating a plume of water during the landing roll.

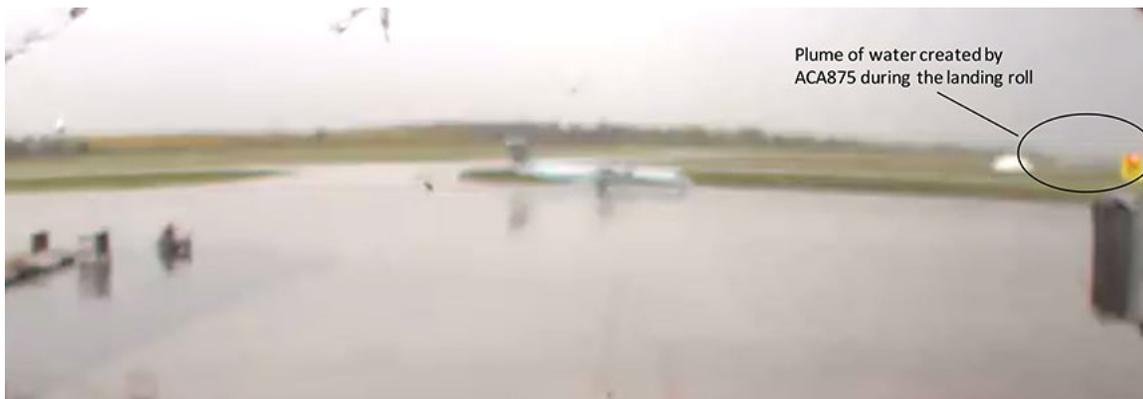
Figure 9. Weather conditions over Runway 24R (at the time of the landing; 12:35) (Source: Aéroports de Montréal with TSB annotations)

Note that at the time of the landing, the shower was passing the threshold of Runway 24R. Also note that the aircraft tires and possibly reverse thrust are spraying a significant plume of water behind the aircraft, indicating the presence of water on the runway.

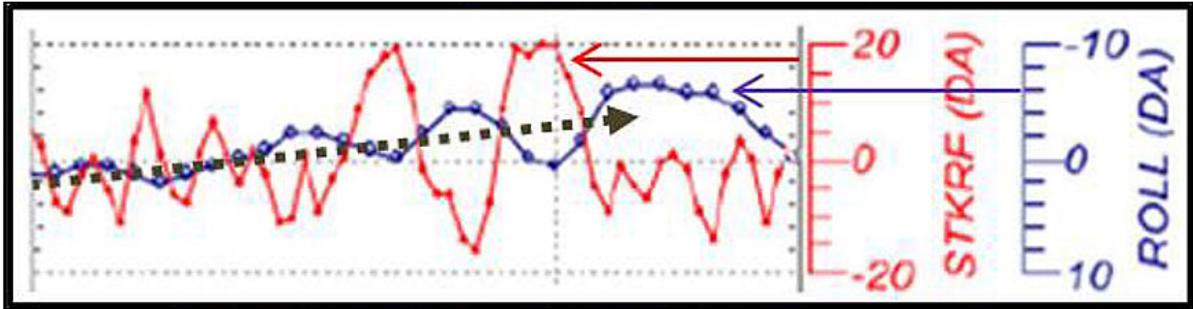
Figure 11. Data from the digital flight data recorder indicating the presence of pilot-induced oscillation

Analysis of the DFDR plots shows that at approximately 120 feet agl, the aircraft experienced 3 rolling oscillations, the amplitudes of which expanded progressively from 2° to 6° (Figure 11). At the same time, pronounced sideways movement of the co-pilot's side stick controller was observed, twice reaching the maximum deflection, and out of phase 90° with the rolling movement of the aircraft. These oscillations accompanied by the opposing deflections by the co-pilot indicate the presence of pilot-induced oscillation.

By definition, pilot-induced oscillation occurs only when the pilot performs actions with the side stick controller that have the effect of maintaining these oscillations. Since the pilot's actions are the source of these oscillations, generally halting all movement or letting go of the side stick controller is sufficient to stop pilot-induced oscillation.

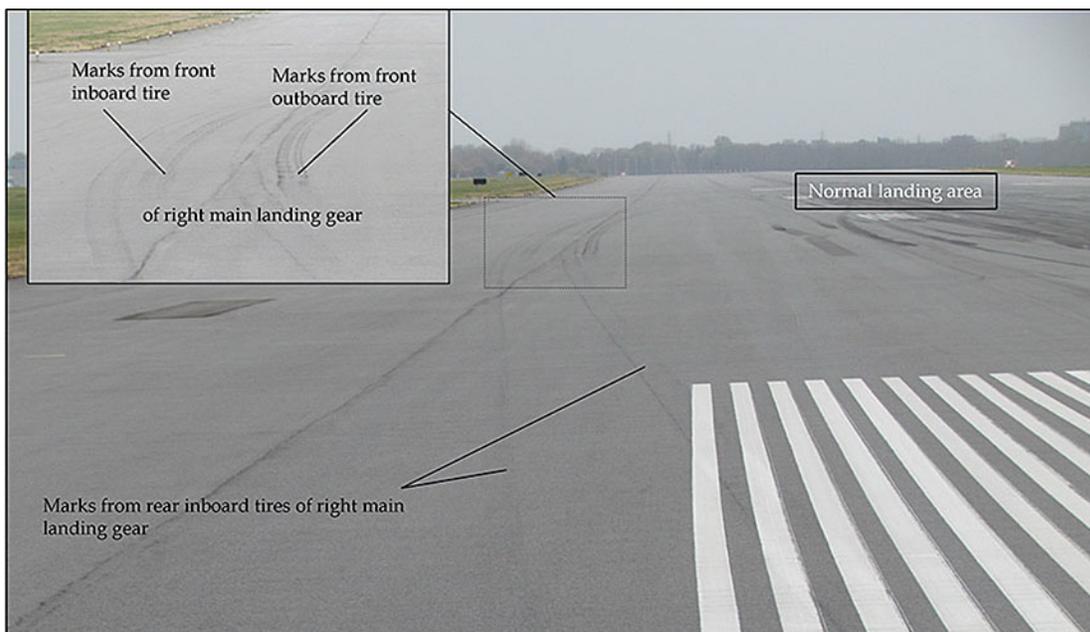
Figure 12. Tire marks on the runway

Tire marks from the main landing gear were visible on the runway (Figure 12). Before compression of the main gear, the rear wheels of the right gear (No. 7 tire and No. 8 tire) left marks that began 1332 feet from the runway threshold and 57 feet to the left of the centre of the runway. At that time, the left rear tire (No. 5 tire) of the left bogie was 97 feet from the centre of the runway and approximately 4 inches from the ground. The trajectory of these marks was shifted 2° to the left in relation to the runway centreline.

Before touching down, the right rear tire of the left main gear (No. 6 tire) struck a first runway edge light 1538 feet from the threshold. The first tire marks from No. 5 tire appeared on the grass 1708 feet from the threshold and 107 feet to the left of the centre of the runway. Subsequently, No. 6 tire struck another runway edge light and passed beside the next light, located 200 feet beyond.

Compression of the right main gear (Nos. 3, 4, 7, and 8 tires) occurred 1734 feet from the threshold and 68 feet to the left of the centre of the runway. Darker tire marks indicated a trajectory that clearly veered toward the right of the runway centreline. These marks suggest good adherence of the tires on the runway surface. No indication of hydroplaning on the runway was observed. At that time, the aircraft was banked approximately 0.5° to the right.

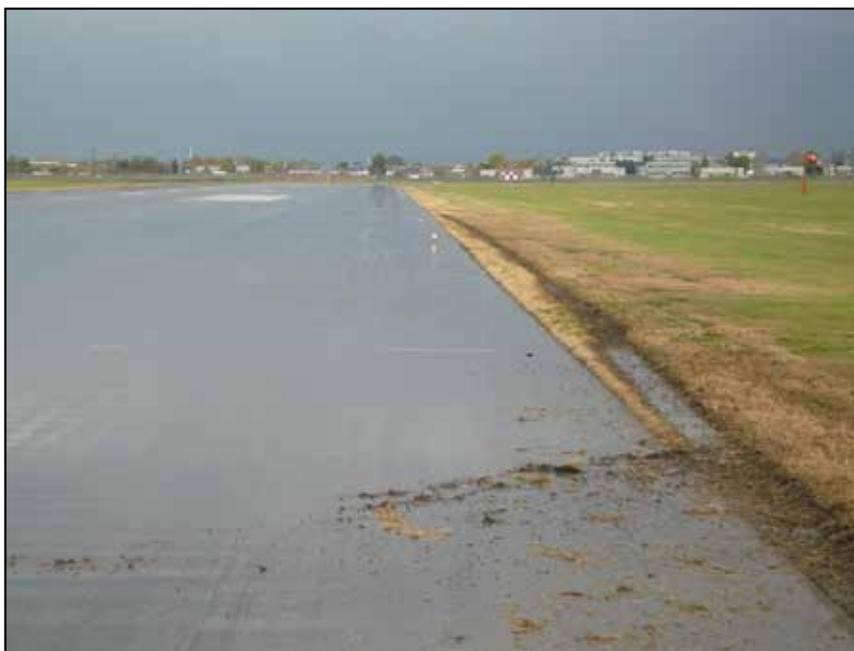
Figure 13. Tire marks on the grass

The aircraft damaged 3 Runway 24R edge lights located on the left side of the runway, between 1500 and 2300 feet from the threshold.

At 2130 feet from the threshold and approximately 107 feet to the left of the centre of the runway, an expansion of the marks was observed on the grass, corresponding to compression of the left main gear (Figure 13). At the same time, the right front tire of the left bogie (No. 2 tire) struck the runway edge light.

The last marks on the grass were 2215 feet from the threshold and 105 feet from the centre of the runway. The total length of the marks on the grass was 507 feet. The runway excursion covered a total distance of 677 feet (Appendix D).

ADM personnel repaired the lights and cleaned the runway with a jet of water and mechanical sweepers. At 1330, the runway was reopened.
