AVIATION INVESTIGATION REPORT
A15W0069

LOSS OF CONTROL AND COLLISION WITH TERRAIN
CONAIR GROUP INC. (DBA CONAIR)
AIR TRACTOR AT-802A FIRE BOSS AMPHIBIAN, C-FDHV
COLD LAKE, ALBERTA, 25 NM NW
22 MAY 2015

Loss of control and collision with terrain

Air Tractor AT-802A Fire Boss Amphibian, C-FDHV

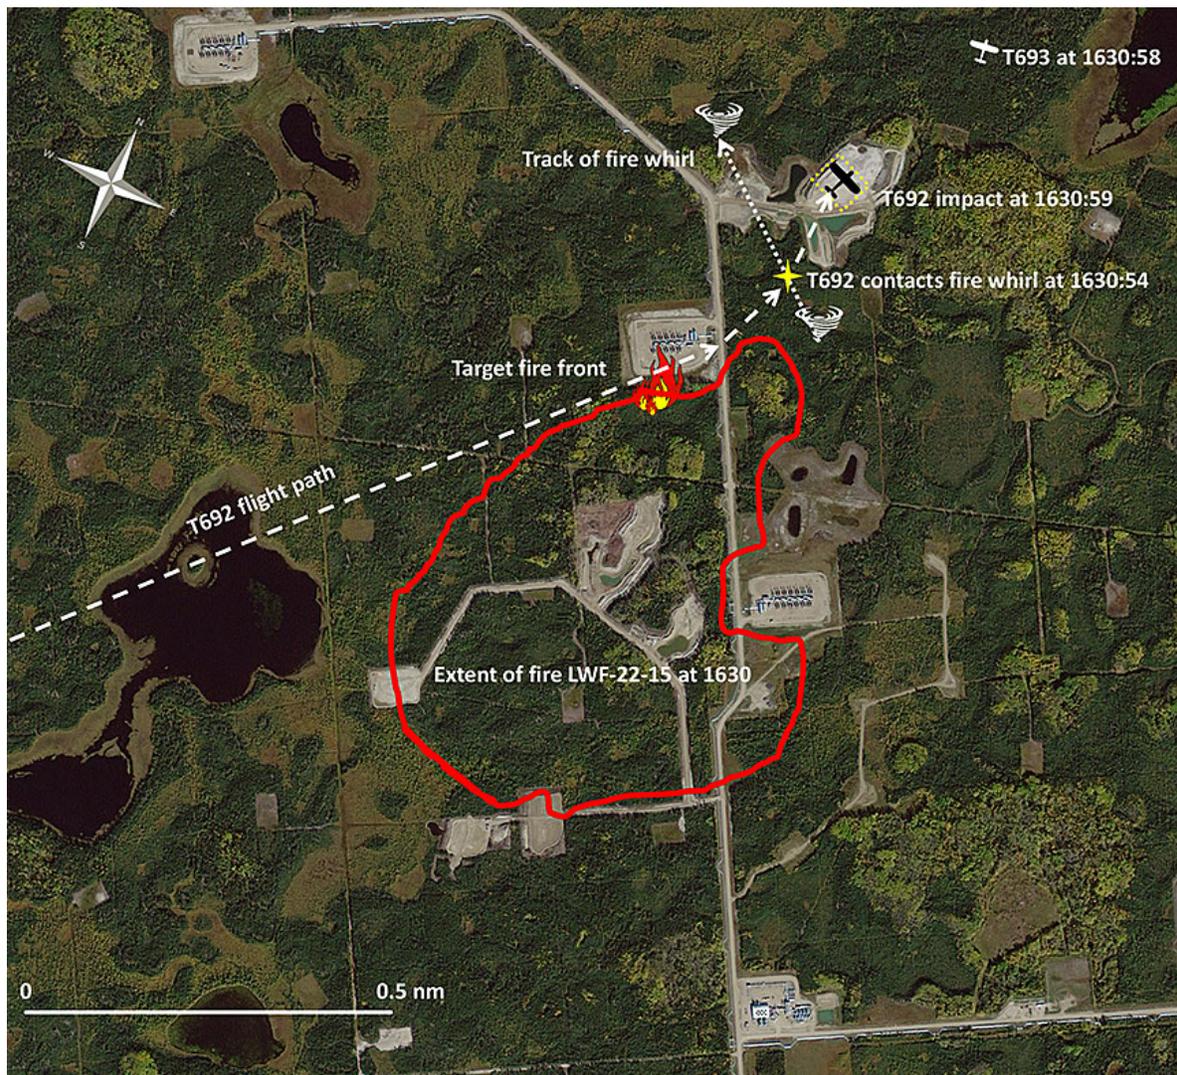
Figure 2. Aerial photograph of the occurrence site (Source: Conair Group Inc., with TSB annotations)

T692 also encountered a severe turbulence event, at 1630:54, 10 seconds after T693. The aircraft DAAM system recorded a change from $4.2g$ to $-3.2g$ in 1.0 second. T692 was seen to pitch to a nose-up attitude and climb to approximately 400–500 feet agl. The aircraft was then observed to roll left and enter a nose-down attitude. T692 struck the ground in a large open area (borrow pit) at 1630:59, right-wing low and close to nose-level (Figure 2). In the last 1.6

seconds before impact, the DAAM data showed a change in g force from $-1.0g$ to $2.9g$ in 1.2 seconds; g force then held at $2.9g$ for 0.4 seconds before the data recording ceased at impact. The impact forces were not survivable. There was no post-impact fire.

Immediately after the accident, a large fire whirl was seen moving from southeast to northwest across the borrow pit west of T692. The fire whirl was approximately 50–100 feet wide at the base and extended to an altitude of approximately 1500 feet agl. It had a very strong rotation and uptake of material. The fire whirl continued across the borrow pit and re-entered the treeline, where another fire was ignited by debris it was carrying. It then disappeared from view shortly after entering the trees.

The aircraft wreckage was located in an open sand-and-gravel area referred to as a "borrow pit." The aircraft had struck the ground right-wing low and in a nearly nose-level attitude. The right wingtip had struck the ground first and was followed by the right float and then the left float. The float structure had collapsed and remained mainly under the aircraft. The aircraft had travelled approximately 80 feet from the first ground scars.

All of the aircraft's components were found and identified within a 90-foot radius of the fuselage, and all main components were still attached to the aircraft. The fuselage and wings had substantial impact damage. All of the fuel and foam tanks had ruptured, contaminating the surrounding ground.

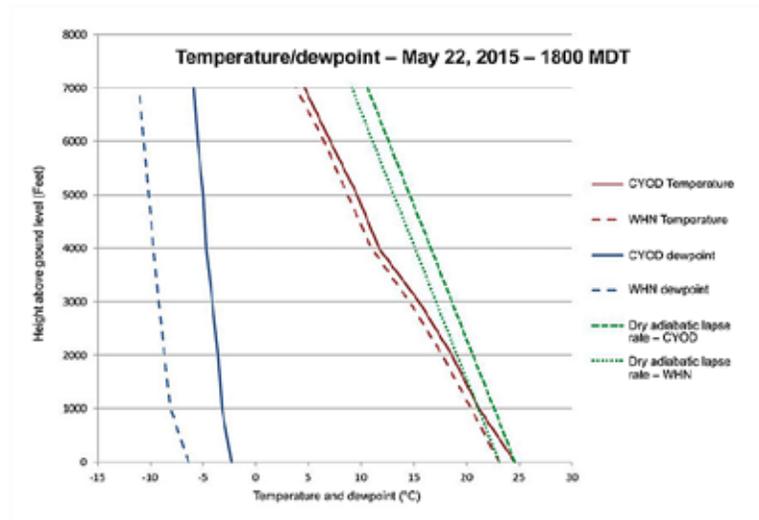
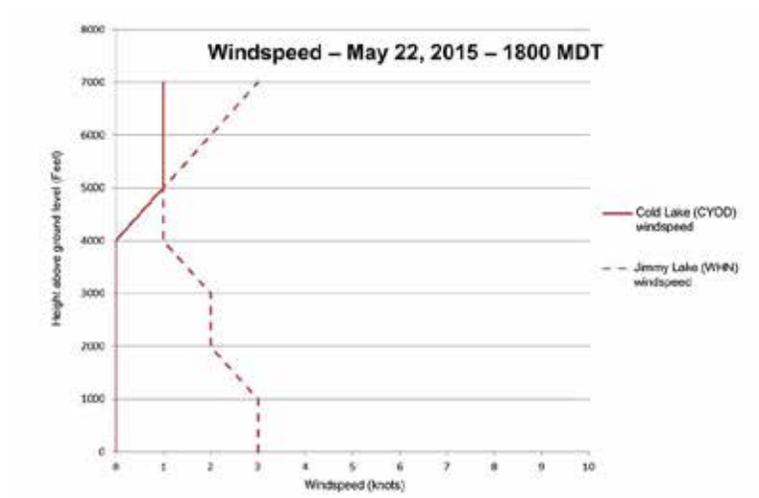
Figure 3. Temperature/dewpoint and altitude for Jimmy Lake, Alberta, (WHN) and Canadian Forces Base Cold Lake, Alberta (CYOD)

Figure 4. Windspeed and altitude for Jimmy Lake, Alberta, (WHN) and Canadian Forces Base Cold Lake, Alberta (CYOD)

from an atmospheric sounding taken at 1800 on the day of the occurrence. The lapse rates³ at both WHN and CYOD are indicative of an unstable atmosphere. The upper wind at both locations was 3 knots or less through to 7000 feet agl.

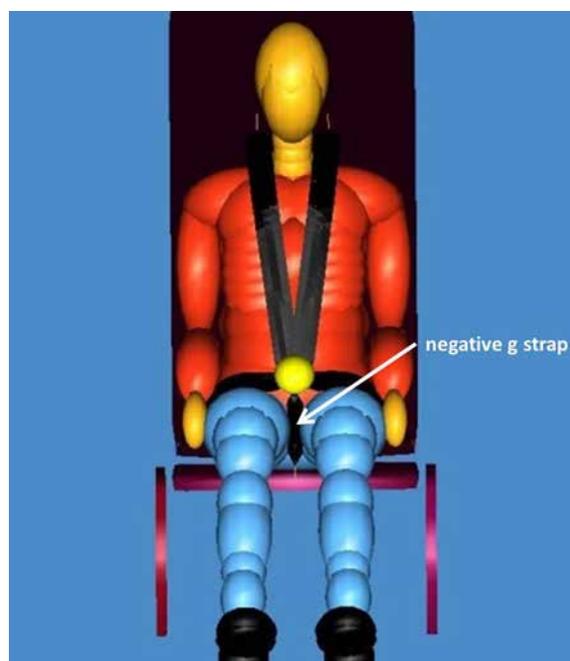
Figure 5. Example of a negative *g* strap (Source: Wichita State University)

The negative *g* strap (Figure 5) is a restraint fixed to the seat structure and placed between the pilot's legs to attach to the buckle joining the lap belts and shoulder straps, creating what is more commonly known as a 5-point harness.

The incident aircraft was installed with a 4-point harness in accordance with regulatory requirements; there was no negative g strap installed.

The company has installed 5-point harnesses in its AT-802 fleet.

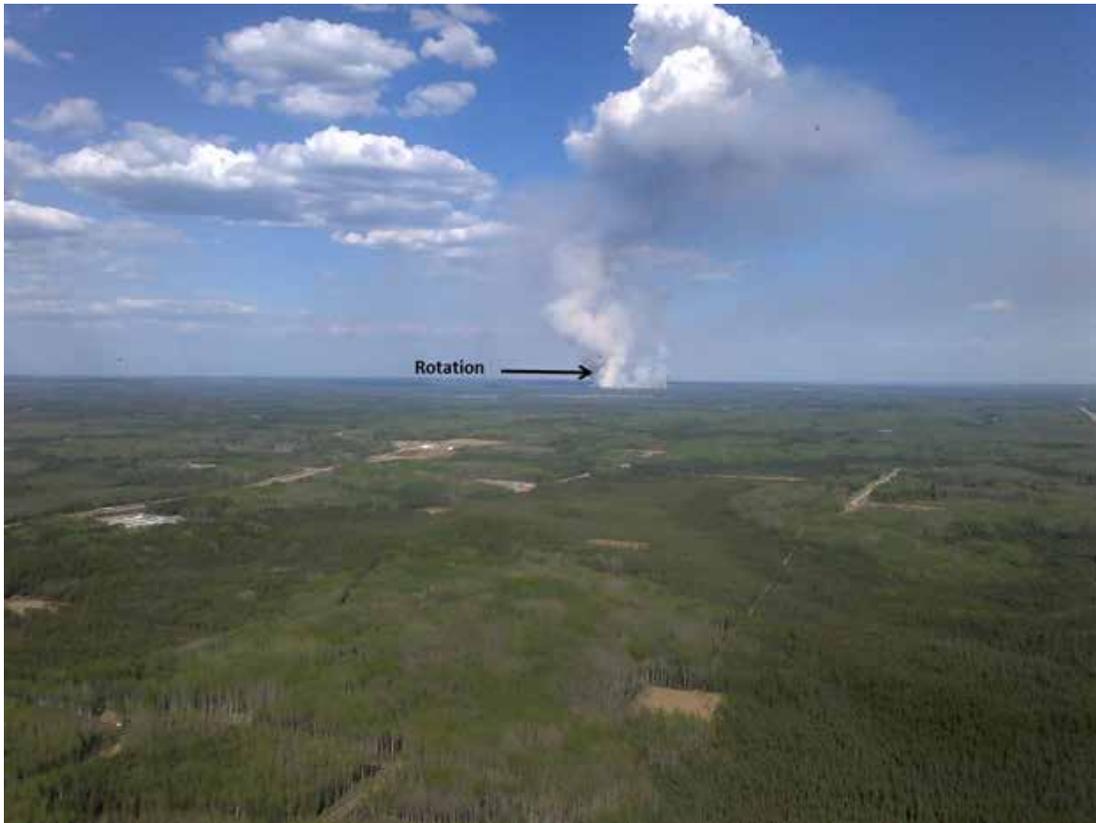
Photo 3. Rotation in the smoke column of fire LWF-122-15 at 1629 (Source: Government of Alberta, with TSB annotations)

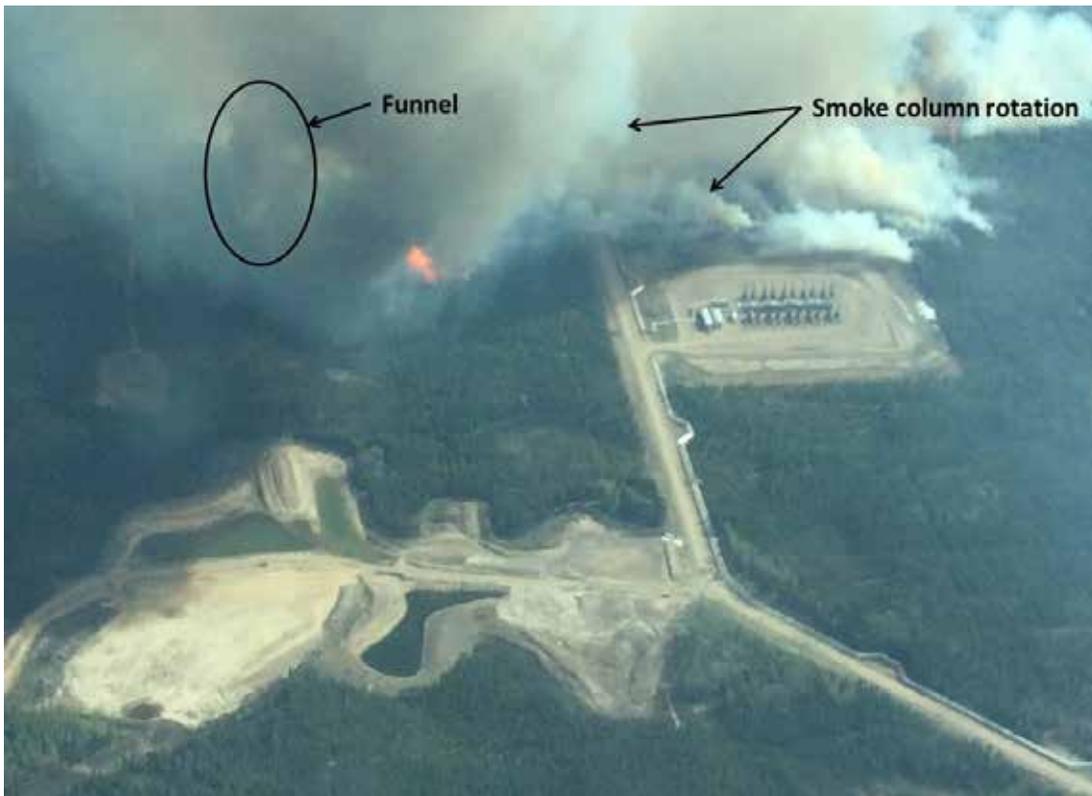
“Plume shedding” is a process in which vortices separate from the main column as the ambient wind moves around it. This wind shear creates eddies on the leeward side of the column that can then form into fire whirls (Figure 6).

Figure 6. The smoke column, showing evidence of plume shedding, with a funnel developing in the smoke, at 1629:53, approximately 1 minute before the accident (Source: Government of Alberta, with TSB annotations)

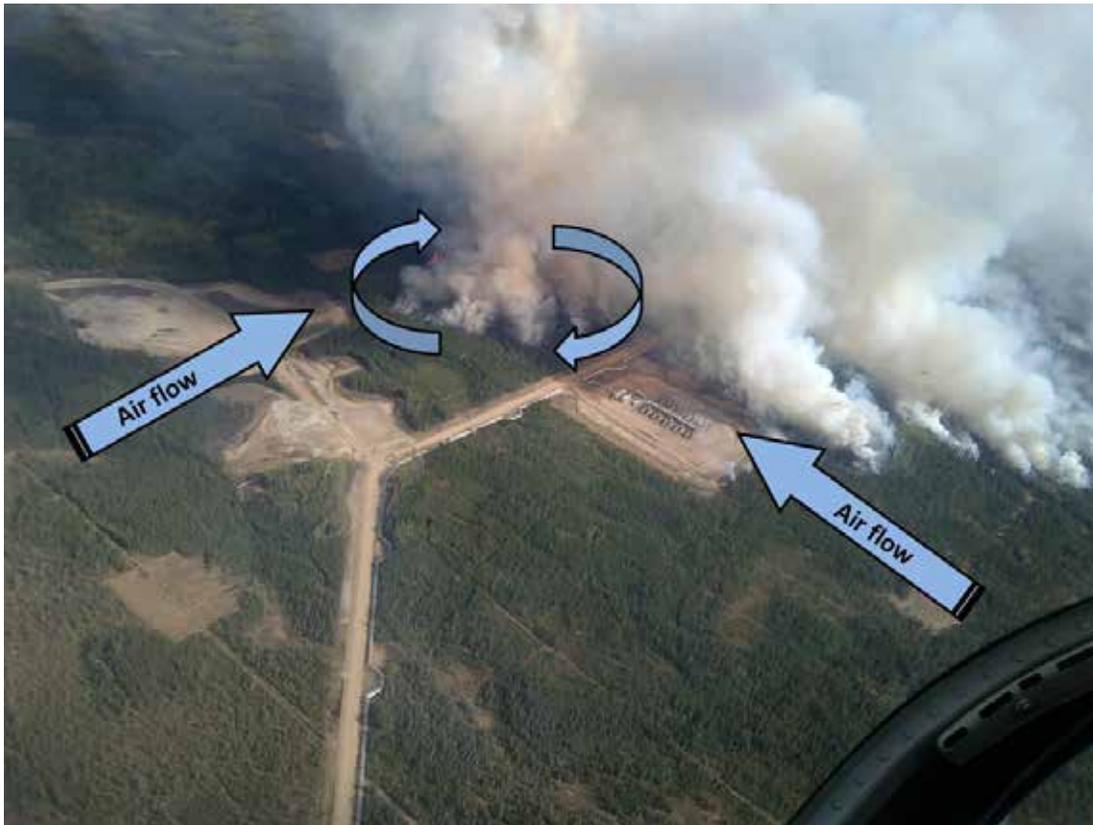
The “L-shaped heat source in cross flow” is seen when the fire forms lines at an angle of approximately 90°. This can occur at the edge of an open area or along road intersections or fire breaks. The air flows into the lines of fire and crosses. The interaction of this flow and the blocking effect of the corner create the rotation (Figure 7).

Figure 7. The smoke column of fire LWF-122-15, showing L-shaped heat-source cross flow (Source: Government of Alberta, with TSB annotations)

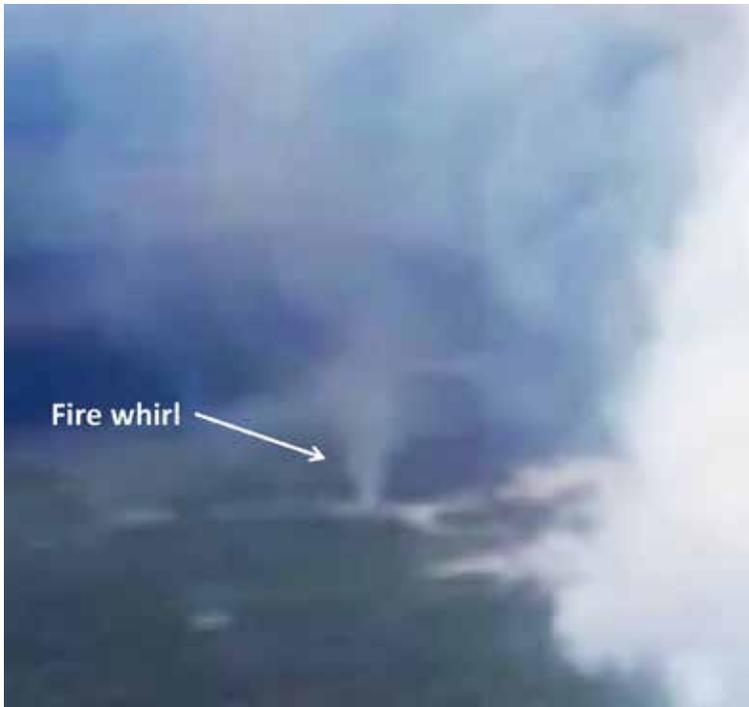
The fire designated LWF-122-15 was growing rapidly on the afternoon of 22 May 2015. The atmosphere was unstable, with a steep lapse rate and light wind. These conditions resulted in a well-defined smoke column rising to a high altitude. As the fire grew in size and intensity, it moved over areas with large clearings joined by roads. This likely created a condition known as “L-shaped cross flow” between heat sources, which initiated the rotation of the air flowing into the fire. The smoke column then began to rotate. With the high temperatures being generated by the fire, the updraft stretched and intensified the rotation. On the leeward side of the smoke column, a fire whirl developed (Figure 9). A review of the acceleration forces recorded in the DAAM data from T693 and T692 showed that, as the fire whirl became well developed, it likely formed a two-cell structure.

Figure 9. A frame taken from a video shows a fire whirl moving across the borrow pit at 1633 (Source: Government of Alberta, with TSB annotations)

When T692 completed its third drop on the fire, the pilot could not see the fire whirl, as it had not yet ingested enough loose debris to make it visible. Because the pilot had not experienced any difficulties on the previous drops, he likely would not have anticipated what was in the flight path.

Travelling at 129 knots ground speed, the aircraft encountered the updraft around the core of the fully developed two-cell vortex and experienced a 4.2g acceleration, causing an accelerated stall. When the aircraft entered the core of the fire whirl, the pilot was likely thrust into the canopy by the -3.2g acceleration. Exiting the core would then put the nose of

the aircraft in the updraft again while the tail was still in the downdraft, causing the stalled aircraft to pitch up violently and enter an incipient spin. Thus, the aircraft's encounter with the fire whirl caused it to enter an undesired nose-up attitude, resulting in a loss of control.
