AIR TRANSPORTATION SAFETY INVESTIGATION REPORT A18Q0016

COLLISION WITH TERRAIN AT NIGHT

Robinson R44 Raven I (helicopter), C-GYMG
Saint-Joachim-de-Courval, Quebec
01 February 2018

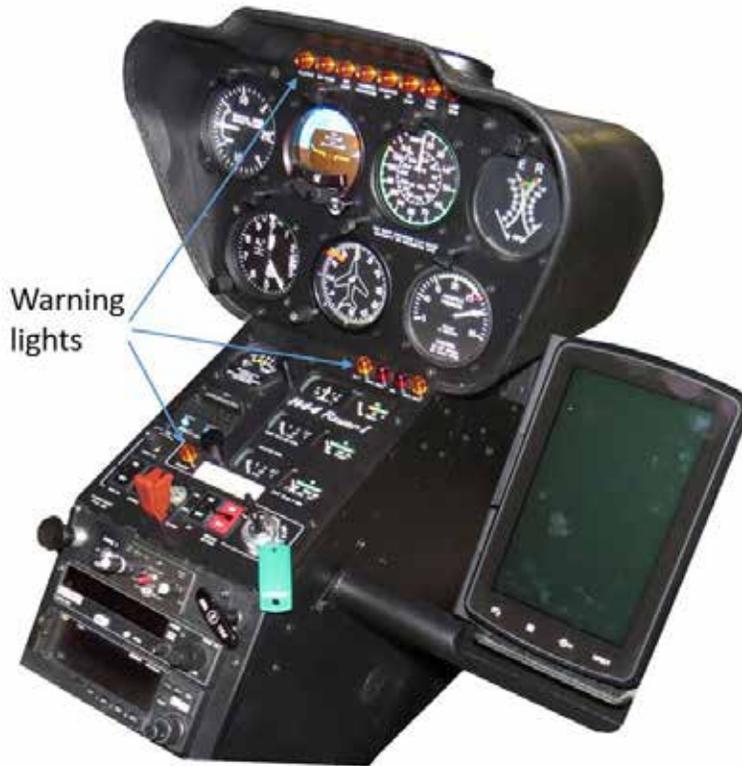
Figure 1. Typical dashboard in a Robinson R44 Raven I

The Robinson R44 Raven I has 13 warning lights that alert the pilot to conditions requiring attention. Eight are at the top of the dashboard, and 5 are on the centre panel (Figure 1).¹³

In this occurrence, only 3 bulbs had intact glass enclosures and showed distinct signs of being off at the time of impact: the MR TEMP (main rotor temperature), ROTOR BRAKE, and CARBON MONOXIDE bulbs. All other bulbs showed signs of damage to the glass enclosure and had fractured filaments; their status at the time of impact could not be determined with certainty (Appendix E).

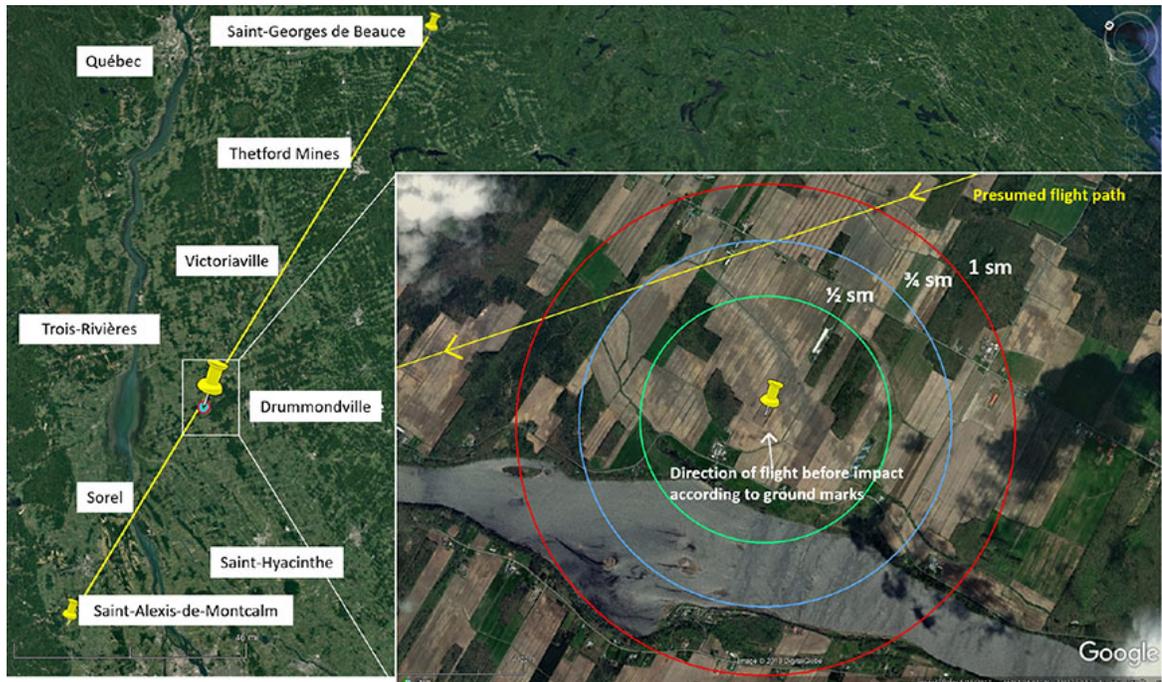
Figure 2. Presumed flight path of the occurrence aircraft, with inset showing the presumed visibility (represented by circles) at the time of the occurrence, and the direction of flight prior to impact, based on ground markings (Source: Google Earth, with TSB annotations)

The topography around the accident site consisted largely of snow-covered farmland and a few houses along the Saint-François River, about ½ sm southwest of the accident site (Figure 2). There were few visual references to the surface that were illuminated by ground lighting. The sky was overcast at the time of the accident, so it is presumed that the celestial lighting was inadequate.

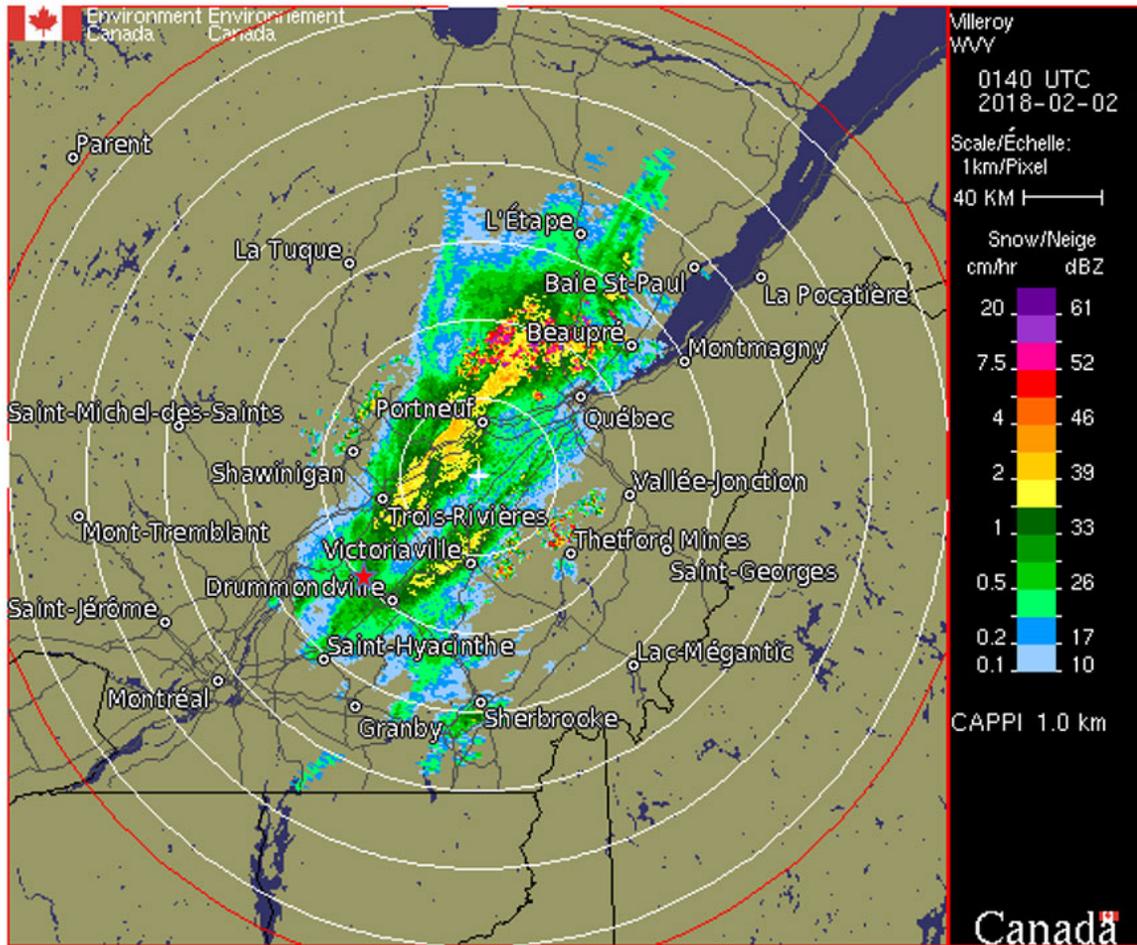
Appendix C – Screen capture of Villeroy weather radar at 2040 on 01 February 2018

After analyzing the weather conditions present in the Saint-Joachim-de-Courval area at the time of the accident, the investigation determined that the surface visibility would have been no more than 1 statute mile (sm) in snow showers. It is very likely that the slant visual range was less than 1 sm. In addition, the risk of frost noted in the weather forecasts meant there was a risk of a layer of frost covering the helicopter's windshield and thus further reducing visibility during flight.

Note: The red star indicates the accident site.
