Air Transportation Safety Investigation Report A19Q0088

LOSS OF CONTROL DURING INITIAL CLIMB AND COLLISION WITH GROUND

Pitts S2E (amateur-built aircraft), C-GONV
Saint-Jean-Port-Joli, Quebec
16 June 2019

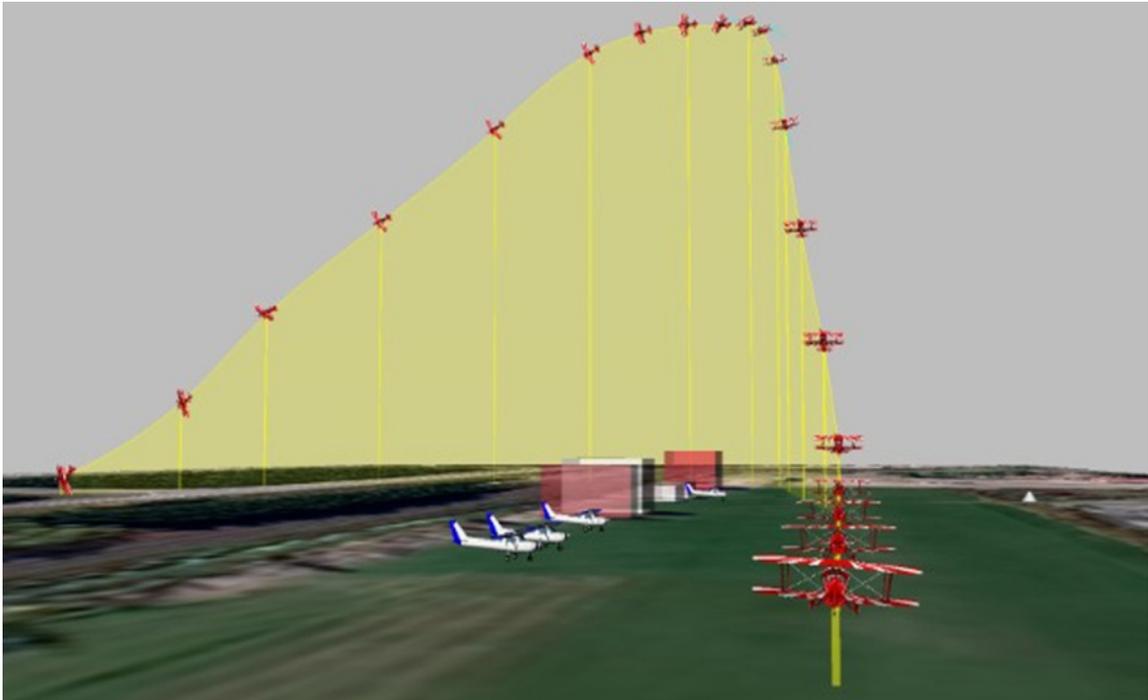
At approximately 1825, after refuelling, the pilot and the morning passenger took off from Runway 24 at the Saint-Jean-Port-Joli Aerodrome on board the occurrence aircraft, to conduct a flight under visual flight rules (VFR) to CSP6, the aircraft's base. Two amateur videos provided to the TSB showed that, after takeoff, the aircraft began a steep climb, then made a steep left-hand turn, lost altitude,

and crashed in a nose-down attitude, leaning left, in a ditch next to a secondary road, approximately 450 feet southeast of the Saint-Jean-Port-Joli Aerodrome (Figure 1). The videos also showed that another aircraft took off immediately after the Pitts had taken off. The information gathered indicated that the pilot was aware that he was being followed closely by another aircraft.

Figure 1. Scale model of the Pitts S2E's flight path created from videos provided to the TSB (Source: TSB)

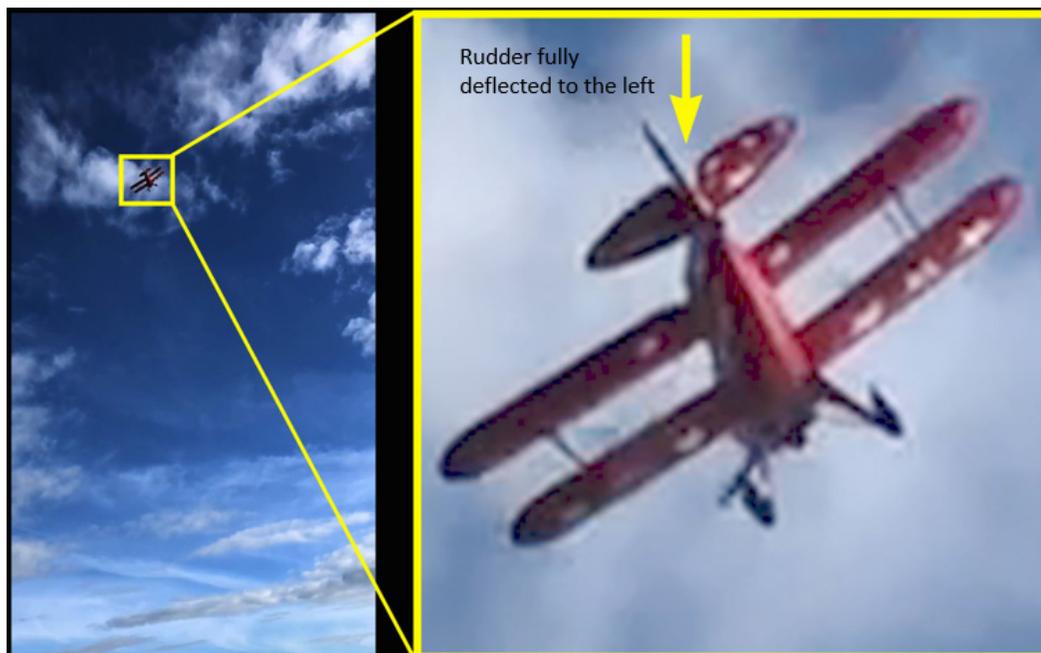
The videos also showed that the aircraft was in a skidding left turn for approximately 3 seconds (an uncoordinated turn). This type of skidding turn generally indicates poor coordination of flight controls (for example, too much pressure on the rudder pedal in the direction of the turn). In the screen captures taken from the videos, it is possible to see the position of the rudder, which was deflected completely to the left during the turn (Figure 2). It was not possible to determine the position of the ailerons.

Figure 2. Position of the rudder during the turn (Source: image from an amateur video taken by a person attending “Open Skies” day)

Once the rudder was fully deflected to the left, the bank angle increased from 22° to 88° to the left. The aircraft was at 351 feet AGL at that moment, flying at a speed of 65 knots, which was less than the stall speed for a 60° turn. The aircraft stalled and rapidly lost altitude. The left bank gradually decreased to 29° when the aircraft was at 122 feet AGL. At that point, the aircraft was flying at a speed of 72 knots, in a nose-down attitude at an angle of 24° . The video enabled investigators to note that, during the descent, the elevator was placed in the up position twice (Figure 3), indicating a recovery attempt before the impact.

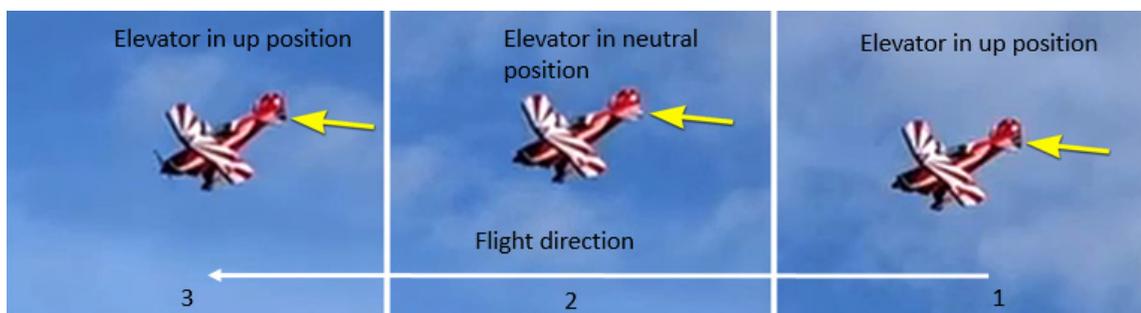
Figure 3. Positions of the elevator (Source: Image captures taken from videos, with TSB annotations)

However, when the up-elevator was applied the 2nd time, the left wing dropped abruptly to an 87° angle when the aircraft was 54 feet AGL. It is highly likely that in that moment, the aircraft was in an accelerated stall.¹⁰

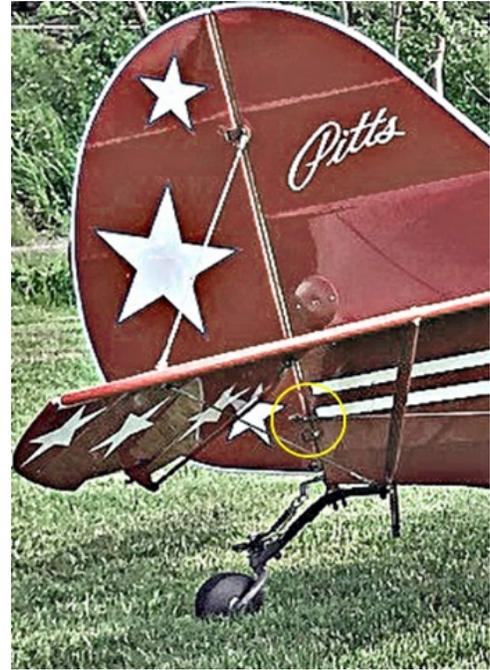
The elevator, rudder, tail wheel and front- and rear-seat rudder pedals, as well as their cables, were examined by the TSB laboratory to determine whether a defect could have led to a loss of control. The rudder is controlled by 2 sets of rudder pedals, one for the pilot and one for the front seat occupant. The rudder pedals are connected to each other and to the rudder using steel cables. These cables are connected to a horn on either side of the rudder using a swaged fork terminal (Figure 4). It was noted that the horn on the right side of the rudder was bent and cracked. An examination of the horn revealed that it had cracked as the result of excessive stress from the impact.

Figure 4. Tail of the aircraft showing the position of the rudder horn (yellow circle) (Source: Frédéric Bilodeau, with TSB annotations)

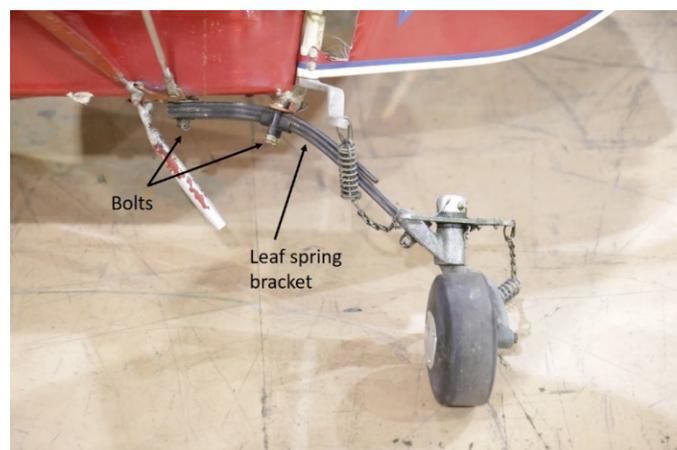
The tail wheel is attached to a leaf spring that is bolted to the fuselage with 2 bolts (Figure 5). The examination found that the rear bolt of the leaf spring was broken. This break allowed the leaf spring to pivot around the front bolt. It could not be determined whether the break occurred before or after impact. However, an examination of the tail wheel assembly revealed that its full movement in one direction or the other could not interfere with the movement of the rudder.

Figure 5. Tail wheel assembly, with arrows indicating the bolts and the leaf spring bracket (Source: TSB)
