# Air Transportation Safety Investigation Report A19Q0146

## COLLISION WITH TERRAIN

Bel-Air Laurentien Aviation Inc.  
Cessna U206G on floats, C-GPPZ  
Lac-à-la-Tortue, Quebec  
22 August 2019

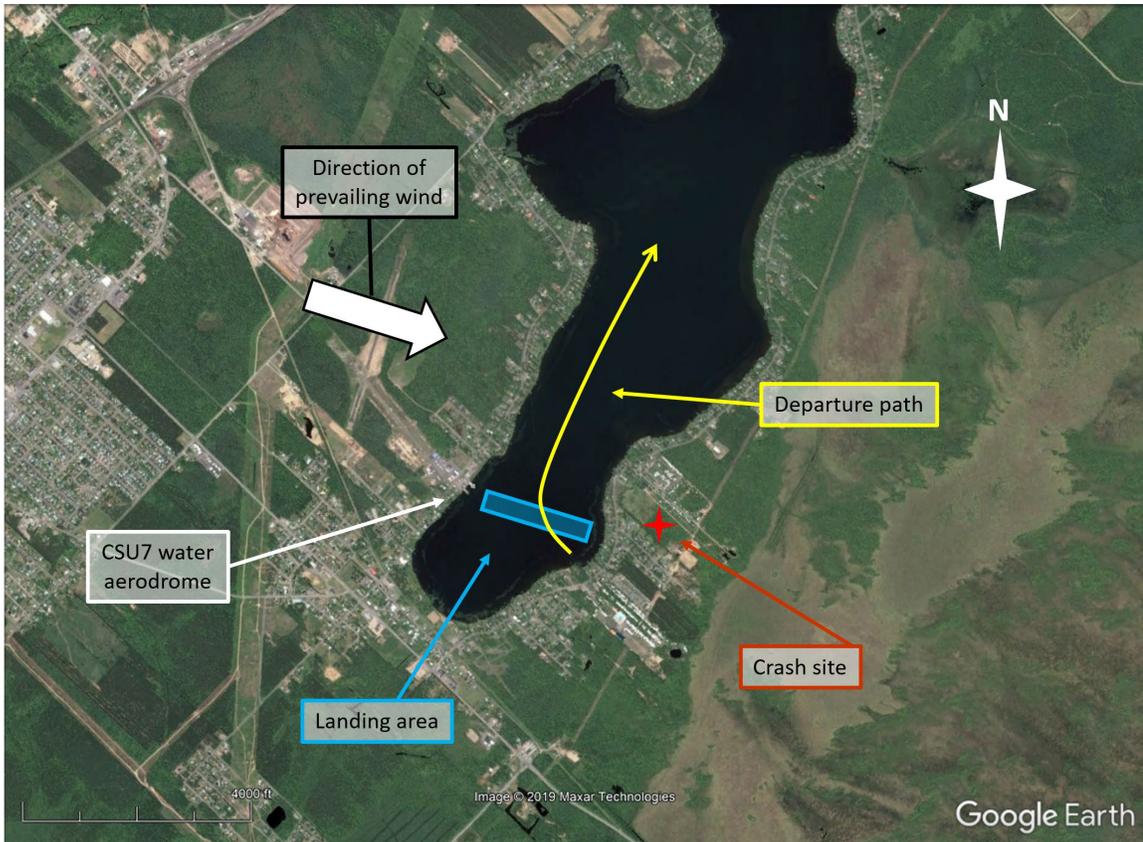
into the wind (Figure 1). After flying his usual flight path, he returned and landed in a northwesterly direction, into the prevailing wind.

Figure 1. Map showing the departure path, the landing area, the direction of the prevailing wind and the crash site (Source: Google Earth, with TSB annotations)

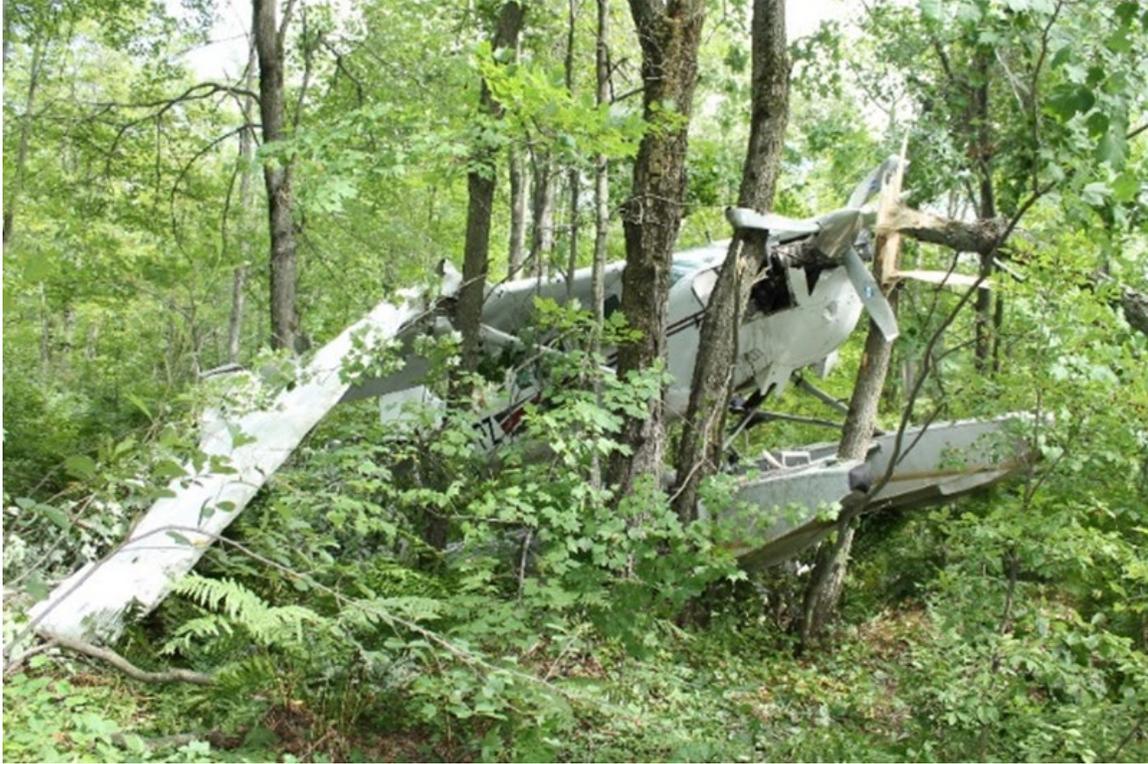
The area surrounding the wreckage, approximately 1000 feet southeast of the lake, was a woodland with large, deciduous trees. The first signs of an impact with trees could be found approximately 250 feet southeast of the wreckage (Figure 2).

Figure 2. Occurrence aircraft wreckage (Source: TSB)

The engine had shifted forward and its mount was stripped from the engine firewall. A brief examination of the engine by investigators found no signs of a defect that could have caused the sudden engine failure. The propeller showed signs that are consistent with it still turning on impact. The mechanical and electric fuel pumps were sent to the TSB Engineering Laboratory in Ottawa, Ontario, for further examination.

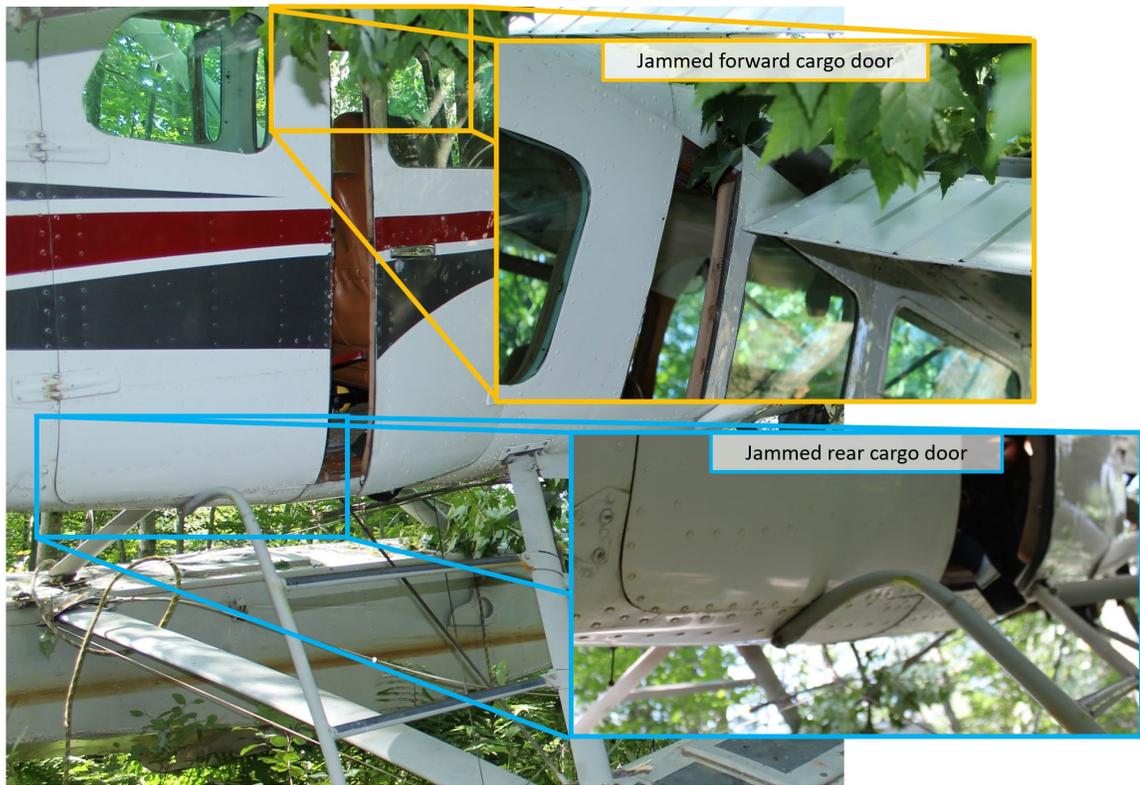
The forward cargo door was partially open and jammed because the flaps were down. This issue, specific to the Cessna 206, was identified and analyzed during TSB investigation A18W0129 and resulted in Aviation Safety Advisory A18W0129-D1-A1.<sup>4</sup> The rear cargo door of the occurrence aircraft was closed and the locking lever was in the stowed position. Investigators attempted to open the rear cargo door, but the top of the ladder<sup>5</sup> was bent from the impact and was preventing the rear cargo door from being opened (Figure 3).

Figure 3. Double cargo door of the occurrence aircraft after the accident (Source: TSB)

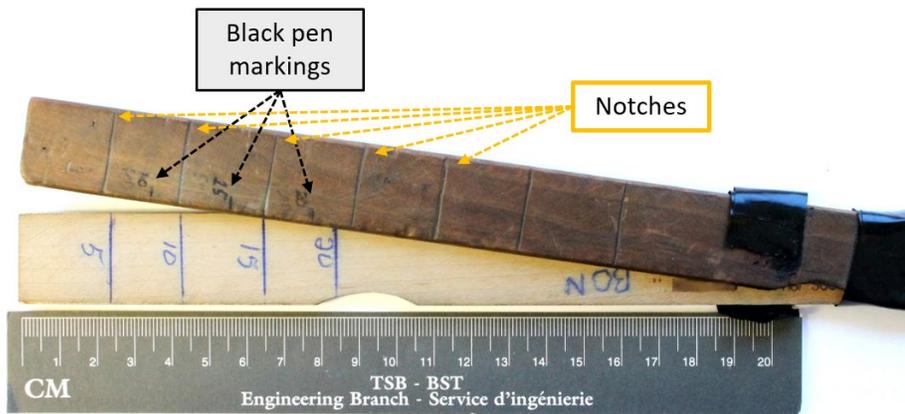
The dipstick used by the pilot was doubled, consisting of 2 sticks glued together at one end (Figure 4). The 1st stick, which was dark brown, had several notches at regular intervals, and 3 black pen markings indicating 10, 15, and 20 gallons. These markings were offset from the notches. The 2nd stick, which was a lighter colour, had blue pen lines indicating 5, 10, 15, and 20 gallons and was labelled "BON" [good] at the unmarked end (Figure 4). These markings were only visible by spreading the 2 sticks apart. The blue pen marks on the 2nd stick closely matched the notches on the 1st stick. A comparison of the various markings revealed that the black pen marks appeared to indicate quantities approximately 2.5 gallons greater than the quantities indicated by the other markings.

There was no operating instruction regarding the use of a home-made dipstick, and the operator's training program did not cover this subject. The pilot of the occurrence aircraft was not trained to use the dipstick for this aircraft. He was relying on the black markings on the 1st stick without realizing that the 2nd stick had another set of markings.

The TSB examined other dipsticks, including one used by another Cessna U206G operator whose aircraft was equipped with the same type of floats and fuel tanks. The black markings on the stick used by the occurrence pilot appeared to indicate quantities approximately 3.5 gallons greater than the quantities indicated by the other operator's stick.

Figure 4. Graduated sticks used to measure the the occurrence floatplane's fuel level (Source: TSB)

Based on the blue markings, each of the tanks would have contained approximately 17.5 gallons of fuel rather than 20 gallons after fuelling in the morning. When the fuel level was checked with the black markings after the 3rd flight on the morning of the occurrence, there was supposedly 10 gallons remaining in the left tank and 15 gallons in the right tank. However, according to the blue markings, there was, in reality, 7.5 gallons remaining in the left tank and 12.5 gallons in the right tank.

Given that the 1st and 3rd flights in the afternoon were conducted using fuel from the right tank, there should have been approximately 2.5 gallons remaining in the right tank by the end of the 3rd flight. According to information gathered, the taxiing time to the takeoff area was longer than usual and the take-off paths were extended for the 3 afternoon flights. Furthermore, the last flight was extended on the return. These 3 elements resulted in more fuel being used than what was expected. The amount of fuel collected by the TSB at the accident site was 0.33 gallons on the right, which was below the minimum usable fuel level. That small amount of fuel led to the engine failure.

- The company checked the dipstick of its other Cessna 206. The fuel level indication was accurate for both tanks.
- A new procedure was introduced, making it mandatory to check the fuel level with a dipstick every time the aircraft is fuelled and after every 2 sightseeing flights.

Operators and pilots who use a home-made dipstick as a tool for measuring fuel should ensure that the markings are calibrated and documented based on parameters specific to their aircraft, including the quantity of unusable fuel in the tanks and the type of landing gear on the aircraft when calibrating.
