MARINE INVESTIGATION REPORT

M00L0114

GROUNDING

BULK CARRIER *FOSSNES*

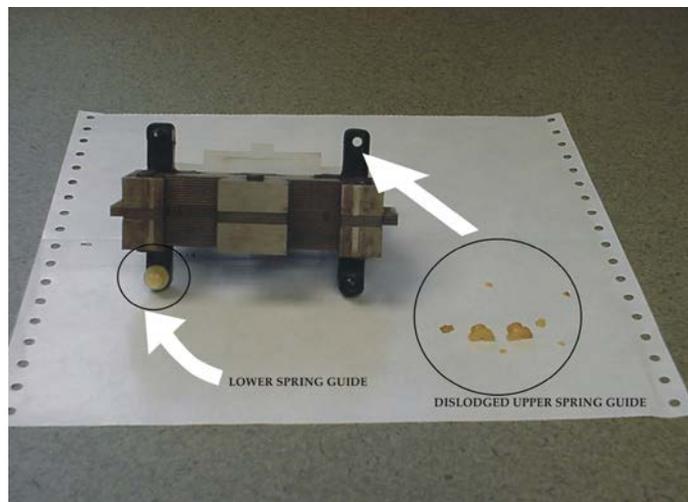
After the grounding, it was observed that the contact surfaces of all phases were damaged by arcing burns, but damage was not uniform. Also, the moveable contact slid with difficulty over the fixed contact, preventing a positive contact.

Pieces of yellowish polymer from one of the spring guides were found scattered around the inside of the contactor casing, and one of the guides was dislodged (Photo 1). Polymer can deteriorate after prolonged exposure to chemicals, heat, cold, stress, sunlight, oxygen, moisture, or pollutants in the atmosphere. Any of these factors, either individually or collectively, will alter the chemical composition of the material. Symptoms such as surface fragility, yellowing, cracking, or loss of elasticity and resilience are all signs of chemical deterioration.

An inspection of the No. 2 power unit contactor revealed that one of the spring guides was also broken and showed signs of chemical deterioration. The working life of the two contactors was approximately the same.

The contactor malfunctioned because small pieces of polymer affected the mechanical movement of the contactor. The deterioration of the polymer used to manufacture the spring guide shows the importance of carefully monitoring the condition of parts and the environment in which the parts are intended to be used.⁵ The degradation of this polymer contributed to the reduction of the theoretical service life of the contactor and created an overcurrent in the supply circuit. Since the three contactors examined had the same defect, the choice of contactors used on board can be questioned.

The TSB sent Marine Safety Information Letter (MSI) 01/01, concerning the contactor defect, to the owner, with copies to the manufacturer, the Administration of the Registry, the shipyard, and the International Association of Classification Societies. The manufacturer, Hydroster, had decided to use other types of contactors as a result of testing new products in 1997.

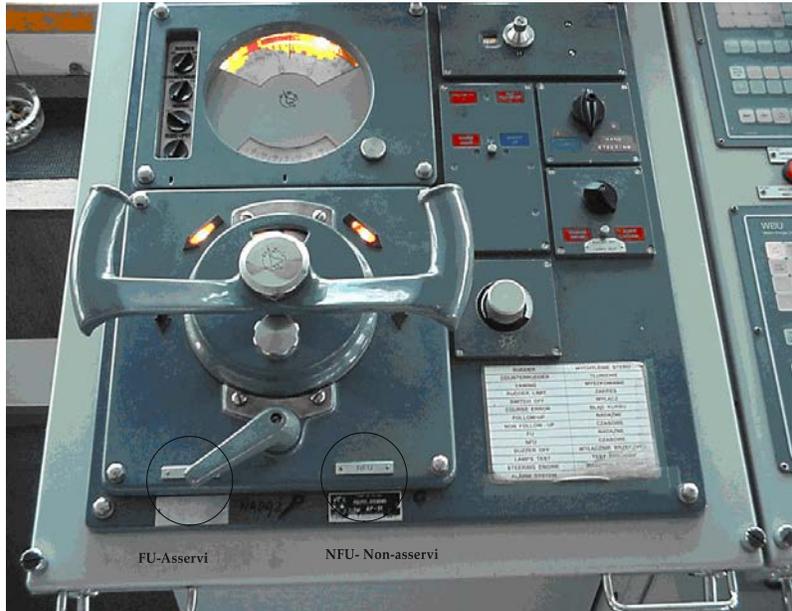
The rudder is activated by a steering wheel on the steering control stand (Photo 2). Below the steering wheel, there is a selector switch used for selecting FU or NFU control mode. The electrical circuit for the FU control mode was energized from the No. 1 starter panel power unit; the NFU control mode was from the No. 2 .

The OOW and the helmsman reported that they tried NFU control mode immediately after the breakdown. However, since they observed no rudder movement from the rudder indicator, they again selected FU control mode.

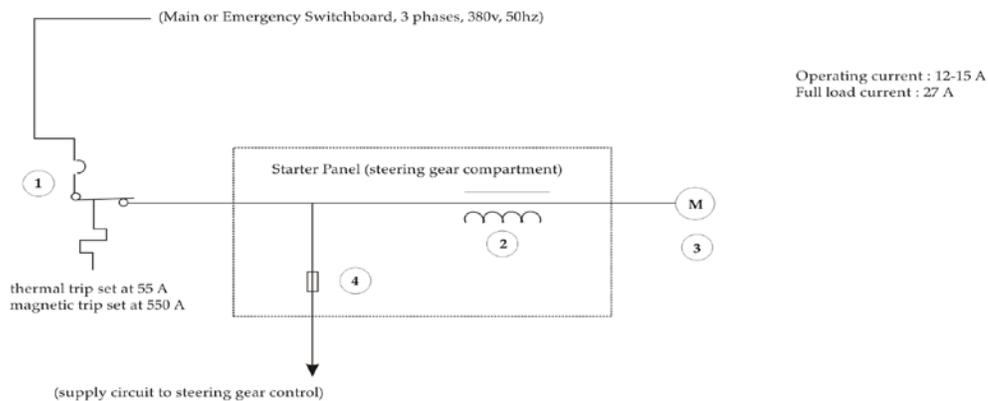
Electrical Arrangement of Steering Gear Power Unit and Control Circuits

When the breaker trips, it will cut power to all circuits connected to it because the steering gear control circuit is connected to the main breaker output of the power unit's power circuit.

The supply circuit of the ship's steering gear control was in compliance with SOLAS requirements. However, although it was in compliance, the point from which power is taken and the location where the overload device is installed could allow an unanticipated breakdown of the control system in FU mode and NFU mode. A test determined that the sudden tripping of the main breaker results in the de-energizing of the supply line to the No. 1 power unit and, consequently, a failure of the FU control mode (Figure 1).

To protect the supply line, the main breaker of power unit No. 1 has two protection devices: one for short circuits and one for overcurrents. These two types of protection are acceptable pursuant to the SOLAS Convention. After the grounding, the test with a megohmmeter on the electrical components of power unit No. 1 revealed no evidence that a short circuit had occurred. All indicates that the malfunction of the closure mechanism of the power unit motor contactor, combined with the high starting current following several starts, contributed to an overcurrent exceeding the setting for long-delay protection. Hence, this excessive overcurrent tripped the main breaker.

The TSB sent MSI 08/01, concerning the inadequacy of SOLAS regulations on steering gear electrical systems, to Transport Canada. If Transport Canada deems necessary, a submission can be made to the International Maritime Organization.

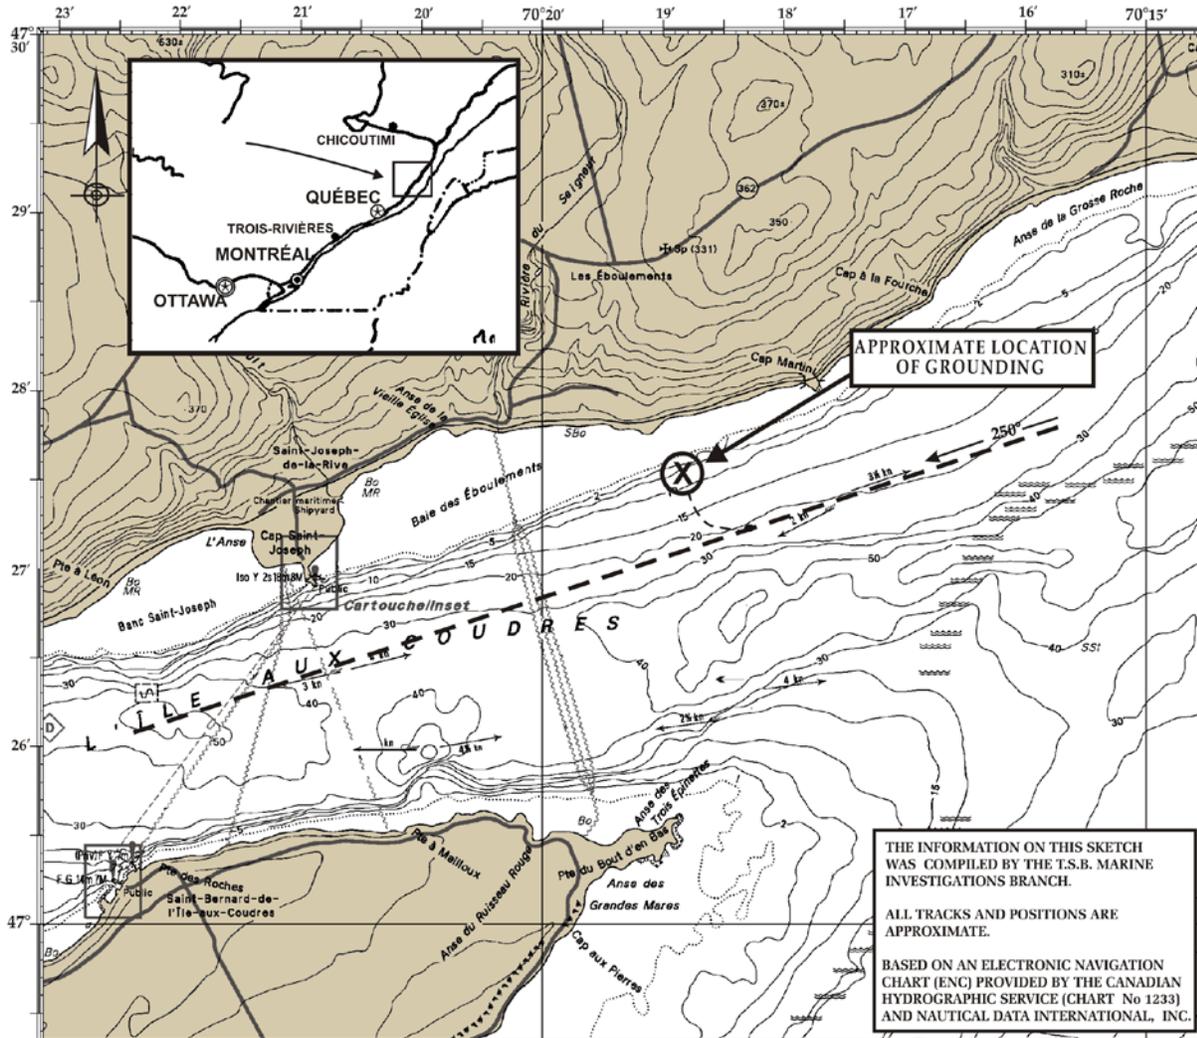
Appendix A—Sketch of the Occurrence Area

Although both anchors were let go, the vessel continued its swing to starboard. At 1201, the vessel grounded in position latitude 47°27'48" North and longitude 070°17'54" West, about two cables southwest of Cap Martin.
