MARINE INVESTIGATION REPORT

M04F0017

GROUNDING

TANK BARGE *KTC 115*

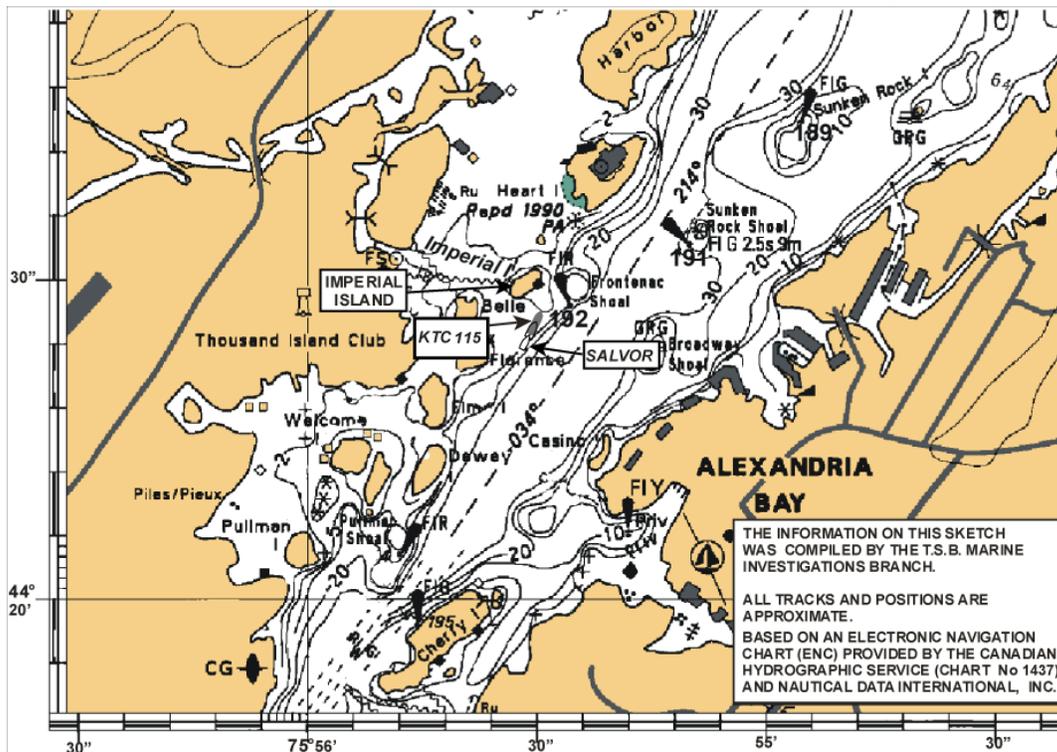
of the situation. Seaway Clayton then contacted the *Salvor* requesting clarification. Free of the tug, the barge continued downstream and grounded on the north side of the channel adjacent to Imperial Island in position 44°20'25" N, 075°55'30" W. During this time, the crew of the *Salvor* was unaware of the position of the barge until it was located by the passing *Thalassa Desgagnes*.

A damage survey of the barge by divers revealed inset bottom plating and three cracks in the bottom of the forward-most starboard tank. A rope was found entangled in the port propeller of the tug, and the tips of the starboard propeller blades were found to be damaged.

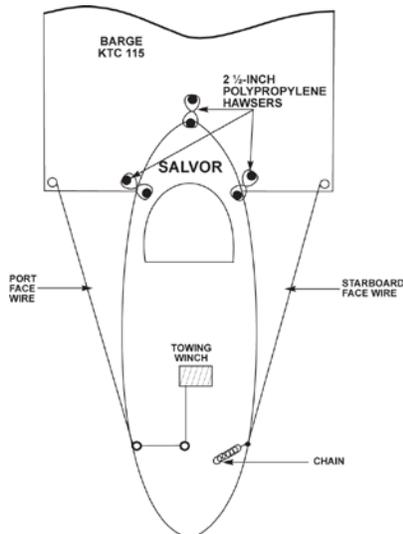
The towing arrangement comprised a notch in the transom of the barge that housed the bow of the tug (see Photo 1). The securing arrangement comprised a 2½-inch braided polypropylene hawser from the bow of the tug to a bitt on the barge and similar hawsers, one at each corner of the barge's notch to the port and starboard shoulder of the tug (see Figure 2). To facilitate steering and backing, single 1½-inch-diameter, 6 x 36 face wires were rigged between quarter bits on the barge and the after deck of the tug. The starboard wire was shackled to a 2-inch steel stud chain, which, in turn, was shackled to a fairlead mount on the deck of the tug. The port face wire was connected through a fairlead to the tug's towing winch that was used to tension the tug in the notch.

Post-occurrence examination of the rigging found that two links of the chain connecting the starboard face wire had failed, and that the port face wire had also parted at the point where it would normally lead through the port bulwark fairlead. Tests on the failed chain links indicate that they failed from sudden overstress.⁷ The tests found that there were no significant corrosion or defects in the failed chain links and that the breaking strength was consistent with standards for that size chain. No certification, inspection, or maintenance records were available on board for either the chain or wire, although a certificate from the wire rope manufacturer was produced by the owner some three months after the occurrence. The history of the failed chain could not be determined by the company; however, it was in poor overall condition with studs loose or missing from some links. Indications are that it probably came from a marine salvage yard.

The master has implemented a procedure on all vessels on which he sails whereby the chain links are replaced by certified shackles, thereby ensuring documented proof of the safe working load for the entire connection system.

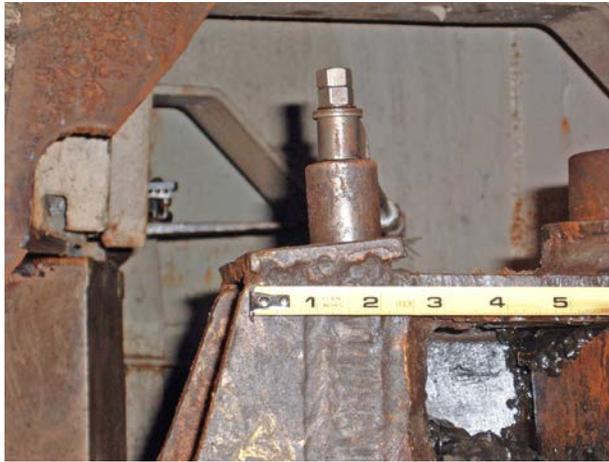
Post-occurrence inspection of the system revealed that the telemotor feedback rod had failed at the adjustable threaded toggle connecting it to the rudder quadrant. Laboratory examination of the failed rod showed that it failed from damage due to fatigue.⁸ The pivot pin that transmits the quadrant motion to the telemotor feedback rod was misaligned, and the rod was found to bind as the rudder moved between midships and hard over position in each direction. The mounting of the pivot pin on which the rod mounts had been modified at some time in the past; however, no records were available to indicate when and by whom. Tests of the steering system showed that both the bridge rudder angle indicator and the NFU steering system did not function when the telemotor feedback rod was disconnected.

The TSB Engineering Laboratory examination of the failed telemotor feedback rod indicated that pre-existing fatigue cracks were present at the location where the rod failed. Fatigue is commonly referred to as the phenomenon that leads to fracture under repeated or fluctuating stresses having a maximum value less than the tensile strength of the material.¹⁰

The telemotor feedback rod on a vessel operates as a push/pull rod to transmit the position of the rudder to the steering control mechanism. Under normal circumstances, when the rod moves freely throughout its full range of travel, the repetitive stresses on the rod are relatively small, and it may be expected to have a long service life. However, the configuration of the feedback rod and tiller head mounting pivot pin had been modified at an unspecified time in the past from its original configuration. The source of the fatigue was determined to be a misalignment between the feedback rod and the tiller head mounting pivot. As the rudder moved throughout its full range of travel, the misalignment resulted in the rod binding, which exacerbated the stress and, ultimately, led to the fatigue failure.
