RAILWAY INVESTIGATION REPORT
R07T0110

MAIN-TRACK DERAILMENT

CANADIAN NATIONAL
TRAIN M36321-26
MILE 264.94, KINGSTON SUBDIVISION
COBOURG, ONTARIO
28 APRIL 2007

Report Number R07T0110

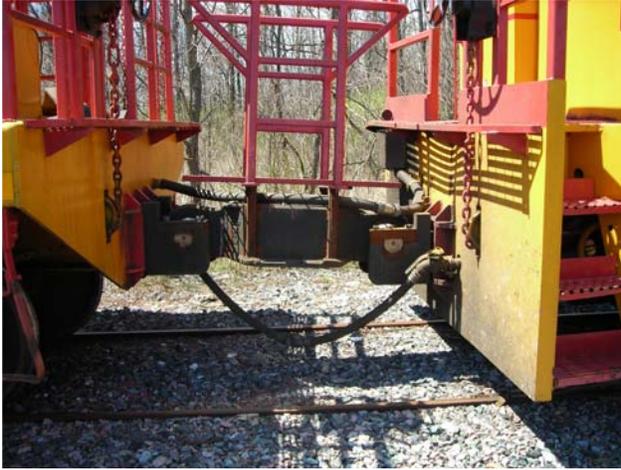
Photo 1a. Non-standard coupling system between car HZGX1750A on the left and car HZGX175 (the Herzog locomotive) on the right

The leading truck of the Herzog locomotive came to rest upright with all wheel sets straddling the south rail. The drawbar between the two cars had swung sharply to its limits during the derailment, producing matching fresh strike marks on the drawbar and restricting side plates of the “U”-shaped connector.

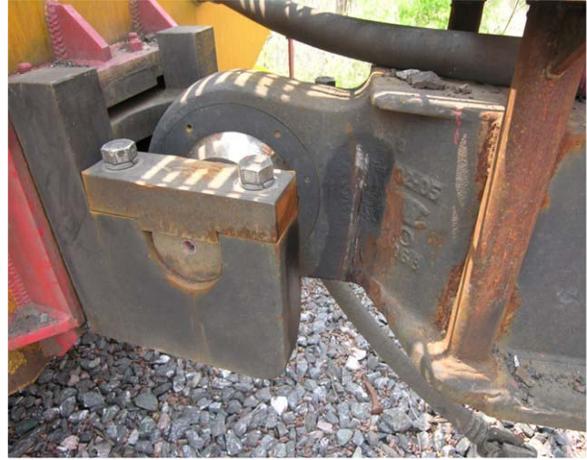
Photo 1b. Close-up of orbital joint showing fresh strike mark from lateral movement to limits

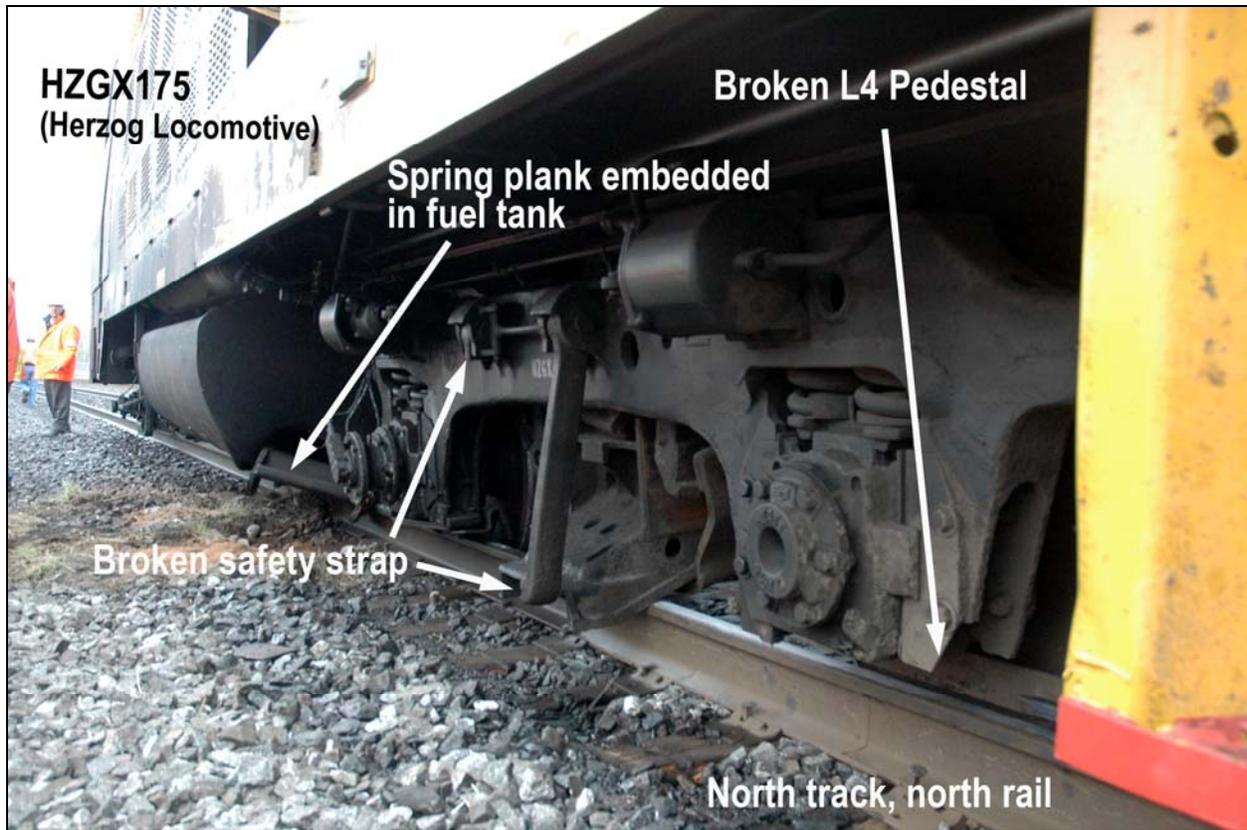
The bottom of the leading L4 truck pedestal (north side), and the attached bottom support plate, brake beam slider and bolt, were missing. The safety strap, which provides support in the event the spring assembly fails, was bent and fractured in two places. The bottom spring plank, which was twisted and fractured, was driven into the bottom of the fuel tank, where it became lodged (see Photo 2). There was a deep impact mark on the side of the spring plank, and a longitudinal tear on the bottom of the fuel tank.

Photo 2. Damage to north side of HZGX175 (Herzog locomotive)

Site examination and the TSB Engineering Laboratory analysis determined that the overstress brittle failure of the Herzog locomotive components did not cause the derailment. Inspection of the damage determined that the pedestal and the spring plank were both struck by an object in the same longitudinal plane. In addition, the shape of the impact mark on the spring plank indicates that the striking object, although not recovered, was likely the broken end of the north rail. The Herzog locomotive, HZGX175, was already derailed when the north rail broke. The end of the broken rail then struck and damaged the components on the leading truck of HZGX175. The spring plank was then driven into the bottom of the HZGX175's fuel tank, leading to the release of diesel fuel.

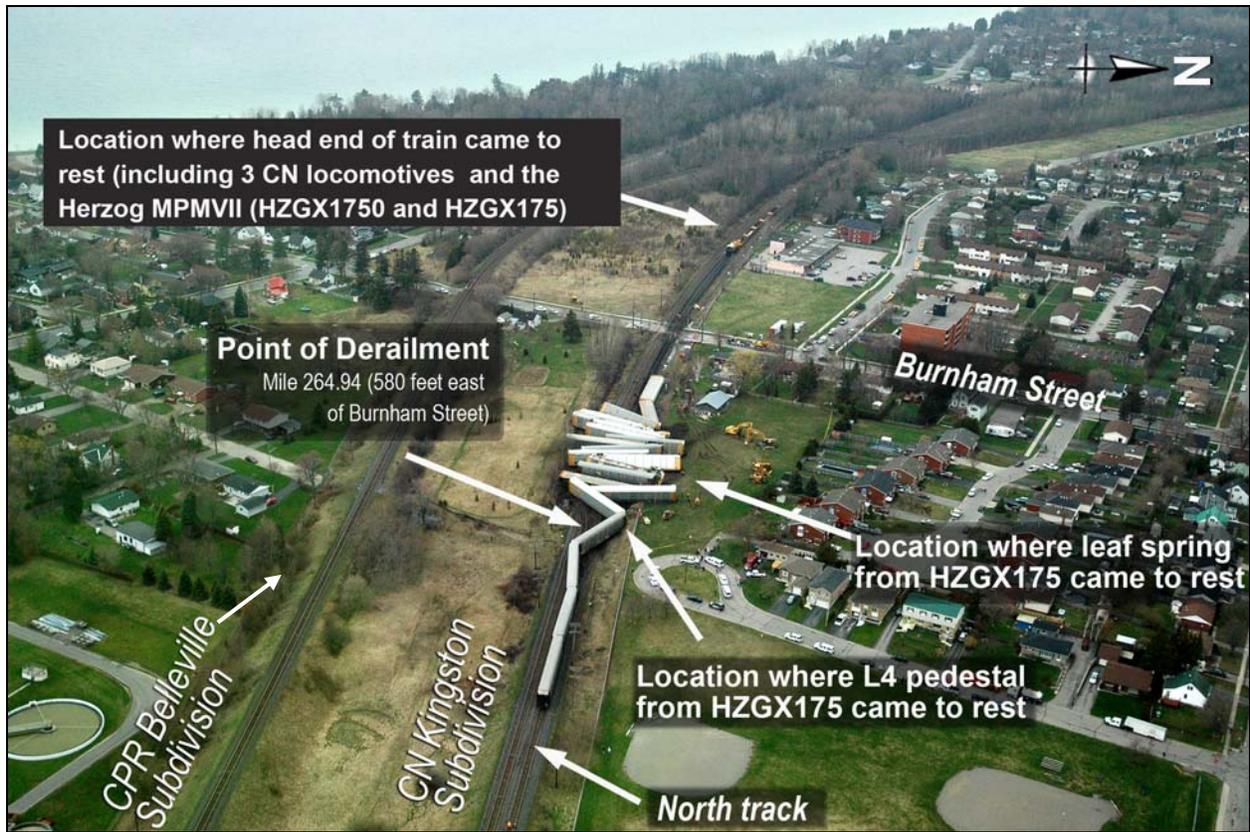
From the Herzog locomotive, there was an approximate 350-foot gap back to the remaining derailed cars east of the Burnham Street crossing (see Photo 3). The first two cars were lying end to end on their sides, rolled to the north of the track. The next 17 cars were jackknifed, stacked side to side, perpendicular across the entire right-of-way, blocking both main tracks. The final three derailed car bodies were upright, parallel to the right-of-way.

Track damage, including wheel flange marks, extended from the derailed Herzog machine back to the most westerly (the 5th) jackknifed car east of the crossing (for a total of approximately 1000 feet). The track structure had fire damage throughout. East of the crossing, the south rail (high rail) was rolled out to the field side and the low rail remained fixed and upright under the derailed cars. Under the jackknifed cars (between the 5th and the 21st derailed car), the north track and portions of the south track were destroyed.

Photo 3. Aerial view of derailment site looking west (Source: Canadian National)

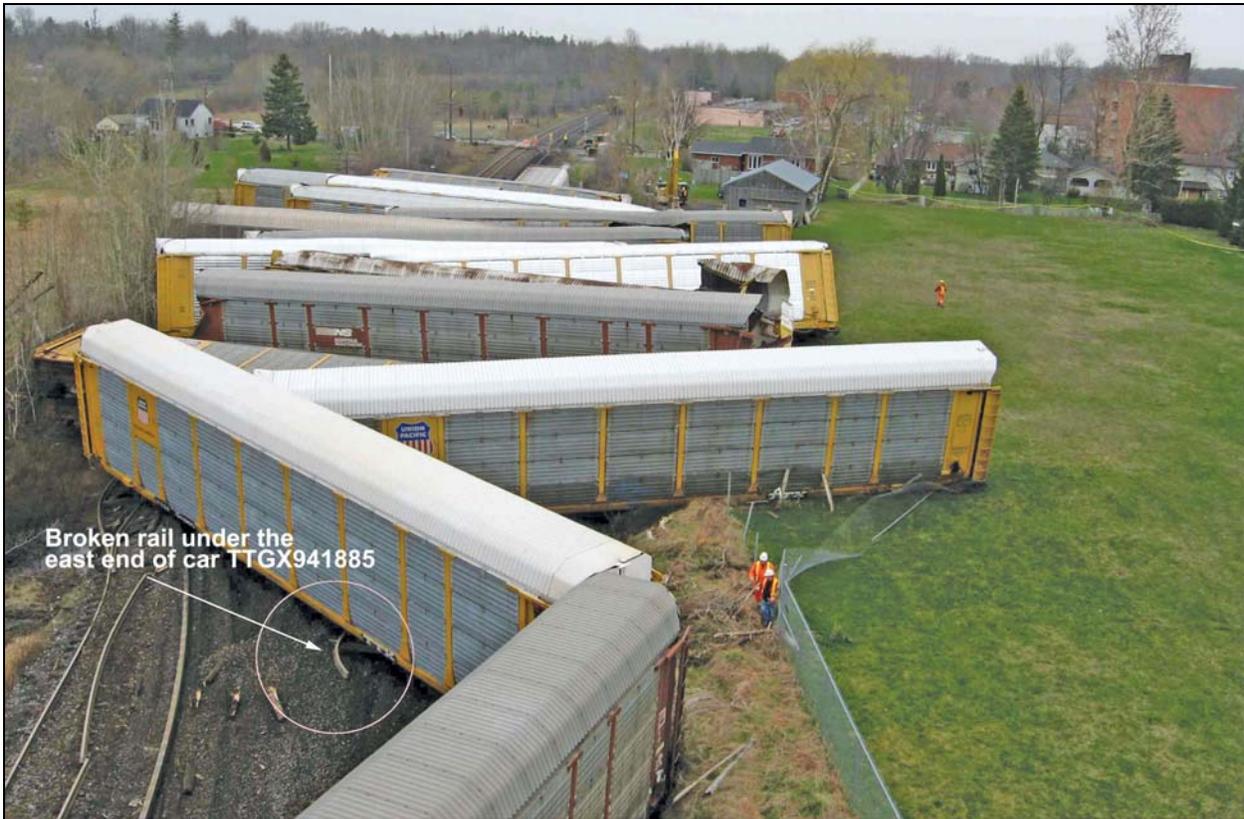
In Photo 4, the aerial view of the derailed cars depicts a piece of rail pinned under the east end of car TTGX941885, with the east-facing end of the north rail elevated. The missing pedestal, bottom plate and brake beam slider from locomotive HZGX175 were found as one piece embedded into the slope on the north side near where the leading truck of car TTGX978605 came to rest.

Photo 4. Aerial view of derailed rolling stock looking west (Source: Canadian National)

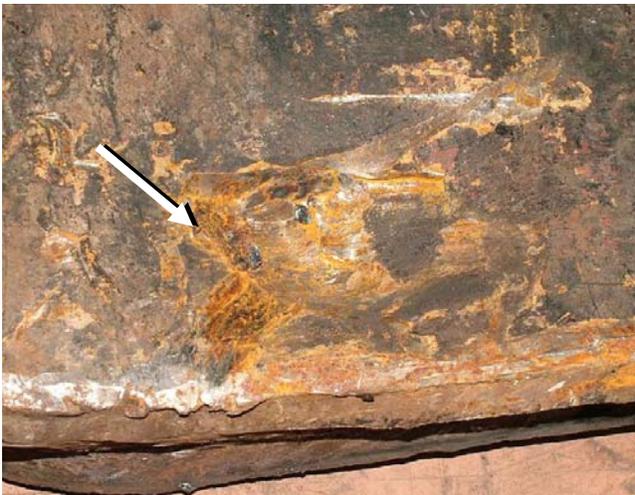
Photo 7a.

- The fracture mode for the rail specimens was through overstress rupture. There was no evidence of a progressive failure. The hardness and microstructure for the rail specimens were typical for this type of rail. No material anomaly was found.
- The pedestal from the Herzog power unit fractured in overstress from a direct impact to the bottom, inboard corner. The two mating fracture surfaces on the pedestal were overstress in nature and showed no signs of progressive failure. No material anomaly was found.
- The spring plank from the Herzog power unit was torn from its support by an impact with a foreign object. The profile of the impact mark matches the rail head profile of the sample rail pieces collected at the site (see Photos 7a and 7b).

Portion of the spring plank leading surface showing impact mark in relation to the profile of sample rail seized from the derailment site
