**RAILWAY INVESTIGATION REPORT
R08T0029**

MAIN-TRACK DERAILMENT

**CANADIAN NATIONAL RAILWAY
FREIGHT TRAIN M39671-14
MILE 33.24, OAKVILLE SUBDIVISION
ALDRSHOT, ONTARIO
18 FEBRUARY 2008**

Report Number R08T0029

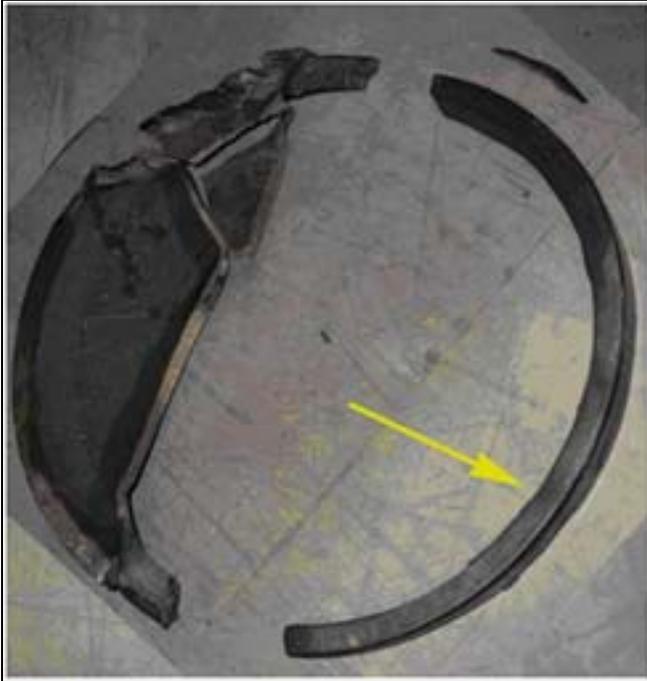
Inspection of the track west of the derailment site revealed a large “C-shaped” portion of wheel rim (see Photo 1a) and impact marks on the head of the south rail, south track (see Photo 1b) at approximately Mile 0.6 of the Dundas Subdivision. At this location, the train was exiting a right-hand curve where CN tracks cross over Highway 403 before entering a wye junction with the Oakville Subdivision at Bayview (see Figure 2).

Photo 1a. The Yellow arrow points to portion of broken wheel recovered at Mile 0.6 of the Dundas Subdivision.

The first large portion of the broken wheel was recovered in the vicinity of Mile 0.6 of the Dundas Subdivision, where a series of significant wheel impact marks were observed on the head of the south track, south rail. In this location, the train traversed a right-to-left-hand curve at the bottom of a steep grade. The first car to derail shifted to the high side of the curve, aligned the outer rim of a high-impact wheel to the low rail, and generated a high-impact load on the rail head at Mile 0.6 of the Dundas Subdivision.

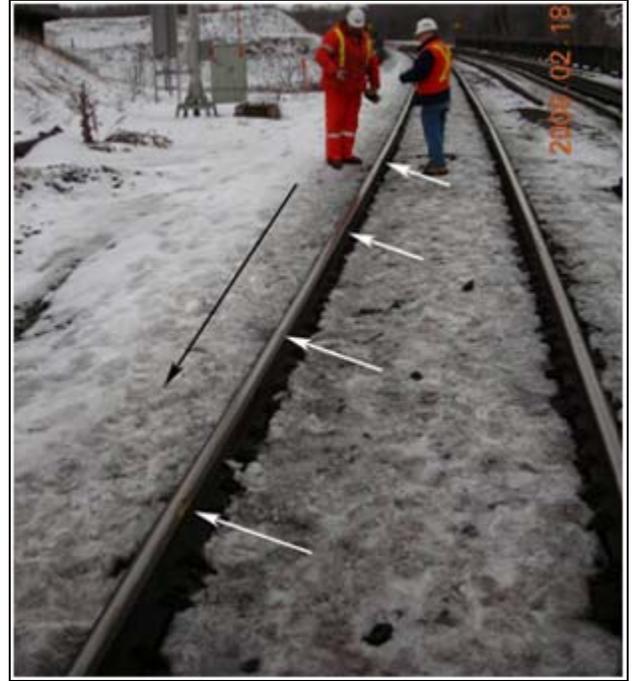
Photo 1b. Mile 0.06 of the Dundas Subdivision. The black arrow shows the direction of train movement. White arrows point to impact marks on the gauge side of the south rail, south track.

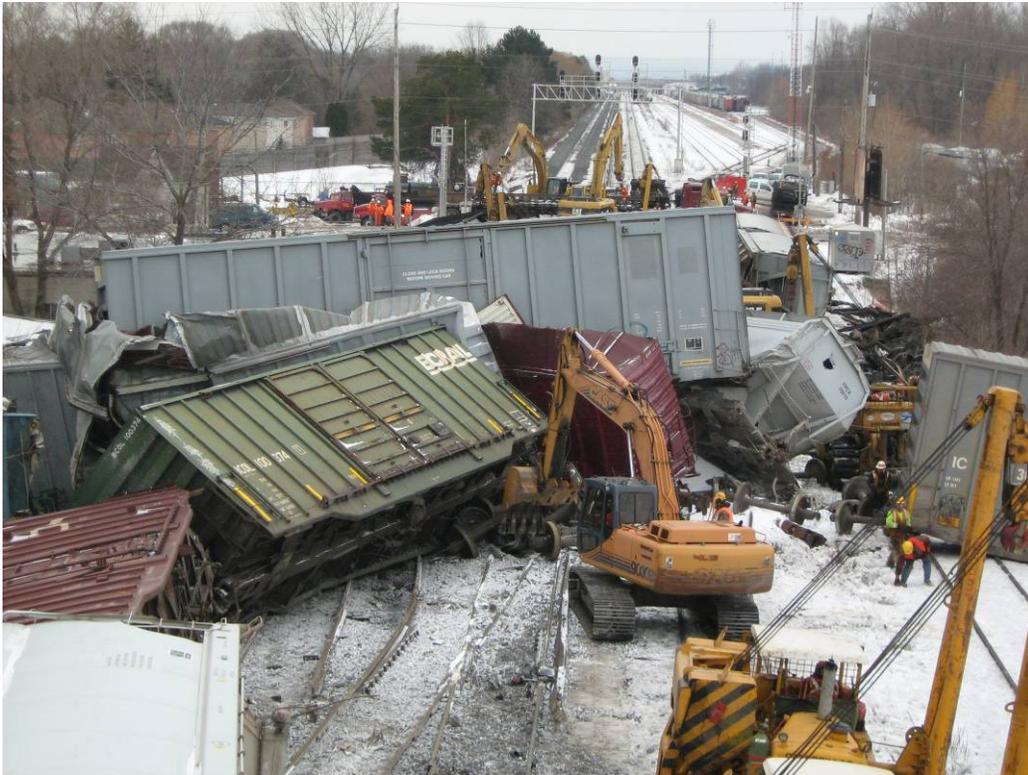
On the west side of the King Road crossing, there were impact marks on the crossing apron to the gauge side of the north rail and to the field side of the south rail. East of the crossing, the 99th to the 108th cars were derailed, piled up, and jackknifed across the right of way (see Photo 2). Some cars had spilled down an embankment to the south onto private property. Many of the derailed cars were crushed, punctured, or leaking product. Two buildings at the derailment site were struck. One sustained serious structural damage.

Photo 2. Aldershot derailment site looking west

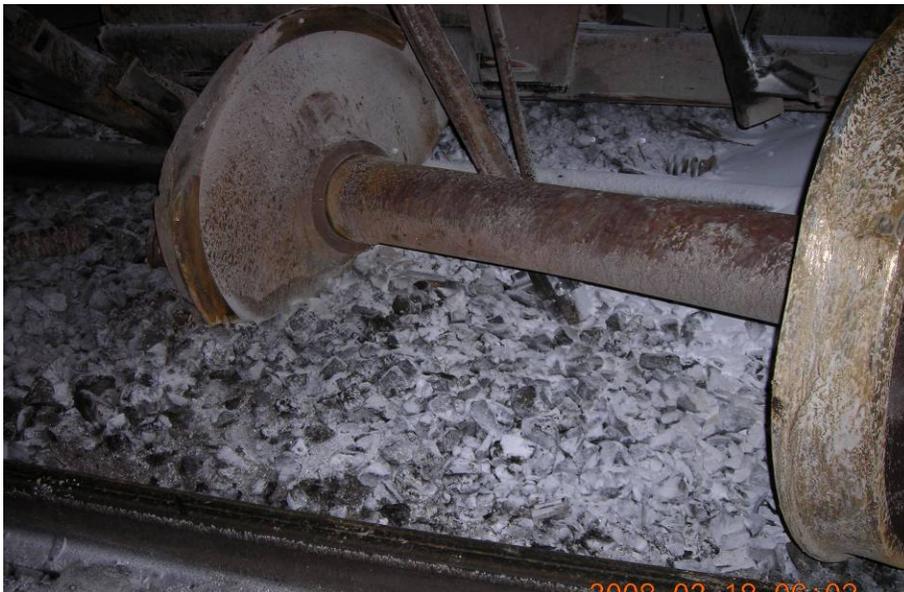
Photo 3. Straight-plate wheel set with one broken wheel at site of derailed cars

This wheel set, along with recovered wheel fragments, was sent to the TSB Engineering Laboratory for analysis (TSB Engineering Laboratory report number LP 040/2008).

- The straight-plate wheel failed when a large outboard section of tread separated as a result of an overstress extension of pounding fatigue cracking.

- Fatigue cracking had initiated in the tread material approximately 0.40 inches below the running surface of the wheel.
- No metallurgical anomalies were observed in the crack origin area.

- The secondary wheel plate fractures were all overstress ruptures.
- With a temperature of 5°C, the fracture toughness of the material from the failed straight-plate wheel was approximately half that of the material from a comparison curved-plate wheel.

- The straight-plate wheel design is more than twice as stiff as the curved-plate design.
- The combination of a high-stress, straight-plate wheel design, low-fracture toughness material, low ambient temperature, and high-impact loads were sufficient to create an applied stress that exceeded the limits of the wheel material.

- Although the fracture had been growing for some time, it originated internally and was visually undetectable until the failure.
- The wheel fractured catastrophically when it failed.

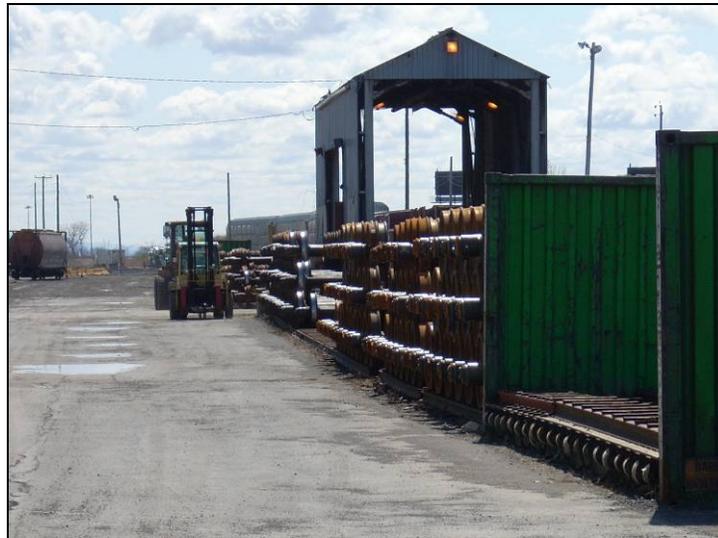
When car ACFX 97330 arrived at Taschereau Yard, it was cut out of the train and transferred to the expedited repair track facility at track W01 (see Photo 4) for wheel change-out. The applicable repair (“bad order”) code was specified as WI (wild impact).

The repair facility features a hydraulic drop table³ protected by a tall, tin-sheathed building. The building is open on two sides to permit rolling stock access. In addition, there is a large open doorway on a third side to permit access for various repair equipment. The work area is illuminated, but provides only limited protection from the environment.

Photo 4. Expedited repair track facility on track W01

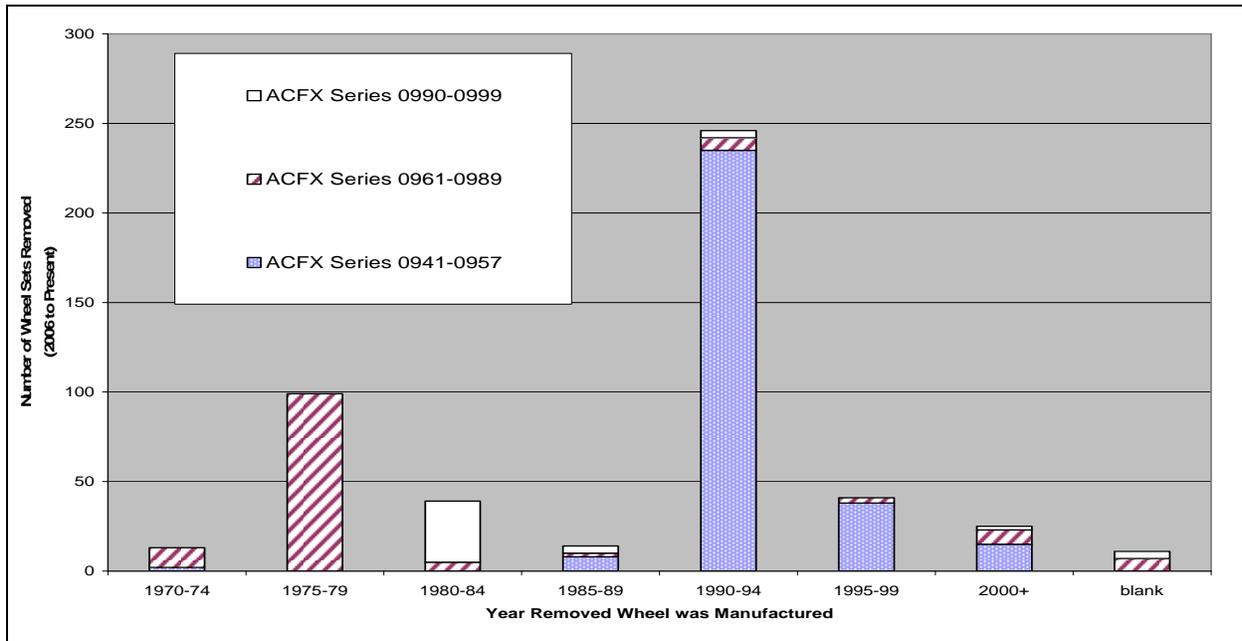
This sampling led to a further review of wheel change-outs for ACFX cars since 2006 (see Figure 2). The review identified an elevated number of wheels cast between 1975 and 1979 and outlier years in cars with the series number 0961 to 0989. The series 0990 to 0999 had an elevated number of wheels cast in years 1980 to 1984 and the series 0941 to 0957 showed anomalous numbers of wheels cast in years 1990 to 1994. The elevated numbers of wheels cast in years 1975 to 1984 match the car built dates.

Figure 2. CN Removal of wheel sets on ACFX cars
