**RAILWAY INVESTIGATION REPORT
R11T0113**

NON MAIN-TRACK COLLISION

**CANADIAN NATIONAL RAILWAY
0600 PLANK ROAD SWITCHING ASSIGNMENT AND
0800 BUNKHOUSE SWITCHING ASSIGNMENT
SARNIA YARD, MILE 57.2, STRATHROY SUBDIVISION
SARNIA, ONTARIO
22 MAY 2011**

Report Number R11T0113

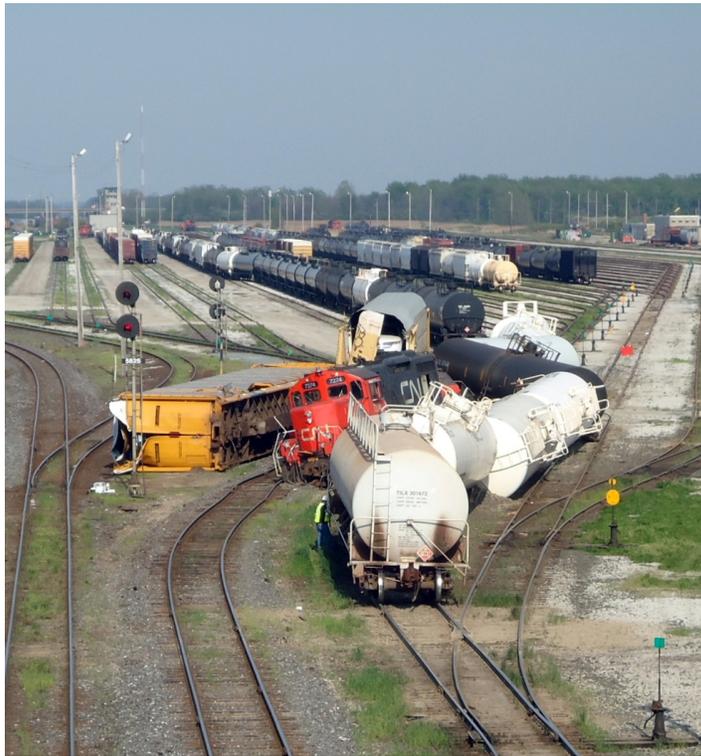
While travelling at 8 mph through the west lead and PPZ, the 28th car of the 0800 assignment was struck by the lead locomotive of the 0600 assignment which was travelling at approximately 9 mph, also in the westward direction. The collision occurred at the point where the 2 tracks converge on the west lead. As a result of the collision, 6 dangerous goods (DG) tank cars from the 0800 assignment derailed to the south side of the west lead track. Two loaded bi-level auto carriers and the locomotive consist of the 0600 assignment derailed to the north side of the west lead track (see Photo 1). There was no release of product, and no injuries. Approximately 400 feet of track was damaged.

Photo 1. Derailed cars – looking southeast

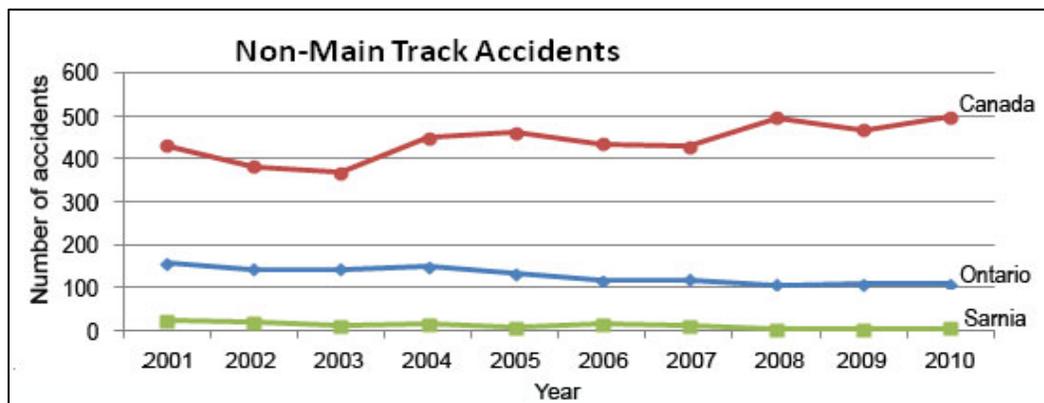
Since 2007, the total number of accidents at Sarnia Yard has decreased significantly. The Yard has reported only 1 collision in the past 3 years, down from an average of over 5 collisions per year for the rest of the decade (see Figure 3). Sarnia Yard has been recognized for its low accident rate and had previously received a company award in recognition of this achievement.

Figure 3. CN non-main track accidents reported for Sarnia Yard, Ontario and Canada
