**RAILWAY INVESTIGATION REPORT
R13W0124**

SUBGRADE COLLAPSE AND DERAILMENT

**VIA RAIL CANADA INC.
TRAIN P69341-28
MILE 83.55 TOGO SUBDIVISION
TOGO, SASKATCHEWAN
28 APRIL 2013**

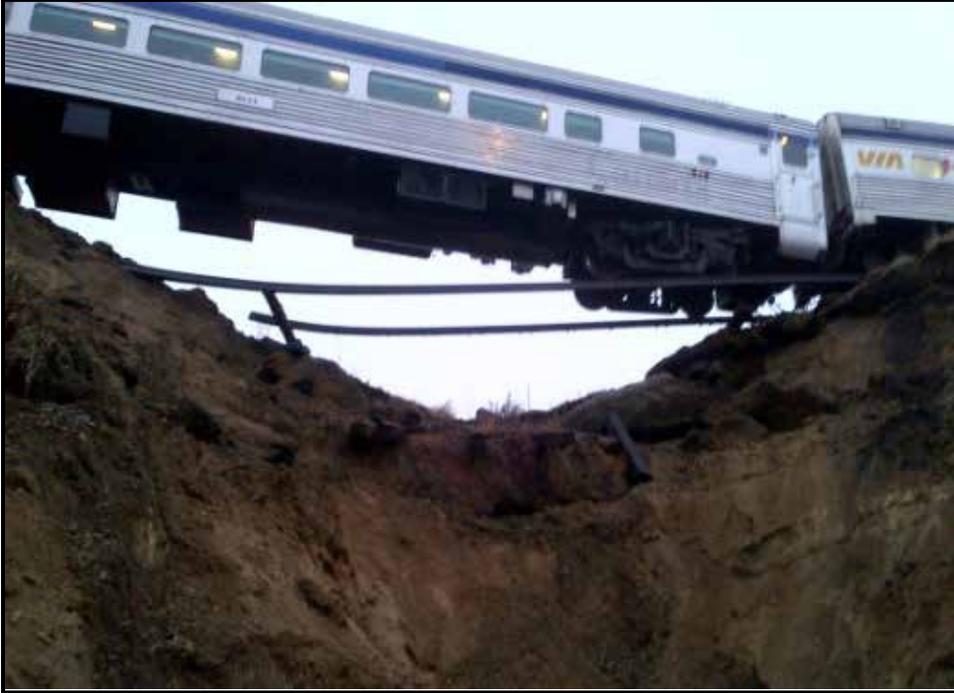
The passenger car came to rest straddling the gap that had opened up under the train (Photo 1). The fuel tanks on both locomotives ruptured in the area of the trailing end plates, due to contact with the rails, and the leaking fuel ignited. Both locomotives caught fire and sustained

Photo 1. A passenger car straddles an embankment after the train encountered a roadbed slump that subsequently collapsed.

The crew observed a 10-foot portion of ballast missing under the track, just ahead of the train near Mile 83.55, and placed the train into emergency. Although immediate action was initiated, the range of vision available to the crew did not allow sufficient time to stop the train before reaching the affected area. As the train traversed the unsupported portion of track, the embankment collapsed further beneath the weight of the train, leading to the derailment.

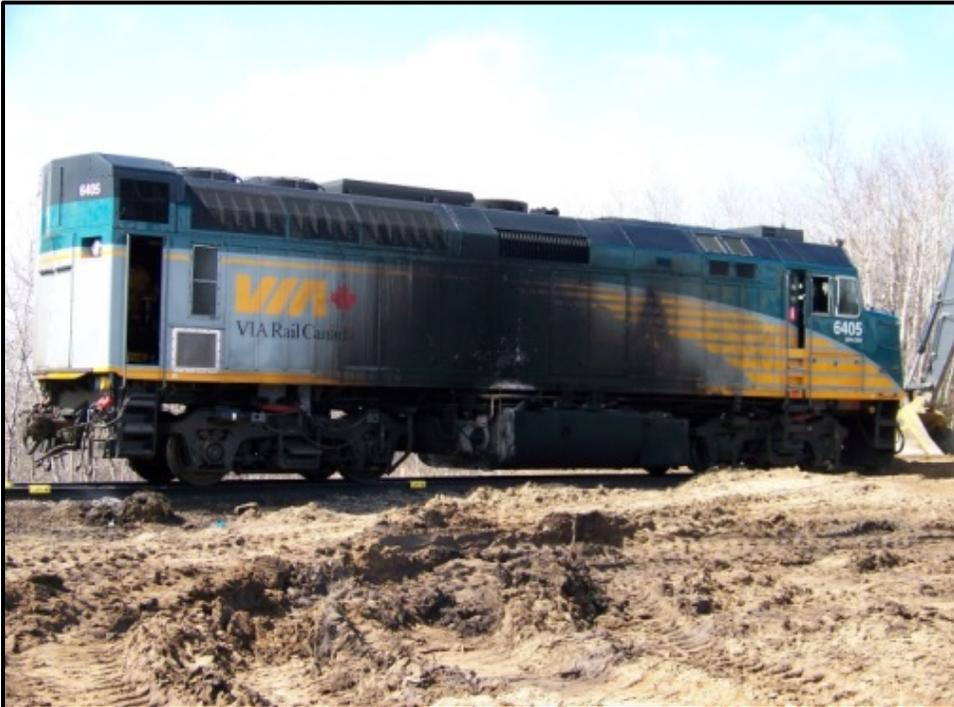
Photo 2. Locomotive VIA 6405, showing damage from the accident fire

- The thickness of the bottom sheet of the fuel tanks was about 3/16 inches (in steel), while the lower third of the end plates measured about 5/16 inches thick—below the S-5506 requirements of 5/16 inches and 3/4 inches, respectively.
- The measured thickness and estimated yield strength results were significantly lower than the minimum S-5506 requirements.

The fuel tanks on both VIA Rail locomotives ruptured when they came into contact with the rail during the derailment and supported the weight of the locomotives. This event resulted in a diesel fuel-fed fire that damaged both locomotives. The fuel tanks' ruptures occurred in areas that would have required reinforcement to meet S-5506 fuel-tank crashworthiness criteria. These locomotives had been rebuilt as part of VIA's locomotive rebuild program initiated in 2007. However, upgraded locomotive fuel tanks were not part of this program.

The Department of Transport require that crashworthiness standards for new locomotives also apply to rebuilt passenger and freight locomotives.

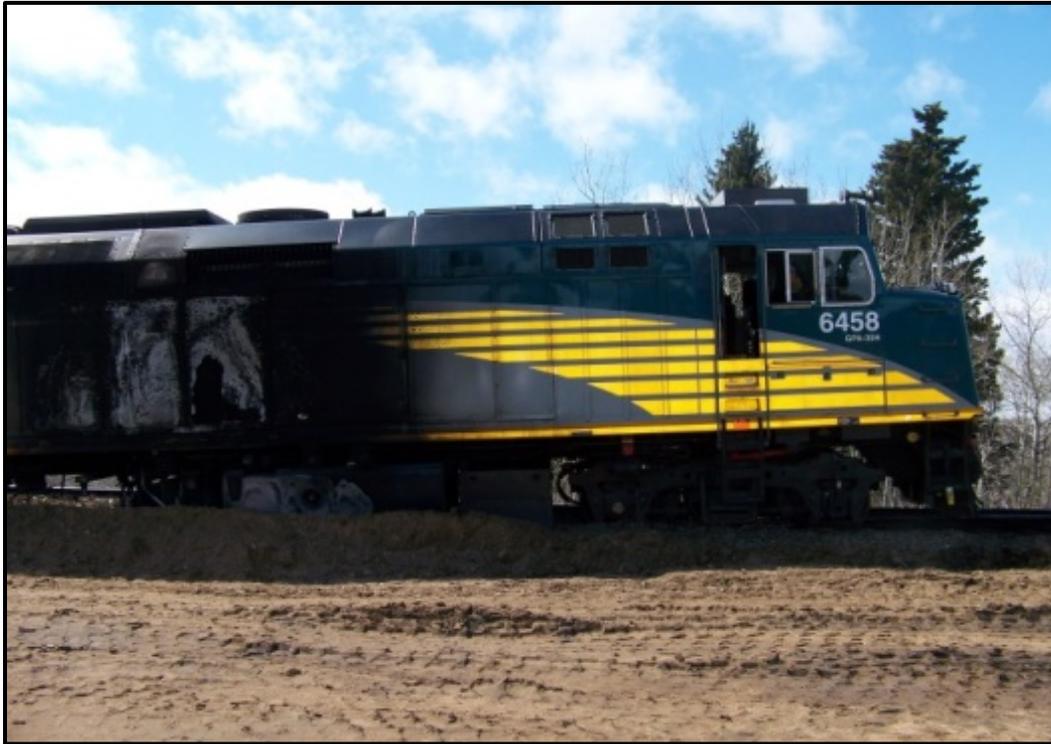
Photo 3. Locomotive VIA 6458, showing damage from the accident fire

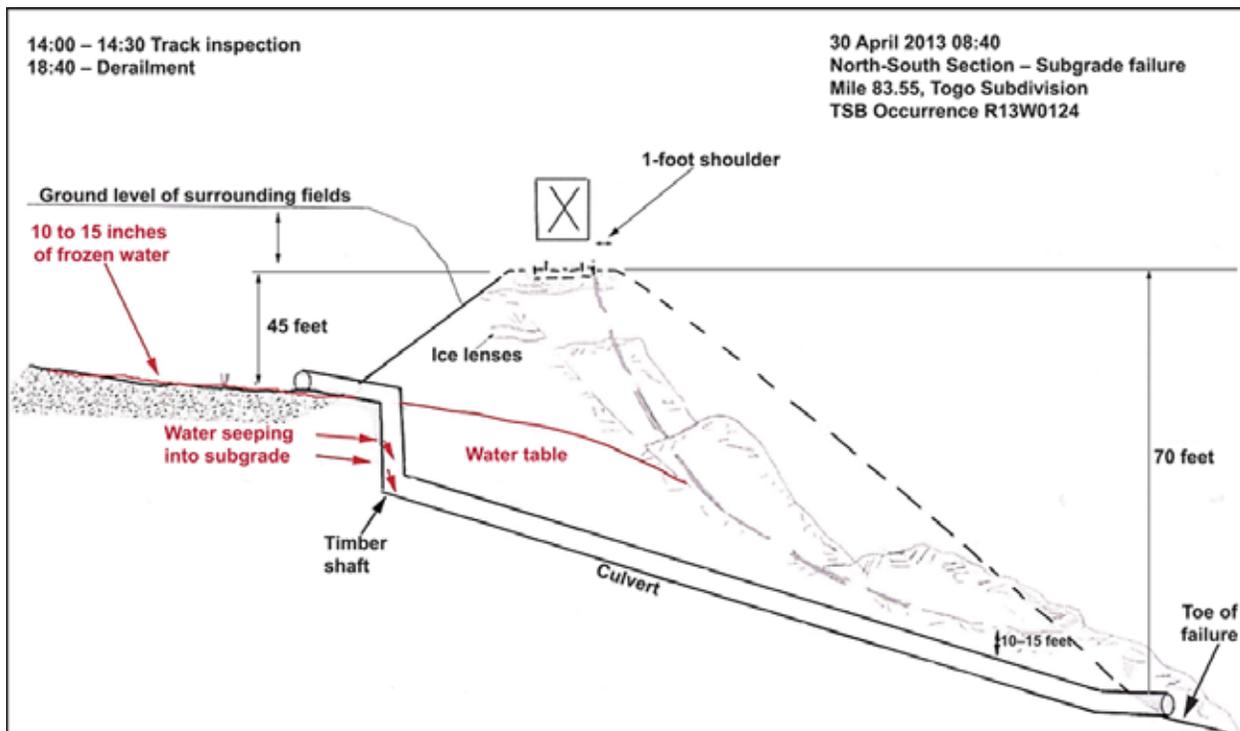
Figure 2. Cross-section detailing culvert, raised track, and slope failure (Source: Canadian National Railway [CN], amended and annotated by TSB)

The culvert through the grade at Mile 83.55 was a compound² design. On the north side, a 48-inch corrugated steel inlet pipe connected with a square, metal-lined timber vertical shaft about 45 feet deep that acted as a manhole and connected to the outlet pipe below (Figure 2).

The embankment collapse occurred due to water saturation and the build-up of pore pressure in moisture-sensitive fills, which resulted from a rapid snowmelt and inadequate water drainage due to the ice plug at the culvert outlet. The frozen culvert had blocked surface drainage and had caused ponding in the upslope ditch. This ponding in turn resulted in excess hydraulic head forming in the culvert barrel and drop structure. The excess head on the leaking drop structure and culvert rivet holes resulted in an elevated piezometric surface condition in the embankment, making it more susceptible to failure. The combination of all factors listed in the geotechnical study caused the landslide.

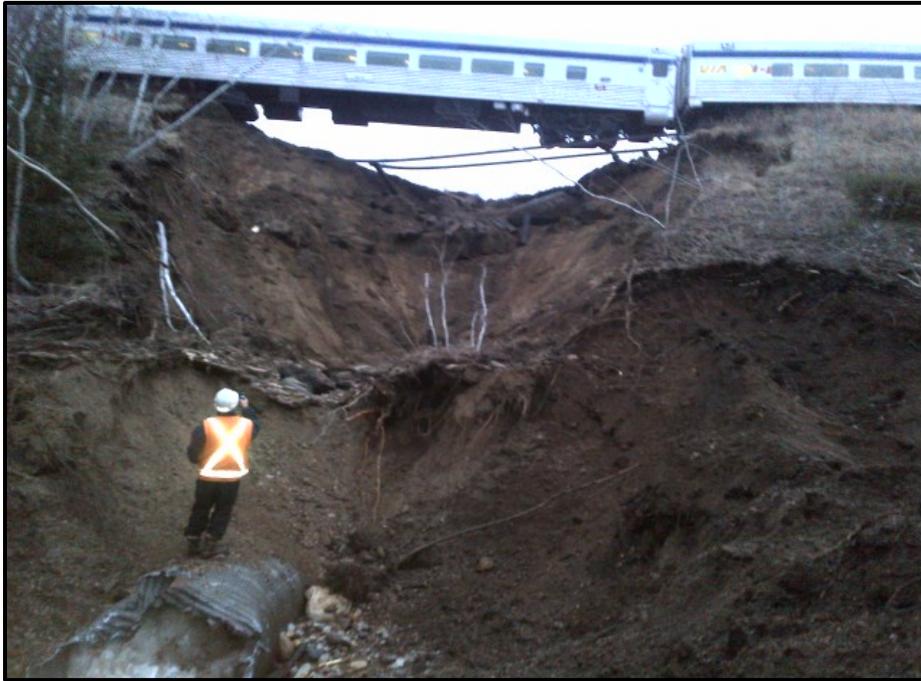
Photo 4. Ice blocking culvert outlet

- The culvert was not displaced by the landslide.
- The culvert outlet was plugged with ice (Photo 4), which prevented drainage, allowing water to accumulate in the upslope ditch.

- The frozen culvert was blocking surface drainage, resulting in ponding in the upslope ditch, as well as excess hydraulic head in the culvert barrel and the timber vertical shaft structure.

was another indicator, but it was only visible if track inspectors stopped and climbed down the bank to the outlet. In this occurrence, the routine track inspections did not identify the blocked drainage system.

Canadian National Railway (CN) produced a video on spring readiness inspections. Two supporting documents were produced, providing additional information specific to signs of potential track embankment instability as it pertains to differential water head, seepage under tracks, and rapid drawdown conditions. The material was provided to all track inspectors and supervisors as a refresher.
