**RAILWAY INVESTIGATION REPORT  
R14D0011**

**MAIN-TRACK COLLISION**

**CANADIAN NATIONAL YARD ASSIGNMENT  
AND CANADIAN NATIONAL FREIGHT TRAIN Q12111-21  
MILE 3.5, MONTREAL SUBDIVISION  
MONTRÉAL, QUEBEC  
23 FEBRUARY 2014**

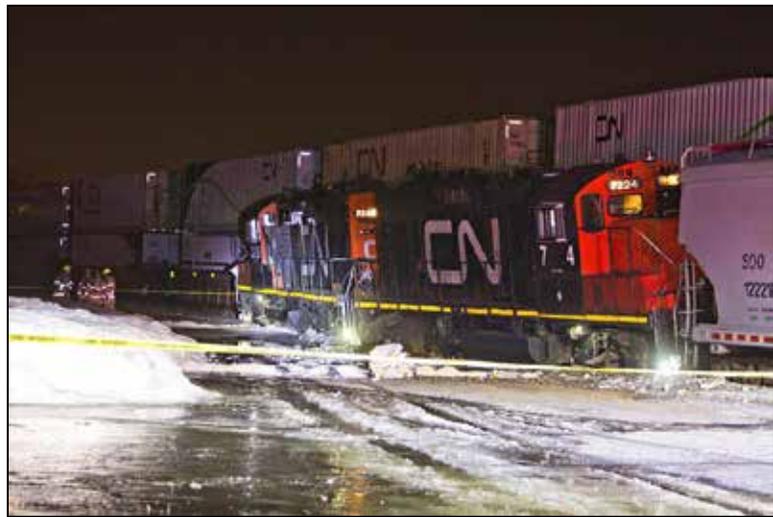
Upon returning to the lead locomotive, the assistant conductor drew the conductor's attention to the imminent collision. The emergency brakes were applied. However, the yard assignment was unable to stop before colliding with train Q12111-21 (train 121), a container train travelling westward on the north track (Photo 1).

Photo 1. Derailment site (eastward) (Source: Félix O.J. Fournier)

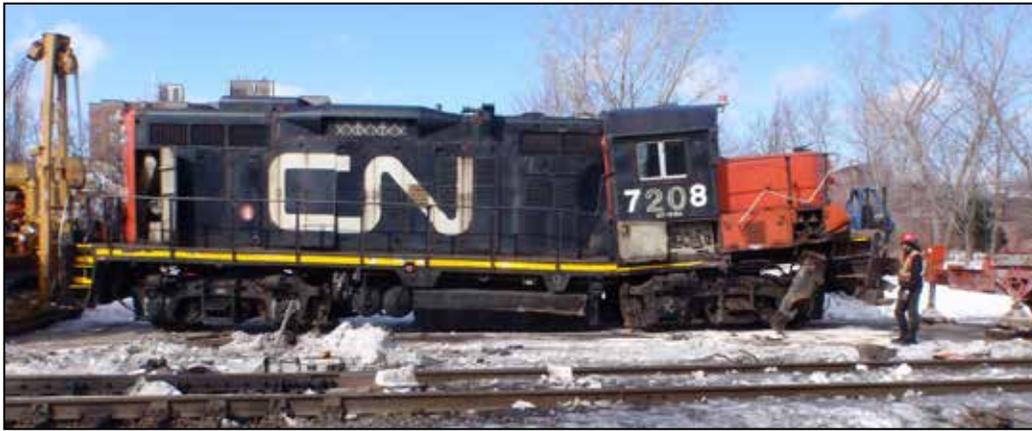
The 2 locomotives of the yard assignment derailed and came to a stop adjacent to switch 501, which connects the freight track to the north track. Lead locomotive CN 7208 sustained considerable damage on the right-hand side to the following components: steps, side ladders, handrails, brake rigging, brake piping and side platforms. Its fuel tank was punctured, causing a spill of approximately 4000 litres of diesel fuel. The first 2 cars (SOO 122215 and SOO 121820) derailed and were damaged on the south side. The steps, side ladders, end ladders and frames of the 2 cars were damaged.

Photo 2. Locomotive CN 7208 after its frame buckled

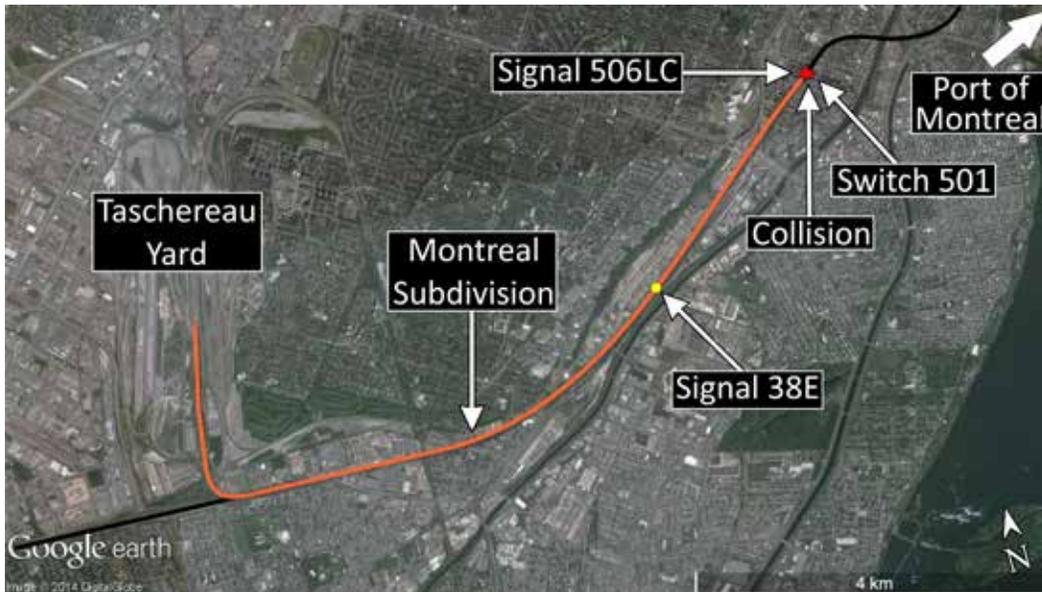
From Taschereau Yard, the yard assignment went on the freight track to reach the north track of the Montreal Subdivision, at Mile 3.5 (Figure 1). The yard assignment was to wait for intermodal train 121, travelling westward on the north track, to pass. Once train 121 had passed, the yard assignment was to continue its trip eastward.

Figure 1. Yard assignment trip (Source: Google Earth, with TSB annotations)

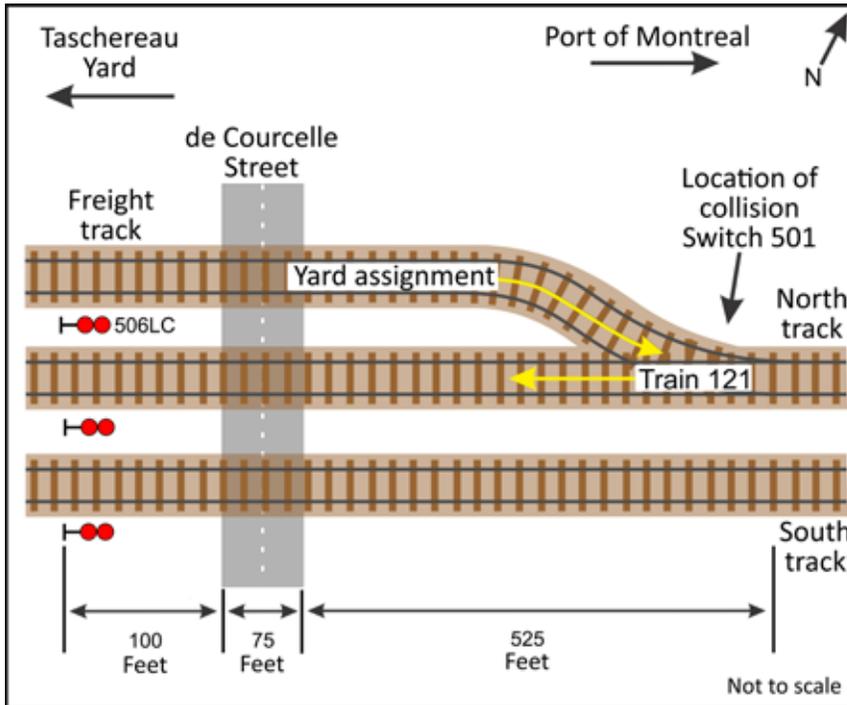
The junction between the freight track and the north track is located at turnout 501, which is equipped with a dual-control switch<sup>8</sup> (Figure 2). This location is under the control of the RTC and train movements are governed by signals. Eastbound movements on the freight track that approach switch 501 encounter approach signal 38E and signal 506LC. Signal 506LC is located 700 feet west of switch 501, and signal 38E is about 6500 feet farther west. The sightline distance to signal 38E is 3600 feet, while that of signal 506LC is 1500 feet.

Figure 2. Collision site

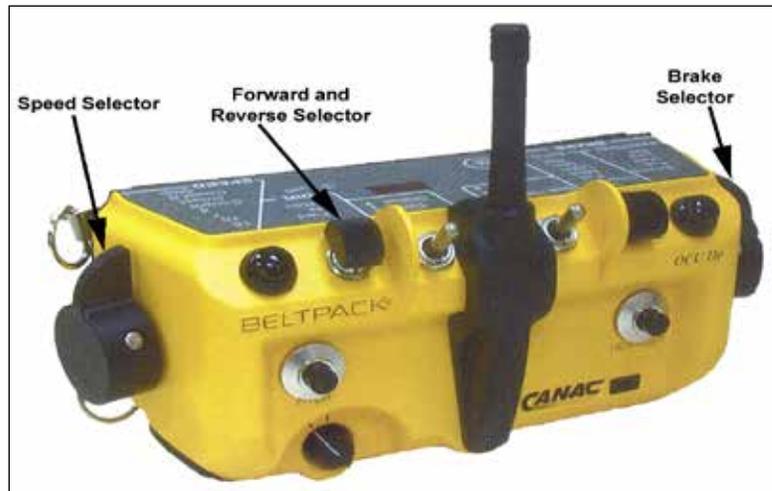
During Beltpack operations, the operator uses an OCU (Photo 3), a 3- to 5-pound box attached to the operator’s safety vest. Radio commands transmitted by the OCU are received and processed by a computer on board the locomotive. The Beltpack OCU is equipped with (but not limited to) a speed selector, a forward and reverse selector, and a brake selector that includes an emergency brake feature.

Photo 3. Beltpack operator control unit
