**RAILWAY INVESTIGATION REPORT  
R14T0160**

**MAIN TRACK DERAILMENT**

**CANADIAN NATIONAL RAILWAY  
FREIGHT TRAIN M-310-31-09  
MILE 127.52, KINGSTON SUBDIVISION  
BROCKVILLE, ONTARIO  
10 JULY 2014**

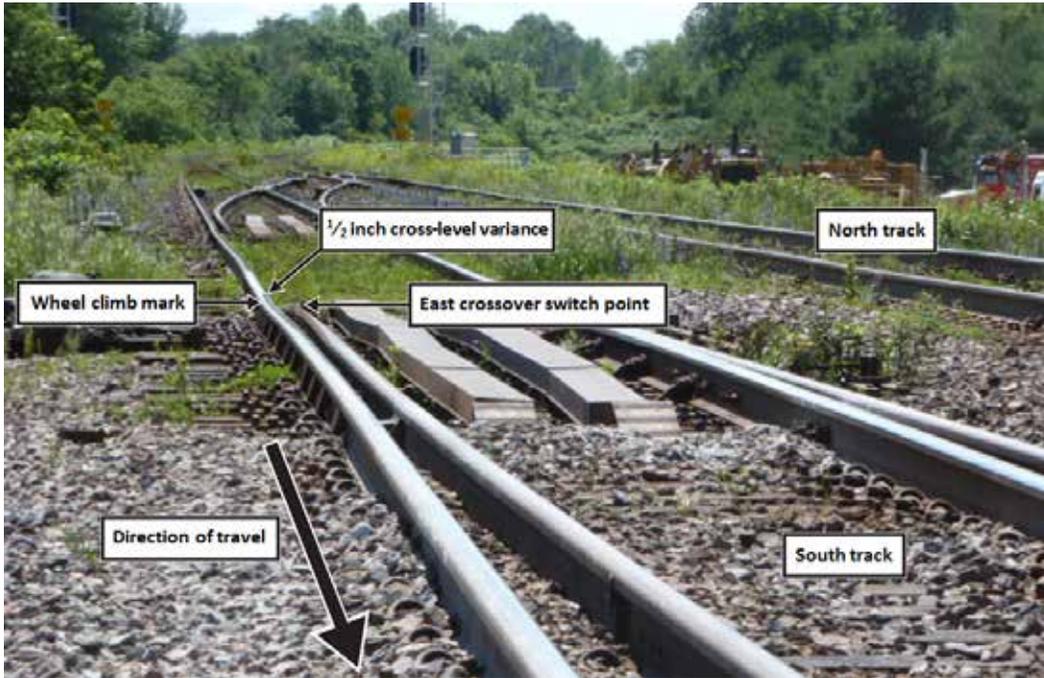
Figure 2. View looking westward along the south main track of the Kingston Subdivision at Mile 127.52

The first mark on the track was located at Mile 127.52, approximately 6 feet west of the switch point for the eastward crossover to the north main track. At this location, a wheel climb mark was observed on the gauge face of the south rail. At the mark, there was a ½-inch low spot (variance) in cross level, approximately 4 feet long (Figure 2), which was within the standard set by the Transport Canada-approved *Rules Respecting Track Safety* (TSR).<sup>3</sup>

The wheel-climb mark on the track observed on the gauge face of the south rail at Mile 127.52 was identified as the initial point of derailment (POD). There was a slightly narrow gauge condition located approximately 124 feet west of the POD. From that point eastward, unloaded gauge and cross-level track measurements leading up to the POD identified a number of non-condemnable track anomalies that are also known to induce excessive truck hunting. The non-condemnable slightly narrow gauge and multiple cross-level perturbations in the south rail likely contributed to the development of excessive truck hunting.

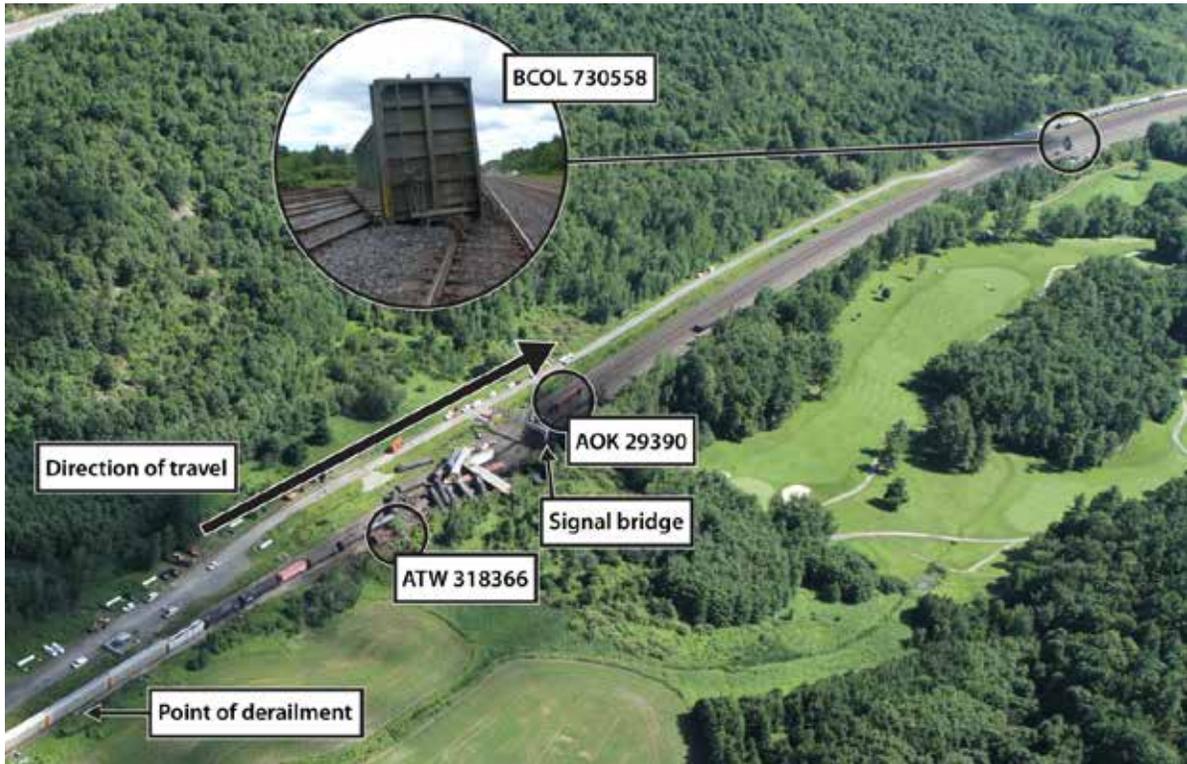
Figure 3. Derailment site, looking northeast

The first 3 derailed cars – the 24th to the 26th cars from the head end – were empty centrebeam bulkhead flat cars about 80 feet long. The first derailed car (BCOL 730558) had been dragged by the head-end portion of the train and came to rest at Mile 126.90. The following car (ATW 318366) came to rest on its side, just west of the signal bridge and main pile of cars. The third derailed car (AOK 29390) came to rest east of the signal bridge (Mile 127.36), askew of the south main track (Figure 3).

Approximately 350 feet of track was destroyed on the north main track and on the south main track. Further east of the signal bridge, the south main track and a yard track were damaged for approximately 2450 feet.

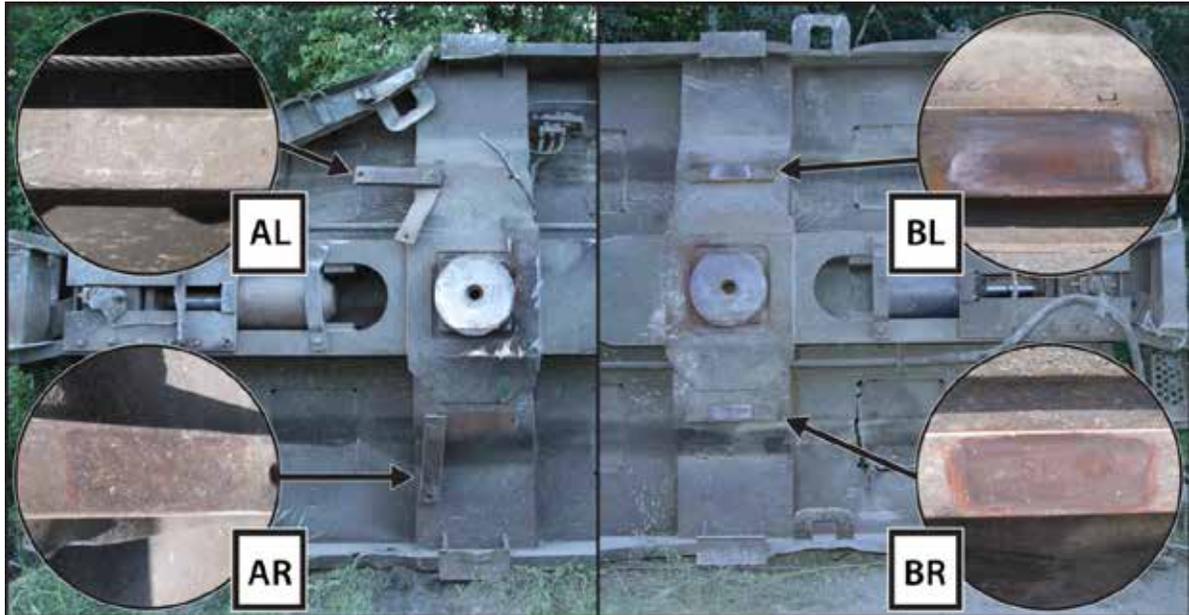
Figure 4. Car body side bearings for BCOL 730558

Examination of the first 3 derailed cars revealed that the AL<sup>6</sup> car body side bearing<sup>7</sup> of car BCOL 730558 showed no signs of contact with the constant contact side bearing (CCSB) cap and only faint signs of contact with the AR body side bearing. The corresponding A-end CCSB caps could not be identified in the wreckage. The B-end body side bearings showed wear marks (Figure 4). Although the B-end truck was still with the car, the CCSB components were missing.

Examination of the underframe of the following 2 cars (empty centrebeam bulkhead flat cars) determined that the car body side bearings exhibited wear marks that indicated there had been contact between the car body side bearings and the CCSBs.

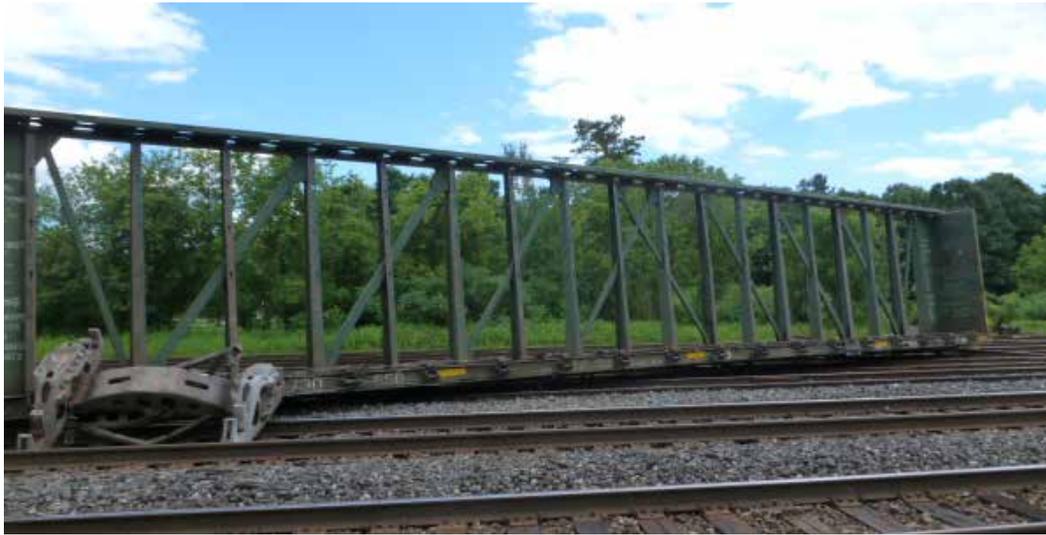
Photo 1. First derailed car, centrebeam bulkhead flat car BCOL 730558

Car BCOL 730558 was an empty 80-foot-long centrebeam bulkhead flat car. Its original equipment at the time of construction (1994) included Barber S2 trucks and standard travel CCSBs. Certain truck designs, such as the Barber S2, have low warp stiffness and are known to be prone to hunting. Examination of the car underframe revealed that the CCSBs from the A-end trailing truck likely had lost much of their preload and were no longer providing effective damping, as they were not in full contact with the corresponding A-end car body side bearings. This suggests that the CCSBs were worn to near or past their condemning limits. The excessive truck hunting on car BCOL 730558 was influenced by the type of car, the speed of the train, the worn condition of the A-end CCSBs and a truck type with low warp stiffness.

1. The derailment likely occurred as a result of excessive A-end truck hunting on empty centrebeam flat car BCOL 730558.
2. The excessive truck hunting on car BCOL 730558 was influenced by the type of car, the speed of the train, the worn condition of the A-end constant contact side bearings, and a truck type with low warp stiffness.
