Rail Transportation Safety Investigation Report R19C0088

MAIN-TRACK TRAIN DERAILMENT

Canadian Pacific Railway
Freight train 118-01
Mile 126.4, Maple Creek Subdivision
Irvine, Alberta
02 August 2019

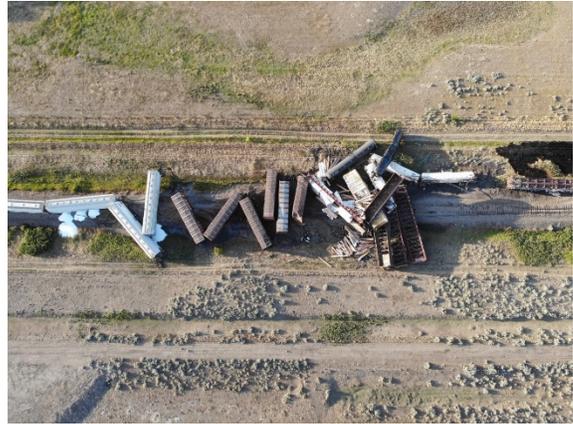
The derailment site was initially cordoned off due to the potential for a dangerous goods release. Preliminary site examination revealed that 2 cars, PROX 23223 and PROX 23282, were on their sides, leaking styrene monomer at a slow rate. Tank car GATX50642 was badly damaged, including tears in the tank, and contained residue methanol. Despite the damage, there was no loss of product from that tank car.

Additionally, there was a small grass fire reported near the right-of-way. The cars had derailed on both sides of the right-of-way in an accordion fashion (Figure 2).

Figure 2. Drone photo of derailment site
(Source: Canadian Pacific Railway)

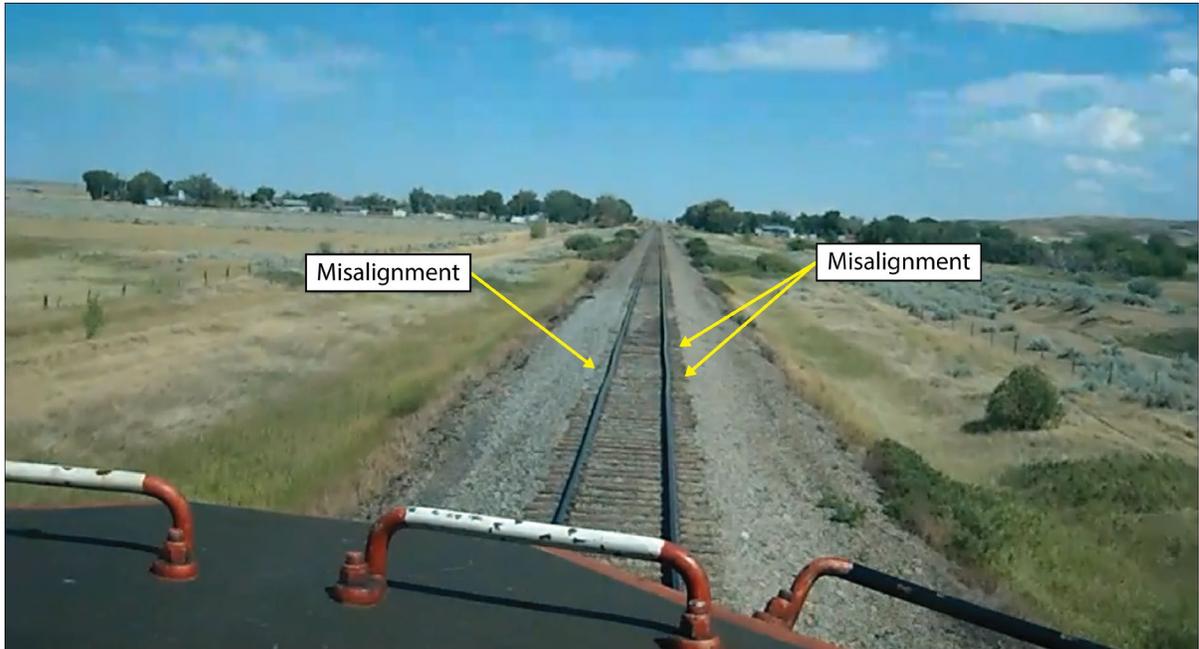
The lead locomotive was equipped with a forward-facing camera. In the vicinity of the derailment, the locomotive camera showed a small misalignment and fresh ballast dumped along the north rail.

Figure 3. Screenshot from forward-facing camera showing track misalignment (Source: Canadian Pacific Railway, with TSB annotations)

Despite the repair work and inspections, the track subgrade remained unstable and the track was therefore more susceptible to the effects of increased longitudinal forces produced by the high ambient temperatures.
