# Marine Transportation Safety Investigation Report M17C0053

## INADVERTENT LOWERING OF SHIP ARRESTER AND CLOSING OF LOCK GATES ON VESSEL

Bulk carrier *Federal Kumano*  
Beauharnois, Quebec  
17 May 2017

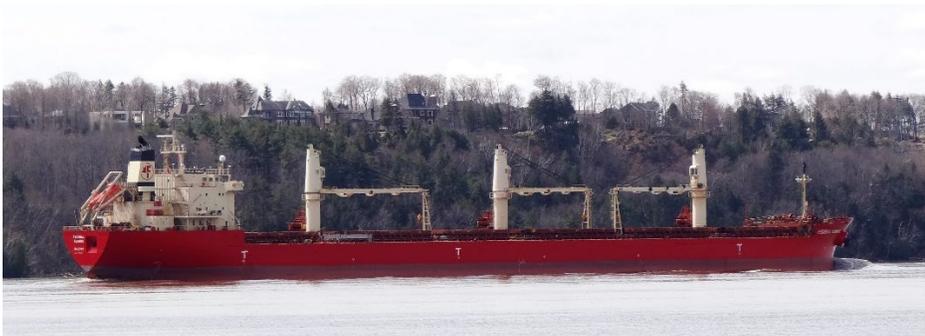
On 11 May 2017, the *Federal Kumano*, a bulk carrier registered in the Marshall Islands (International Maritime Organization No. 9244257), departed Duluth, Minnesota, U.S., loaded with 23 100 tonnes of wheat (Figure 1). The vessel was scheduled to transit the Great Lakes and the St. Lawrence Seaway en route to Algeria.

Figure 1. *Federal Kumano* (Source: Jacques Trempe)

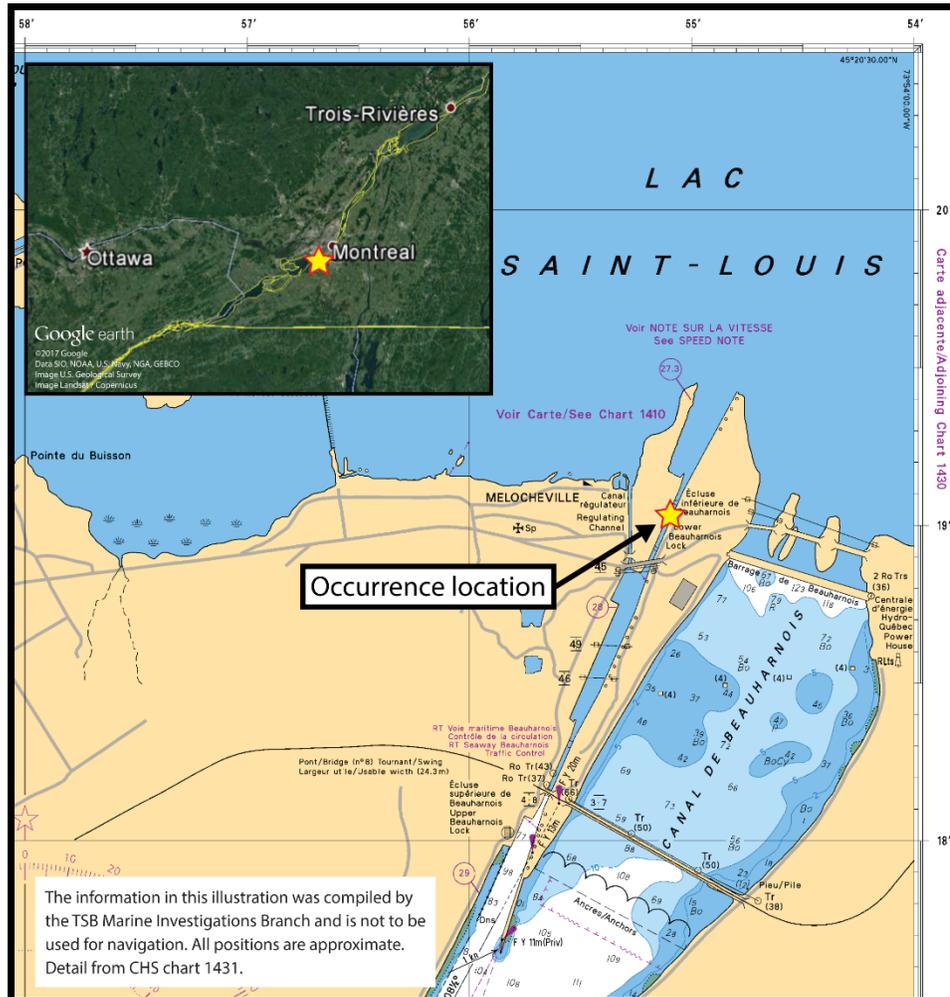
Around 0800<sup>1</sup> on 17 May, the vessel was exiting the Lower Beauharnois lock in the St. Lawrence Seaway under the conduct of a pilot<sup>2</sup> (Figure 2). This lock is 1 of 13 that form part of the Canadian section of the St. Lawrence Seaway facilities and that are managed by The St. Lawrence Seaway Management Corporation (SLSMC).<sup>3</sup> The lock operator is located in a remote control station in Saint-Lambert, Quebec.

Figure 2. Occurrence location at Lower Beauharnois lock (Source: Canadian Hydrographic Service and Google Earth, with TSB annotations)

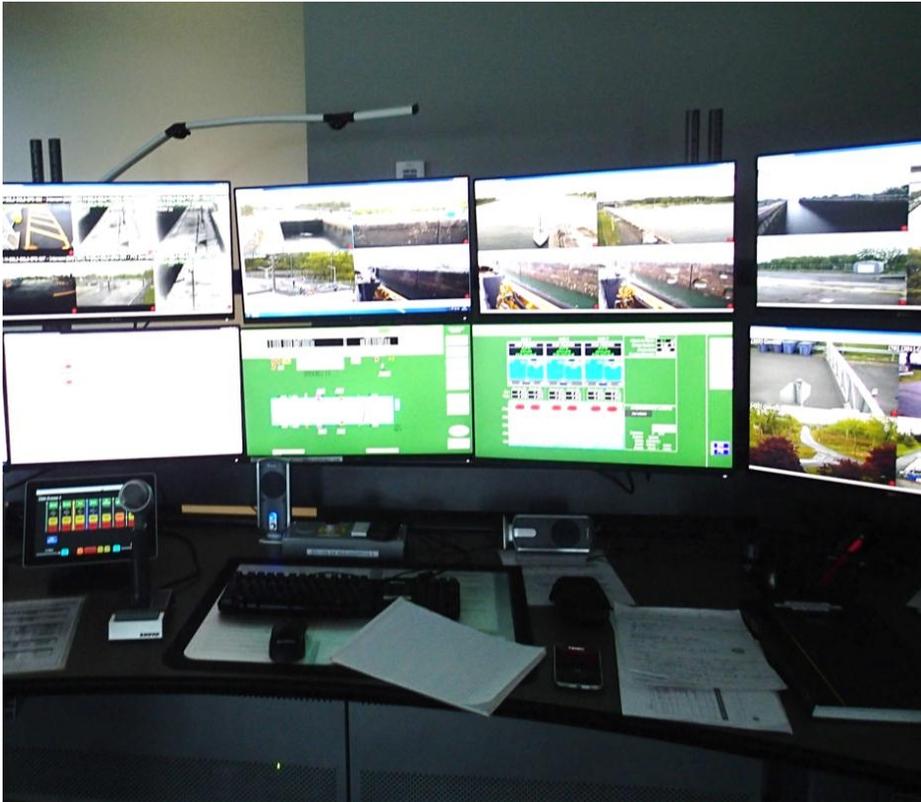
The workstation camera layout in the remote control centre is similar to that of the workstations at the locks. Each workstation has a number of closed-circuit television cameras and applications to allow lock operators to view all equipment (Figure 3). These control stations include screens displaying video feeds of the lock or canal structure, perimeter security cameras, the traffic management system, the automatic identification system, vessel traffic, and the hands-free mooring system.

Figure 3. Lock operator workstation
