AIR TRANSPORTATION SAFETY INVESTIGATION REPORT A19P0002

LOSS OF SEPARATION

NAV CANADA
Vancouver Area Control Centre
Vicinity of Kelowna, British Columbia
03 January 2019

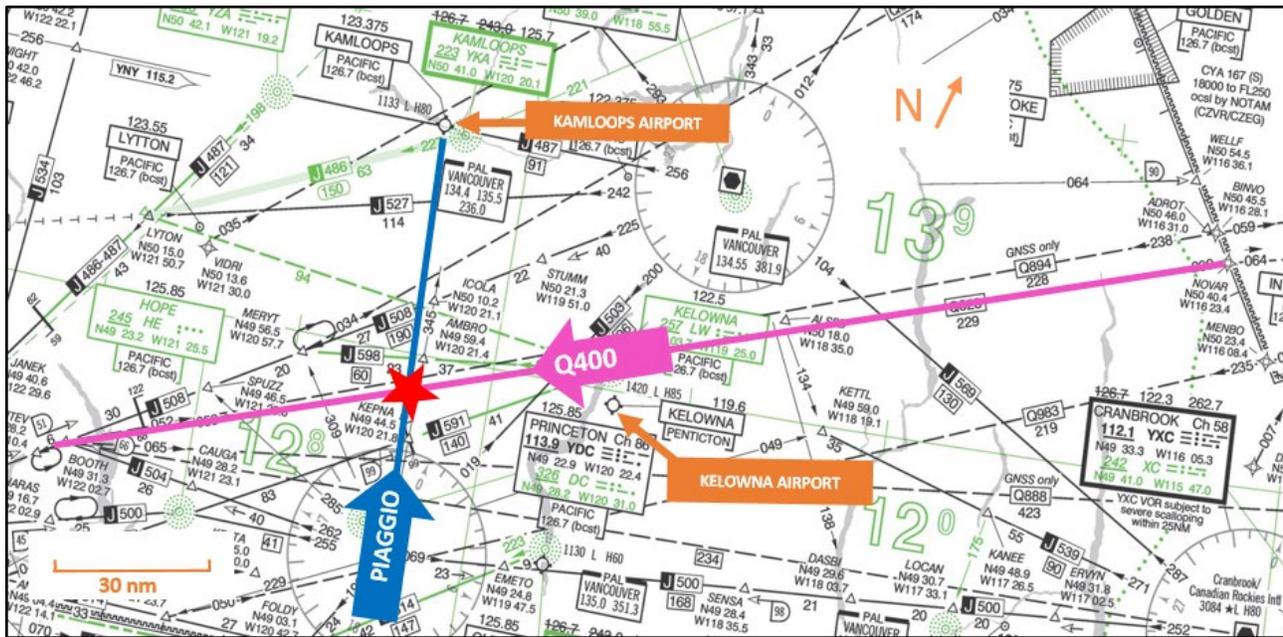
The Q400 was flying in a southwesterly direction from the northeast of CYLW. The Piaggio was flying in a north-northwesterly direction from the south of CYLW. Both aircraft were operating at flight level (FL) 220.¹ Their flight paths would cross to the west of CYLW (Figure 1).

Figure 1. Approximate routes and point of conflict of the Q400 and the Piaggio (Source: NAV CANADA Enroute Low Altitude Chart LO2, with TSB annotations)

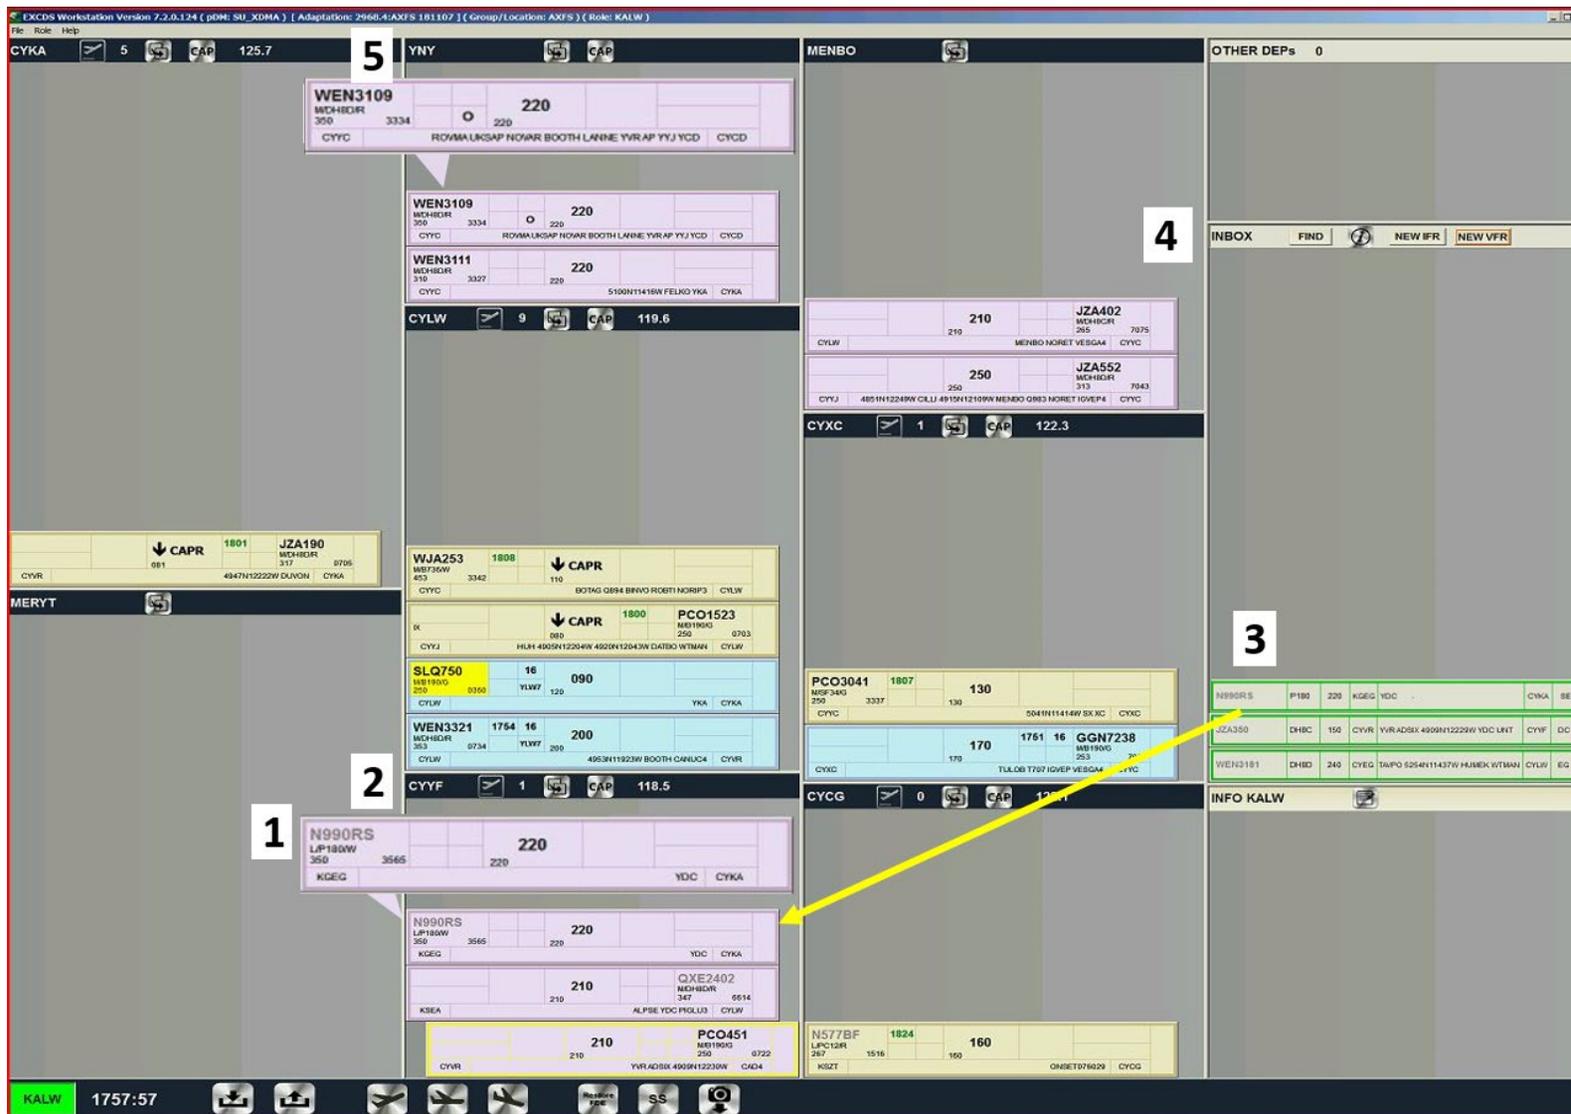
At 0957:57, the KALW sector controller moved the Piaggio's FDE from the EXCDS inbox and posted it to the active panel for Penticton Airport (CYYF) because the Piaggio would enter the airspace for CYYF first, once it had entered the KALW sector airspace (Figure 2).

Figure 2. Screen capture of the KALW sector controller's Extended Computer Display System screen at 0957:57 (1757:57 UTC) showing the locations of the Piaggio's and the Q400's flight data entries (Source: NAV CANADA, with TSB annotations)

- 1 The Piaggio's flight data entry (FDE).
- 2 The active panel for Penticton Airport (CYYF).
- 3 The Piaggio's FDE in the Extended Computer Display System (EXCDS) inbox. The FDE was moved from here to the active panel for CYYF.
- 4 The EXCDS inbox.
- 5 The YNY (Enderby) active panel.

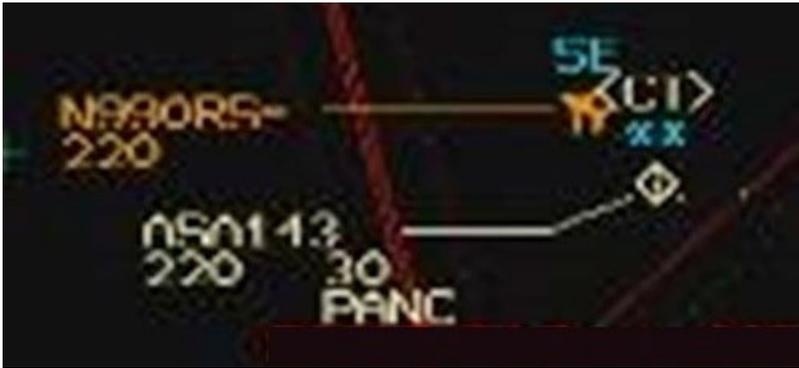
At 1000:00, the Piaggio's target appeared on the CSiT. At 1000:14, the KALW sector controller observed a problem with the target: the Piaggio was in fact displayed as 2 targets. One target was showing as Air Alaska flight 143 (ASA143) en route to Ted Stevens Anchorage International Airport (PANC), Alaska, United States, and a 2nd target displayed as N990RS, which was the Piaggio's registration. The correct target was the one showing as ASA143; this target had a CAATS disparity error¹⁰ associated with it, indicated by the notation < CT > (Figure 3).

Figure 3. Close-up view of the Canadian Automated Air Traffic System Situation Display showing the Piaggio as 2 targets
(Source: NAV CANADA)

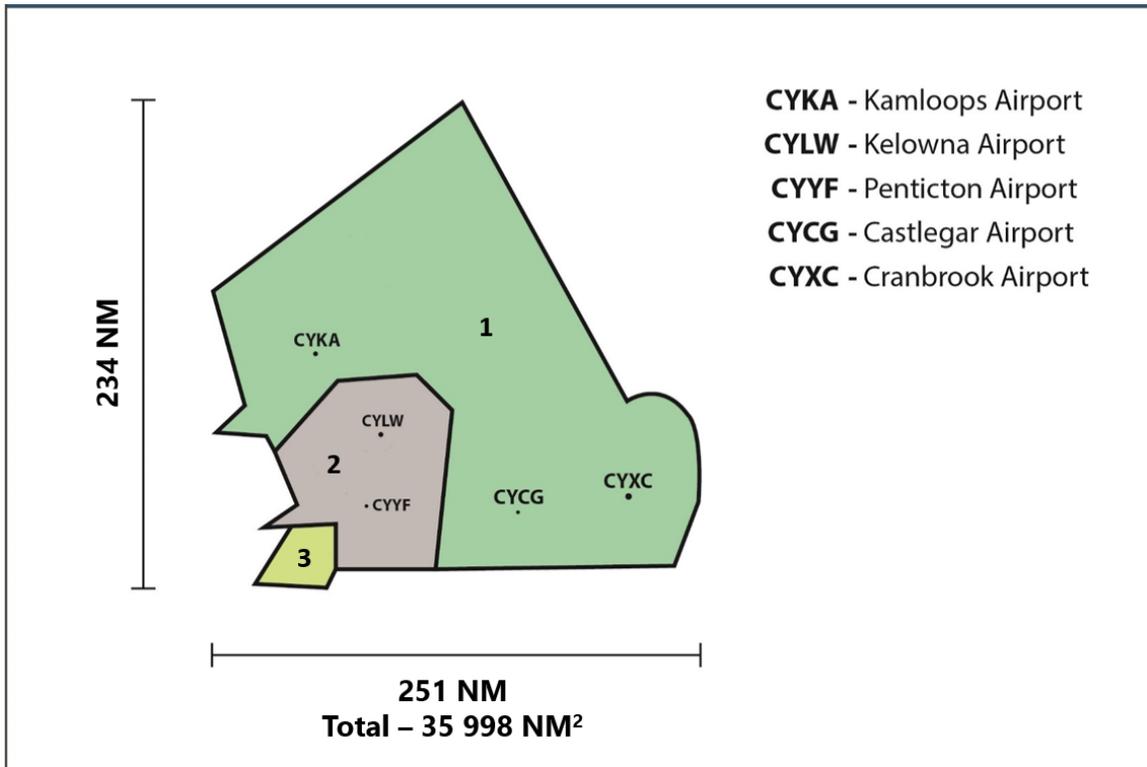
Figure 4. Map of the KA sector airspace within the Airports Specialty of the Vancouver Area Control Centre. Note: the Airports Specialty is also referred to as the Airport Complex. (Source: Adapted from the NAV CANADA Vancouver ACC Unit Operations Manual [effective 31 March 2016], Attachment B: Vancouver ACC Sectorization)

- 1 Surface up to and including FL 250
- 2 Above 13 000 feet up to and including FL 250
- 3 Above 13 000 feet up to and including FL 200

Combining the KA and LW sectors meant that the KALW sector controller was responsible for aircraft operating under IFR into and out of CYKA, as well as CYLW, CYYF, Cranbrook/Canadian Rockies International Airport (CYXC), Castlegar/West Kootenay Regional Airport (CYCG), Trail Airport (CAD4), Vernon Airport (CYVK), and Princeton Airport (CYDC). The KALW controller was also responsible for aircraft transiting through the airspace.

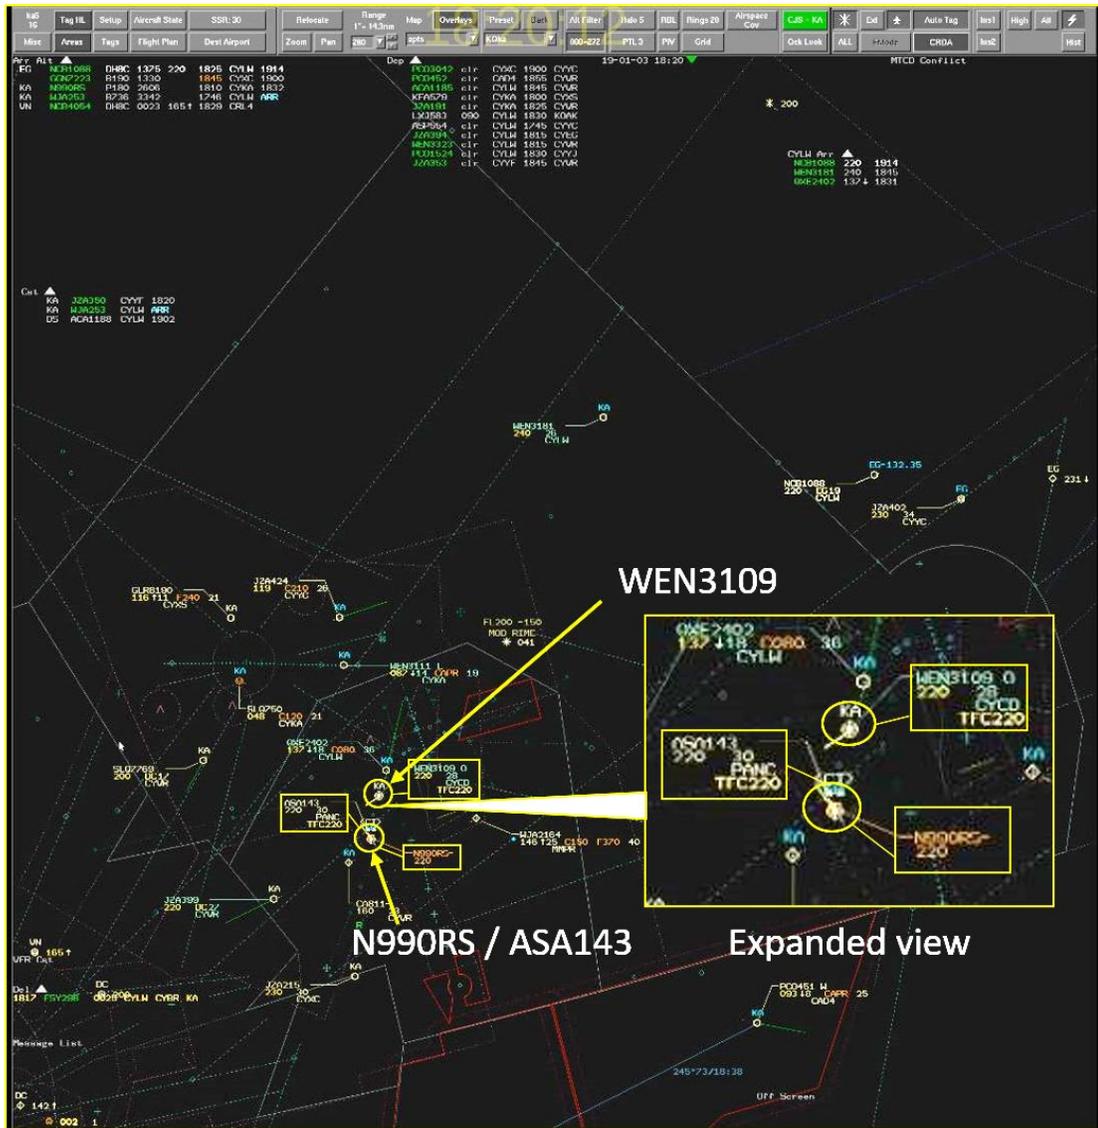
Given the size of the KALW sector airspace, the range of the KALW sector controller's CSiT was set to 280 NM, so that 1 inch of screen resolution was equal to 14.3 NM. This setting enabled the KALW sector controller to see the entire sector, including flights that were about to enter the sector (Figure 5).

Figure 5. Screenshot of the KALW sector controller’s Canadian Automated Air Traffic System Situation Display set to a range of 280 nautical miles. The expanded view shows the Q400 (WEN3109) and the Piaggio (here shown as both ASA143 and N990RS). (Source: NAV CANADA with TSB annotations)

When the range of the CSiT is set at 280 NM, the density of flights on the screen can make aircraft targets appear relatively close together (more than 1 flight in 1 inch of screen). When the TFC220 alert appeared in the Q400’s and the Piaggio’s data tags, there were several other aircraft in their vicinity, adding to the visual clutter on the screen and making the visual alert difficult to detect.

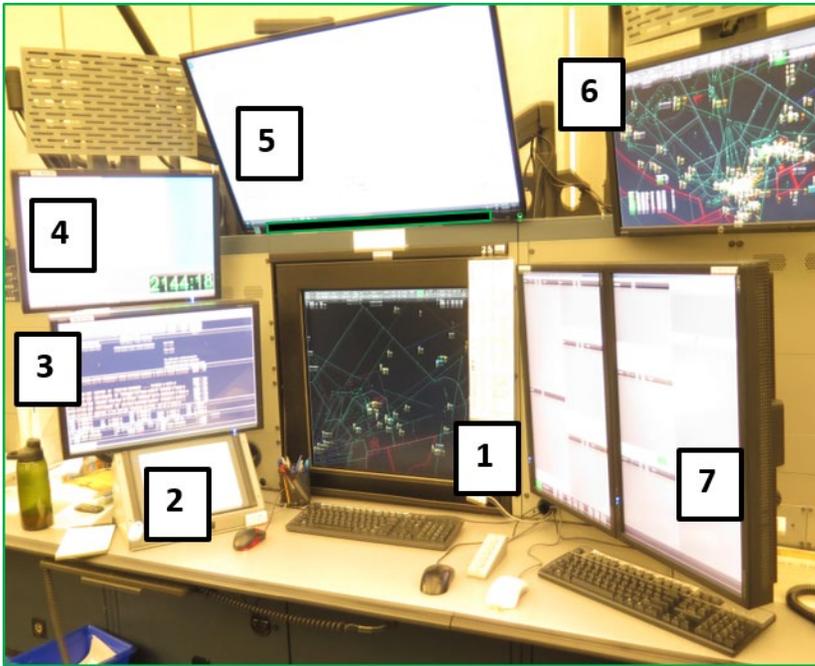
Figure 6. Airports Specialty air traffic controller workstation (Source: TSB)

- 1 Canadian Automated Air Traffic System (CAATS) Situation Display (CSiT)
- 2 Voice Switching and Control System (VSCS)
- 3 Extended Computer Display System Weather Data Element (EXCDS WDE)
- 4 Computerized Video Information Display System (CVIDS)
- 5 NAV CANADA Information Display System (NIDS)
- 6 Peer Display
- 7 Extended Computer Display System (EXCDS)

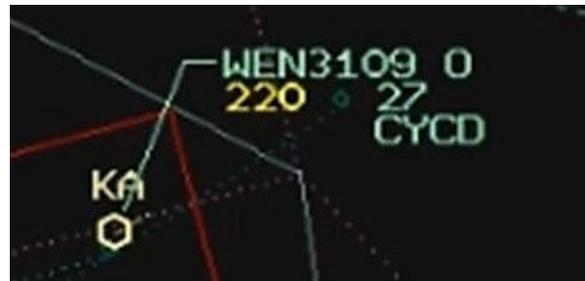
CAATS receives data from various sources to create an aircraft's flight profile. The CAATS' FDPs provide an aircraft's flight plan data, including a flight's CAATS-assigned transponder code, to the radar data processing system re-host (RDPSR) so it can correlate flight plan data to the radar track of an aircraft. The FDPs and RDPSR continuously compare an aircraft's flight plan data and radar track. When the flight data and radar track correlate, the aircraft's target is displayed as a polygon on the controller's CSiT (Figure 7).

Figure 7. Close-up view of the Canadian Automated Air Traffic System Situation Display displaying the Q400's (WEN3109) correlated target
(Source: NAV CANADA, with TSB annotations)

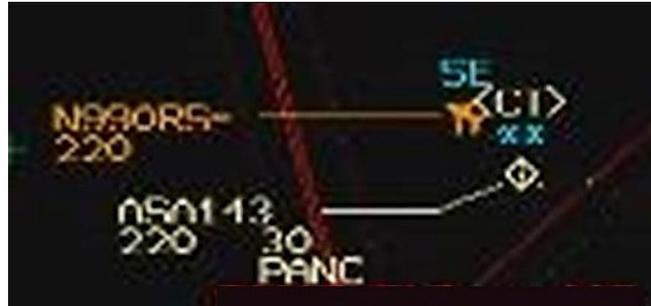
Figure 8. Close-up view of the Canadian Automated Air Traffic System Situation Display showing the Piaggio displayed as the ASA143 flight, an uncorrelated target, and the Piaggio's position based on the Canadian Automated Air Traffic System flight data processors flight plan data as a non-radar target. (Source: NAV CANADA)

Therefore, when the Piaggio's flight plan data was later entered into the CAATS FDPs, transponder code 3565 was assigned to the Piaggio because it was available for assignment in the FDPs, even though the ASA143 flight from 10 hours before was associated with transponder code 3565 in the RDPSR.

When the CAATS FDPs compared the Piaggio's flight data to the RDPSR radar track, the target's data tag appeared as the ASA143 flight on the controller's CSiT and it had a CAATS disparity error associated with it, because the information in the CAATS FDPs and RDPSR did not correlate.

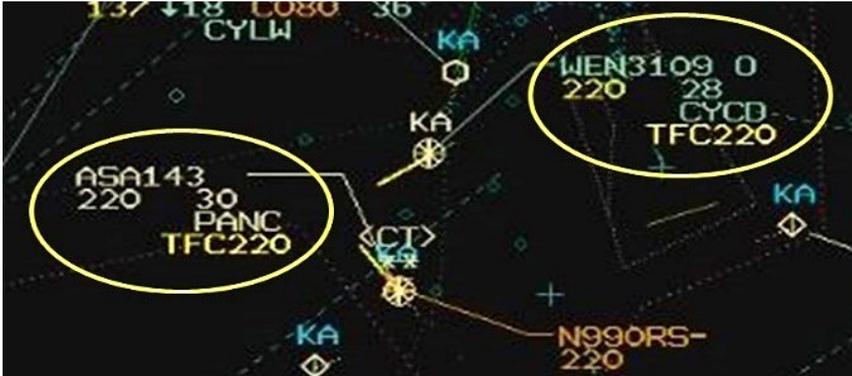
Figure 9. Close-up view of the Canadian Automated Air Traffic System Situation Display with the TFC220 alert for the Piaggio (shown as ASA143) and the Q400 (WEN3109) (Source: NAV CANADA, with TSB annotations)

At 1020:12, a Predicted Conflict Alert – Traffic (TFC)¹² appeared in the data tags for the Q400 and the Piaggio (the data tag showing the Piaggio as flight ASA143) on the KALW sector controller's CSiT. The KALW sector controller was communicating with another aircraft and looking at its flight plan and did not see the visual alert or hear the associated audible alarm for the TFC alert.

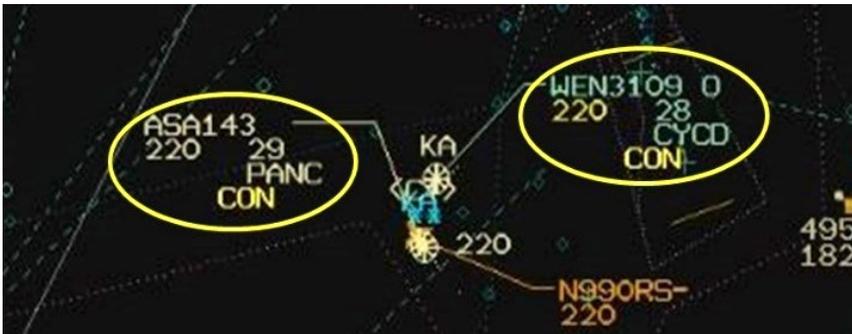
If separation is not maintained and the system predicts a conflict between the aircraft, and the aircraft are 1 minute from each other, the TFC alert will change to a CON alert. When a CON alert is displayed, a loss of separation between the 2 aircraft has occurred, as shown in Figure 10.²⁸

Figure 10. Close-up view of the Canadian Automated Air Traffic System Situation Display showing the 2 occurrence aircrafts' data tags after the TFC220 alert changed to the CON alert (Source: NAV CANADA, with TSB annotations)

Both the TFC and the CON have an associated audible alarm as well as the visual alerts provided to a controller on the CSiT.

In this occurrence, the KALW sector controller neither saw the visual alert nor heard the audible alarm; however, another controller working a nearby sector heard the audible alarm.
