AVIATION OCCURRENCE REPORT

A97H0011

LOSS OF CONTROL ON GO-AROUND (REJECTED LANDING)

AIR CANADA CANADAIR CL-600-2B19 C-FSKI
FREDERICTON AIRPORT, NEW BRUNSWICK
16 DECEMBER 1997

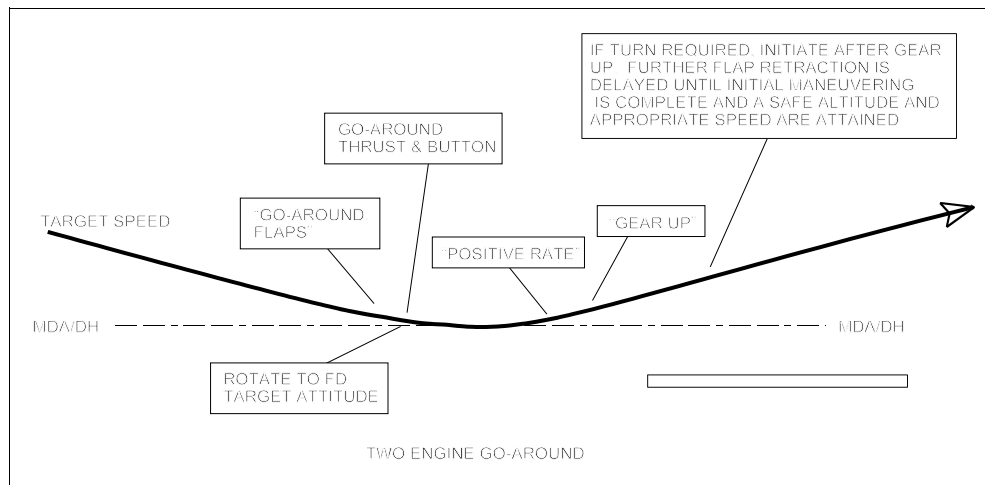
Figure 2 - Two-engine go-around (from AOM, p. 02.37.02)

The following graphic outlines the two-engine go-around procedures (as depicted in the *AOM*, page 02.37.02).

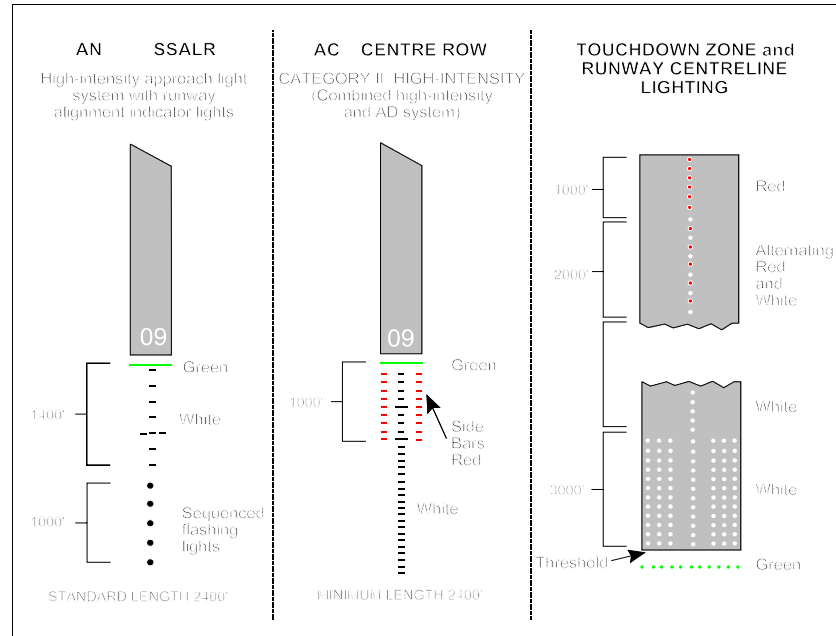
Figure 3 - Approach and runway lighting

airborne and ground-based equipment associated with the ILS systems must meet much more stringent requirements regarding failures, accuracy, and inspections. The airport/runway must be equipped with a backup power system, a sophisticated approach lighting system (see AC in Figure 3), runway centre line and touchdown zone lighting (pictured on the right in Figure 3), and two RVR transmissometers. The airport facilities must be monitored, and someone must be available to advise flight crew of any outages or failures of equipment required for the approach. The aircraft operator must provide detailed procedures in the operations manual. The captain must have at least 300 hours as pilot-in-command and 100 hours line-flying on type, the captain and first officer must have taken and passed an approved program of training, and the flight crew must have proven performance to graduate from Interim Category II (150-foot decision height) to Category II.

The CL-65 aircraft met all of the requirements for Category II approaches; however, the Fredericton airport facilities and ILS installation were not suitable for Category II approaches. Runway 15 was equipped with AN type approach lighting (see Figure 3), and did not have touchdown zone or runway centre line lighting. The flight crew were qualified to fly to Category II limits, but only if the captain was flying the aircraft with the autopilot coupled.
