Marine Occurrence Report

F.V. "NORTHERN OSPREY" sank
in approximate position
60°23'N 60°54'W,
off Northern Labrador,
as a result of
being damaged by ice
27 June 1990

Report Number M90M4020

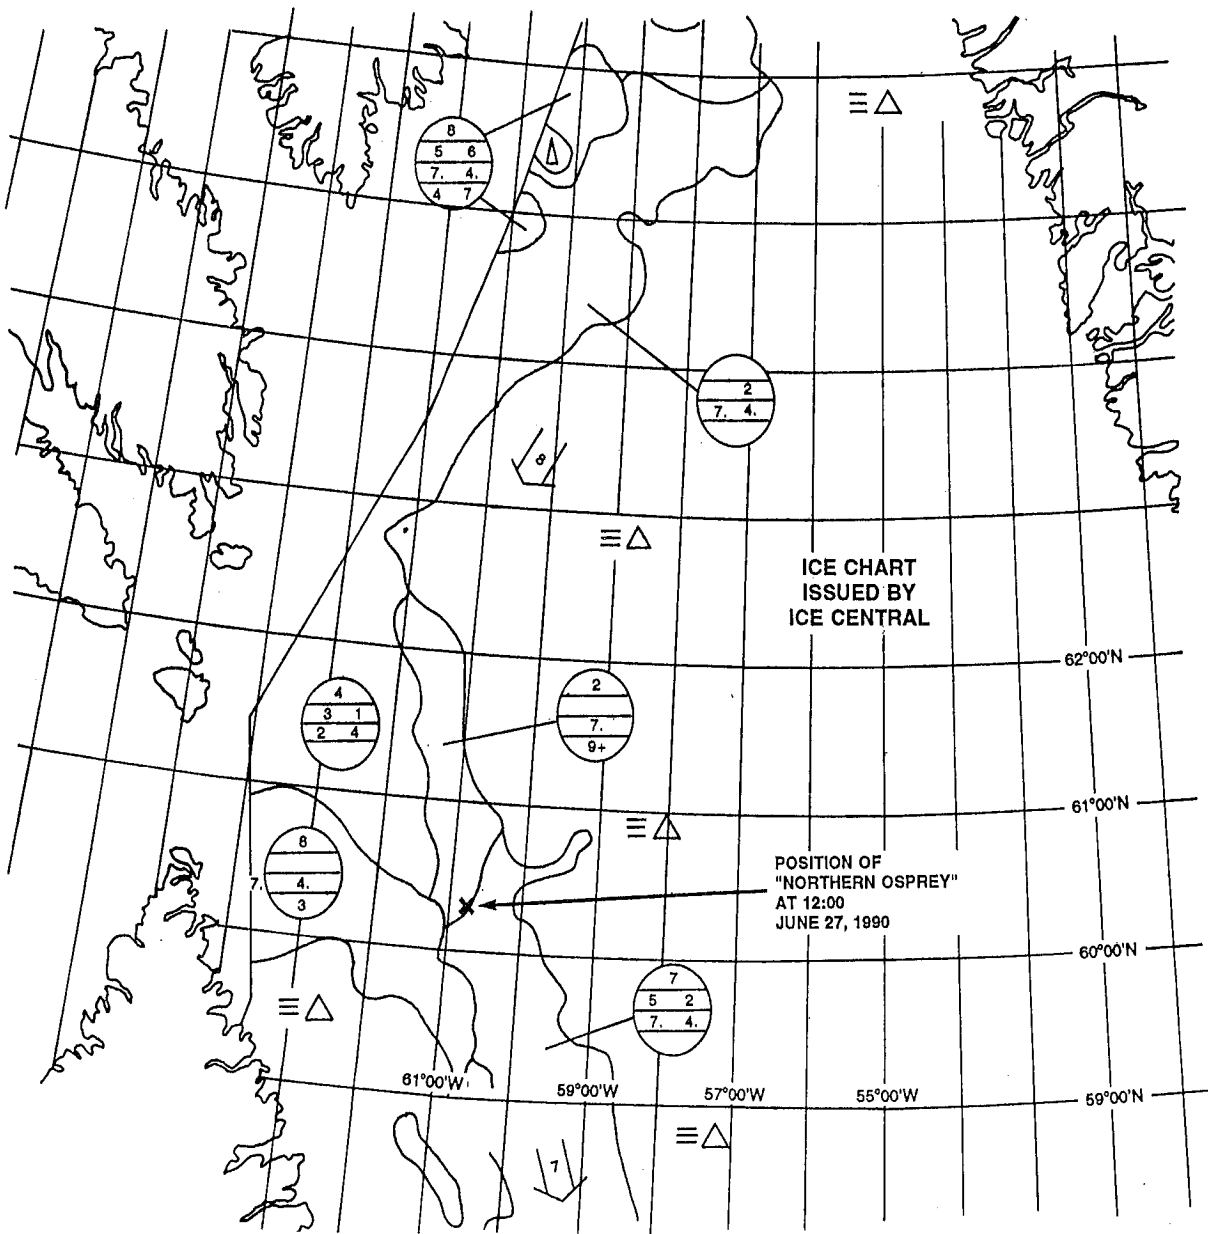
ICE CHART
ISSUED BY
ICE CENTRAL

The ice conditions in which the "NORTHERN OSPREY" was operating before sinking were compatible with the ice forecasts and were such that approximately two tenths of the sea surface was covered in floes of old ice with high concentrations of strips of multi-year ice. The master reported ice of about one metre above the surface, and ice conditions nearby had been reported of thicknesses exceeding 140 cm (55 inches). Based on the master's estimate of the ice thickness above the surface, it could have extended to as much as nine metres beneath the surface.

POSITION OF
"NORTHERN OSPREY"
AT 12:00
JUNE 27, 1990
