MARINE INVESTIGATION REPORT

M00C0033

PASSENGER VESSEL "TRUE NORTH II"

16 JUNE 2000

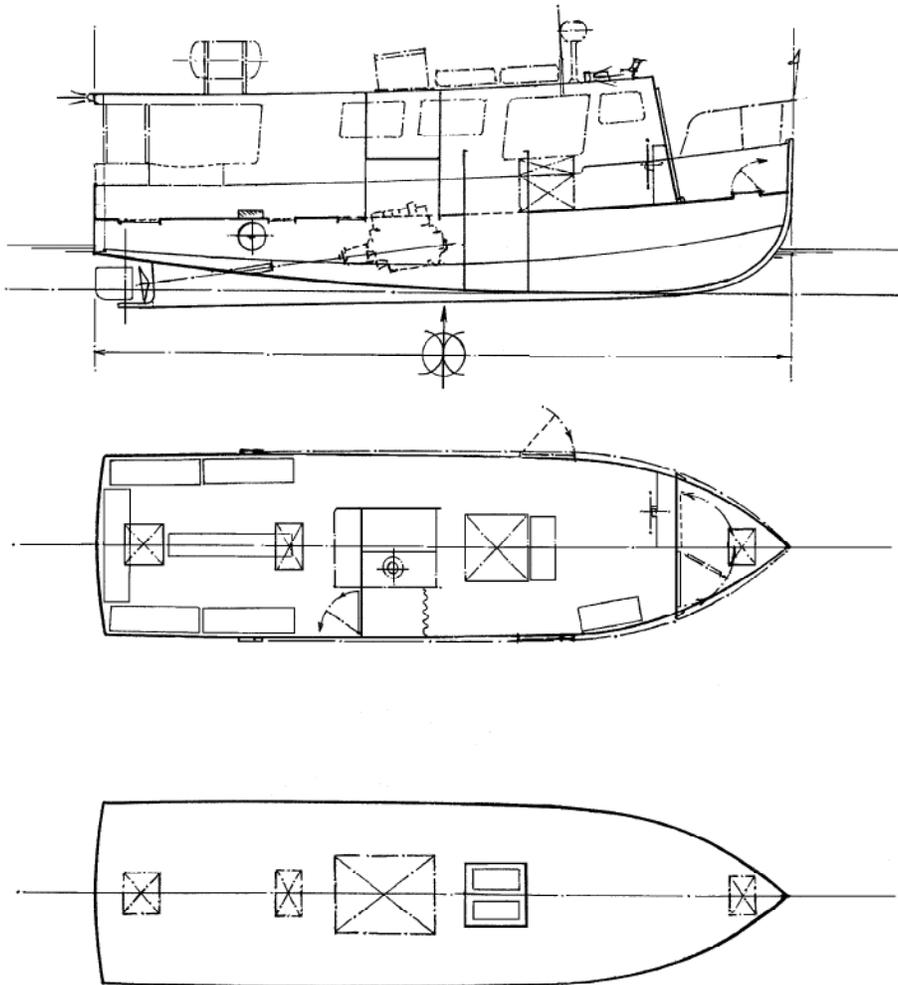
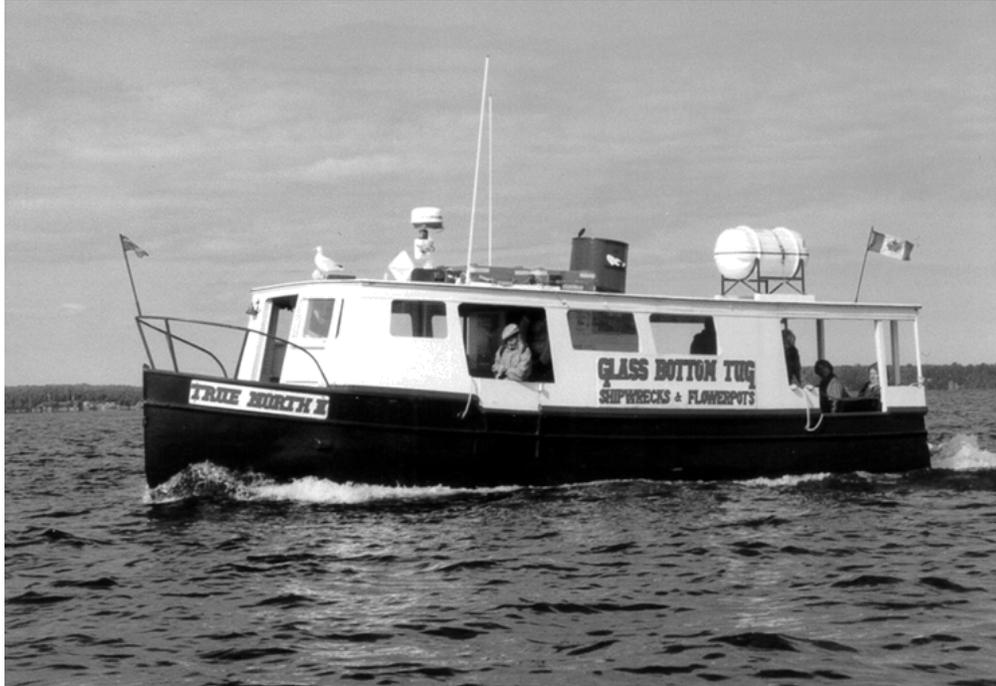
A watertight steel trunk, arranged on the centreline forward of midships, extends above main deck level and encloses clear plastic panels fitted in the bottom shell plating. The clear panels allow viewing of underwater features such as shipwrecks at Fathom Five National Marine Park.

The wooden superstructure, which provides shelter from the weather for deck passengers, is open at the after end and has large passenger embarkation openings in the port and starboard sides forward of midships.
