MARINE INVESTIGATION REPORT

M00W0303

STRIKING OF A BRIDGE

TUGBOAT *MILLER RICHMOND* AND
BARGES *MILLER 201* AND *MILLER 206*
PITT RIVER HIGHWAY BRIDGE, BRITISH COLUMBIA
18 DECEMBER 2000

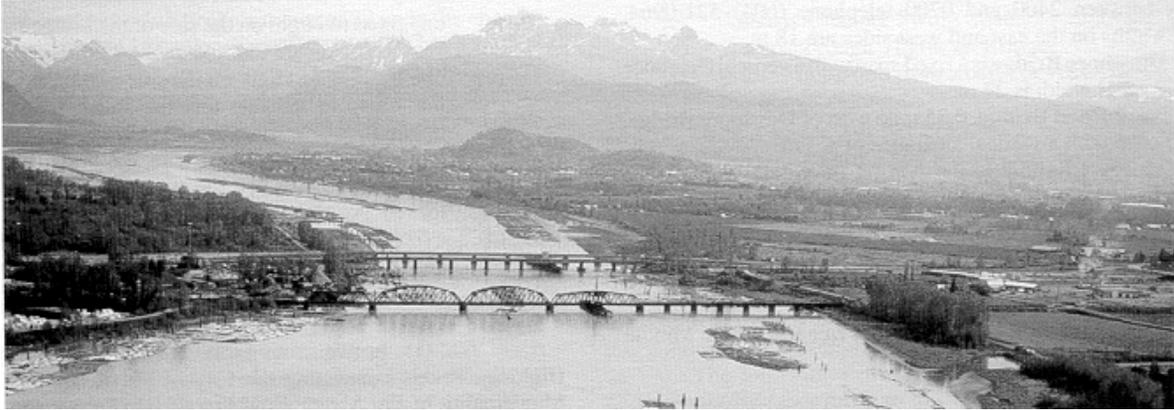
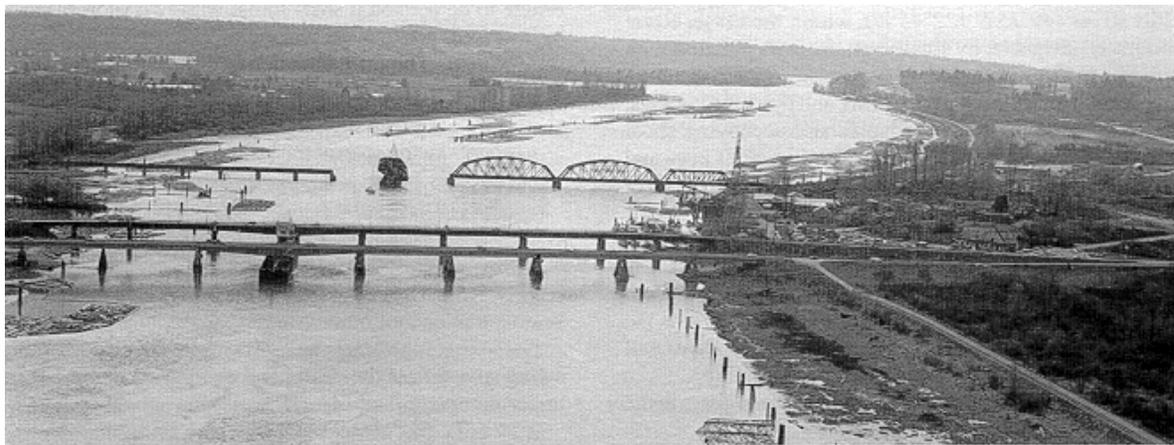
Appendix C - Photographs

The striking caused extensive damage to the protection pier. There was no major disruption to either highway bridge traffic, or to marine traffic. No one was injured and there was no pollution as a result of this occurrence.
