MARINE INVESTIGATION REPORT

M02W0061

MALFUNCTION OF AUTOMATIC STEERING CONTROL
FOR RIGHT ANGLE DRIVES

BOWEN QUEEN

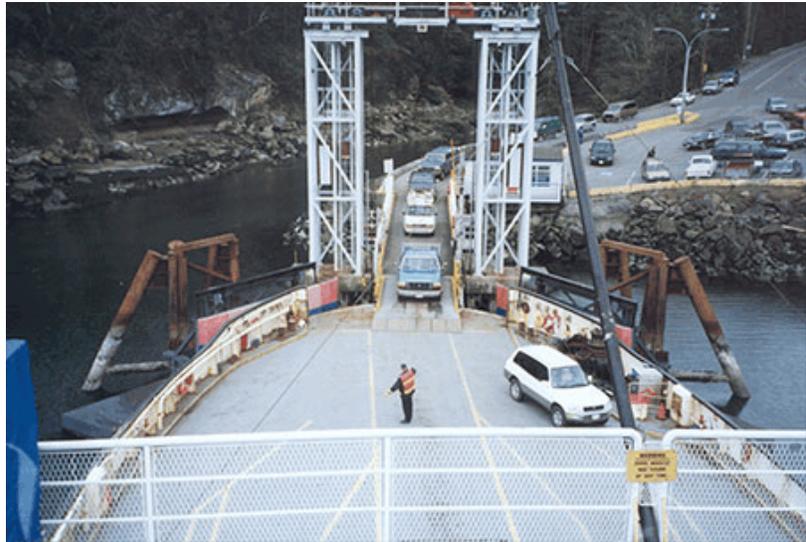
At about 1755 on 13 April 2002, the *Bowen Queen* departed Nanaimo Harbour for the scheduled crossing to Descanso Bay, Gabriola Island. The crossing was uneventful and the vessel arrived at Descanso Bay at 1820. When in position at the dock the master aligned all four RADs in the 'pushing in' direction, the shore ramp was lowered and the discharging of foot passengers and vehicles commenced.

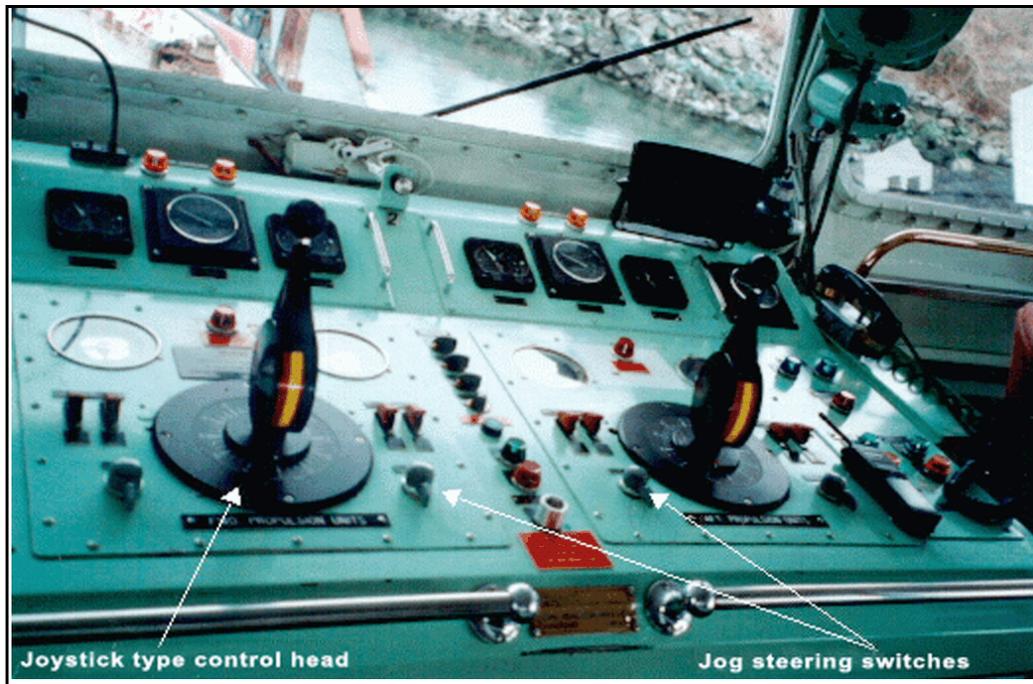
Meanwhile in the wheelhouse, the master had declutched all four RADs, rotated the two forward legs so that they would provide a braking action and then re-clutched them in. The vessel was backed away from the ramp and did not make contact with it. It was then taken about 30 m away from the dock, where the four RAD units were operationally tested to determine the cause of the malfunction. When none was found, the ferry returned to its berth and safely discharged all the remaining cars.
