# MARINE INVESTIGATION REPORT

## M17A0004

### Grounding

Bunkering tanker *Arca 1*  
Little Pond, Nova Scotia  
08 January 2017

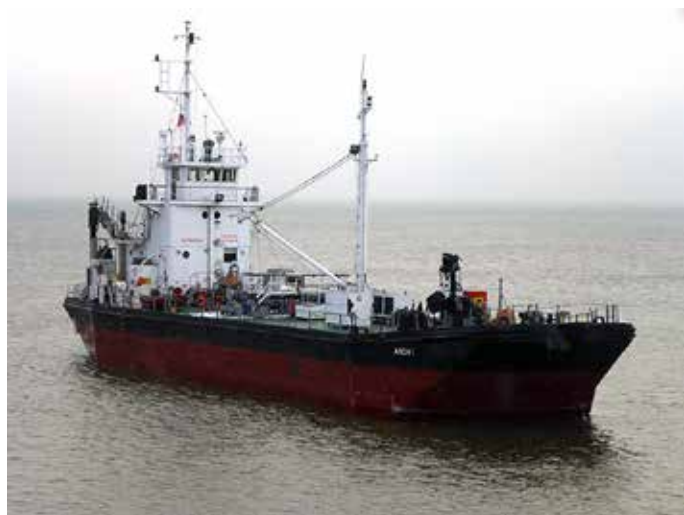
Figure 1. *Arca 1*

The *Arca 1* is a bunkering tanker with a capacity of 1527 m<sup>3</sup>, designed for the transportation of oil to vessels at a maximum speed of 8 knots (Figure 1). The vessel was built in St. Catharines, Ontario, in 1963 and had operated in the ports of both Montreal and Sorel, Quebec. The vessel was restricted to minor waters voyages, Class II.<sup>1</sup> In 2004, a second hull was installed over the internal oil storage tanks, providing a double hull (Appendix A). The construction of the second hull provided a 750
