MARINE TRANSPORTATION SAFETY INVESTIGATION REPORT M21C0265

CAPSIZING

Rescue boat 1864
Off Île au Diable
Montréal, Quebec
17 October 2021

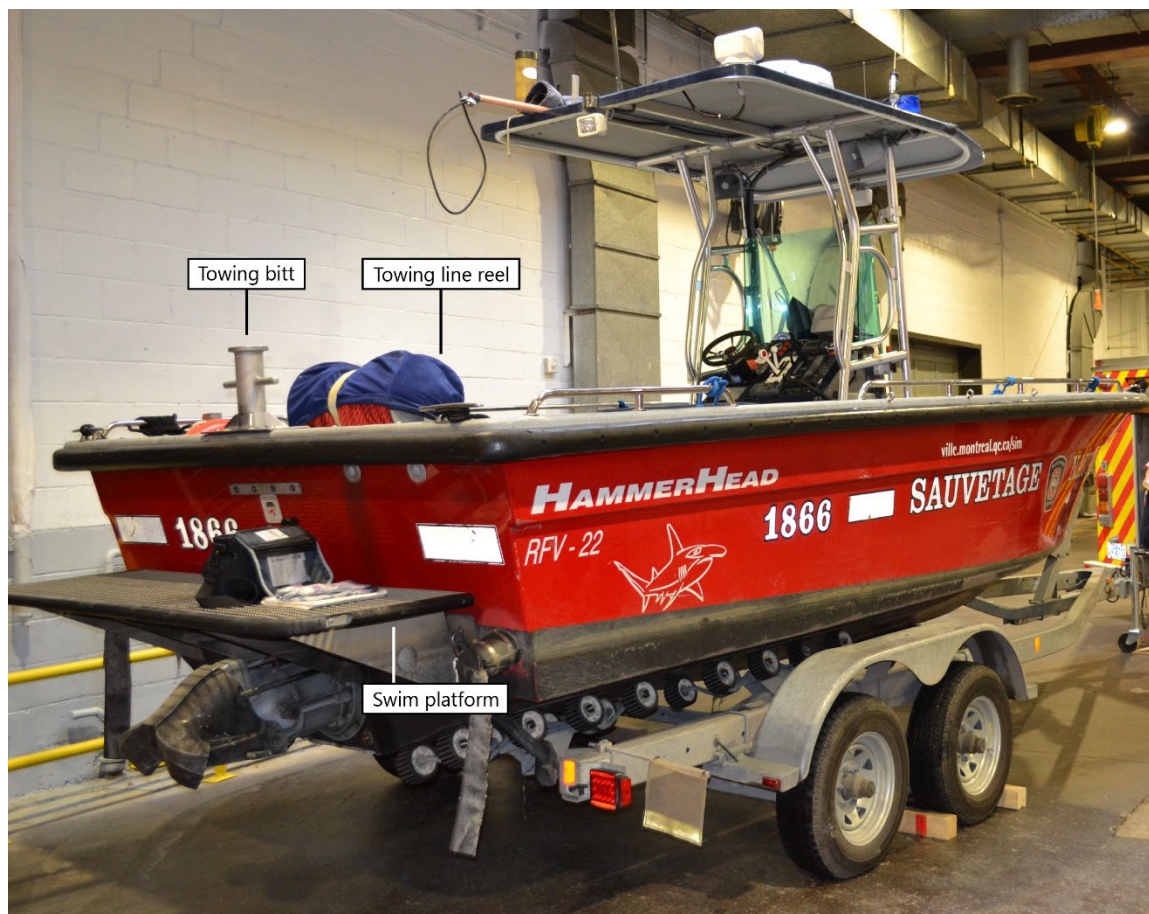
The inboard motor was protected by a drum and driven by reaction propulsion (waterjet). A towing line reel and towing bit were installed aft of the drum (Figure 1).

Figure 1. HammerHead RFV-22 (sister boat to the occurrence boat) with tow cable reel, towing bitt and swim platform labelled (Source: TSB)

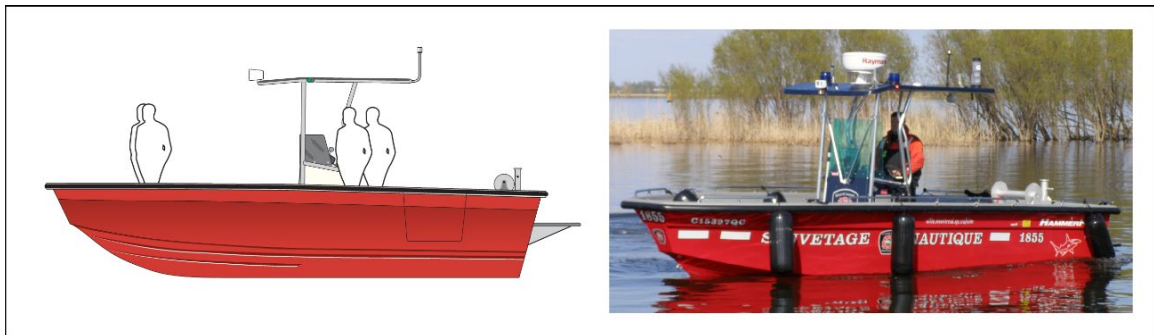
That evening, unit 1864 consisted of 4 firefighters: 2 lookouts, 1 coxswain, and 1 lieutenant. With the water temperature at 17 °C, the unit members donned their rain gear and personal flotation devices (PFDs) and quickly launched the boat (figures 3 and 4).

Figure 3. Side view of a HammerHead RFV-22 with 4 people on board (left) and photo of the 1855 (sister ship to the 1864) with 1 person on board (right) (Source: TSB)

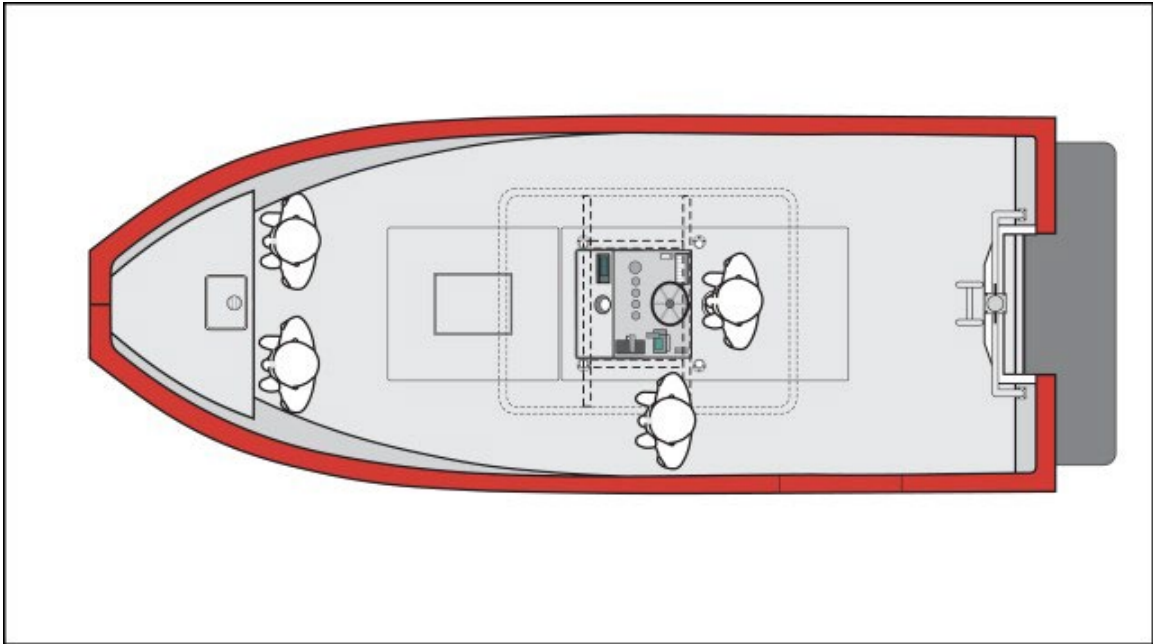
Figure 4. Overhead view of a HammerHead RFV-22 with 4 people on board (Source: TSB)

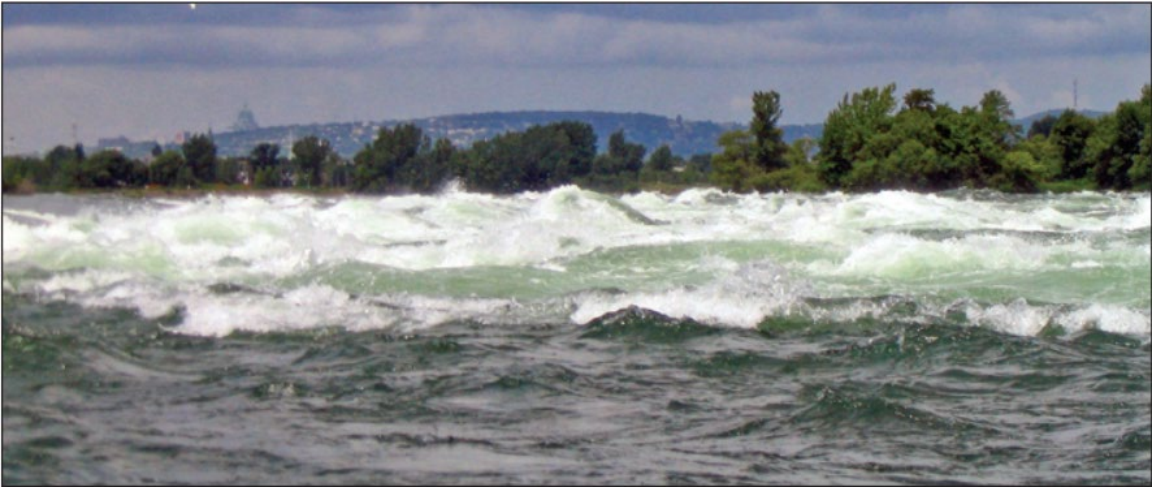
The training handbook also describes the characteristics of the various bodies of water around and on the Island of Montréal, including the Lachine Rapids, with accompanying images. The images of the Lachine Rapids (figures 8 and 9) show only 2 waves in the area, focusing on the roughest parts of the rapids. The handbook states that rescue by boat in this section of the river should only be carried out by experts. However, the handbook does not define “expert.”

Figure 8. The Devil's Drop in the Lachine Rapids, between Goat Island and Heron Island, from the Service d'incendie de Montréal training handbook (Source: Service d'incendie de Montréal, training division, Sauvetage nautique : manuel du participant [2004])

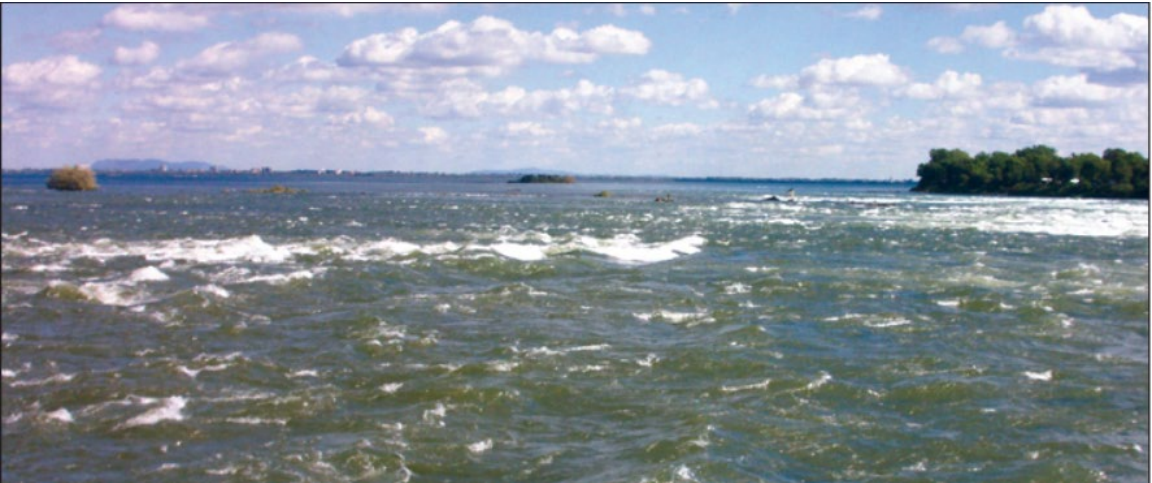
Figure 9. The Big Joe wave in the Lachine Rapids, off Goat Island, from the Service d'incendie de Montréal training handbook (Source: Service d'incendie de Montréal, training division, Sauvetage nautique : manuel du participant [2004])
