RAILWAY INVESTIGATION REPORT

R99T0017

TRAIN PASSED A SIGNAL INDICATING STOP

VIA RAIL CANADA INC.

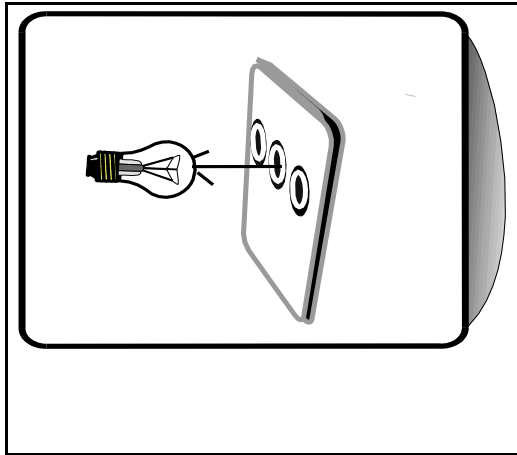
The signals used at Trenton Junction were called Type SA-1 searchlight and were manufactured by General Railway Signal Corporation (GRS) based in Rochester, New York. GRS was purchased by Alstom Signaling Inc. (Alstom) in 1998. The signals were built according to Association of American Railroads (AAR) specifications (relevant portion cited in Appendix B).

A searchlight signal is an electromechanical device that consists of a lamp at the rear of a metal box (housing), an assembly of three discs (yellow, red and green) immediately in front of that lamp, called a rotary movement, and a lens in front of that rotary movement. As power is applied to the mechanism, depending on the polarity, the rotary movement swivels in front of the lamp to expose the appropriately coloured disc and display a certain colour. The assembly's resting position (when no power is applied) is vertical, with the red disc exposed to the lamp to ensure a stop indication is displayed under normal conditions or during a power outage.

A known problem with this type of assembly is that it could freeze in place, when the temperature is below freezing, should moisture be present in the mechanism and the three-disc assembly come in contact with the

metallic housing. Should this occur, the signal may not display the desired indication. Under such conditions, the fail-safe feature would not function.

The searchlight signal, located at the top of the signal arrangement for signal 2352S at Trenton Junction, was examined at the TSB Engineering Branch Laboratory to determine if a malfunction could have occurred when VIA 52 approached and passed it. Representatives from Alstom, the manufacturer, as well as the regulator, Transport Canada (TC), attended. The mechanism was dismantled, and the parts were examined. No sign of malfunction was discovered and no sign of moisture was observed inside the assembly.

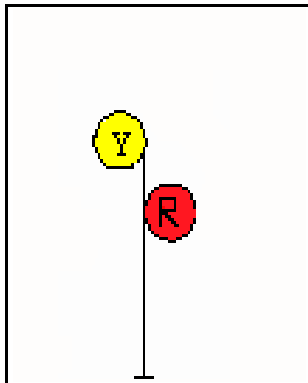
The signal control network is a bi-directional network with no energy flowing while in the “resting” state. As there is no energy applied to any of the signal mechanisms, they all display a stop indication (as explained in 1.12.2.1). In a typical circuit design, when a signal is requested, a relay (GZ relay) goes to the energized position to energize a traffic relay (F relay) and de-energize a lock relay (L and LS). The polarity to the signal mechanism is controlled by the line relay (D relay) coming in from the adjacent location. As explained in 1.12.2.1, the polarity determines in which direction the rotary movement moves to display a coloured disk.

The line circuit between Trenton Junction and the approach signal (2352S) operates as follows.

- When signal 2328S is displaying a stop indication, the green mechanism repeater (2328SAGP) is in the de-energized position. The positive energy path causes signal 2352S to display a yellow-over-red indication (clear to stop signal).
- When signal 2328S is displaying a permissive indication, the green mechanism repeater is in the energized position, which causes signal 2352S to display a green-over-red indication (clear signal).
