**RAILWAY INVESTIGATION REPORT**  
**R08T0158**

**CROSSING COLLISION AND DERAILMENT**

**VIA RAIL CANADA INC.**  
**TRAIN NUMBER 60**  
**MILE 138.21, KINGSTON SUBDIVISION**  
**MALLORYTOWN, ONTARIO**  
**15 JULY 2008**

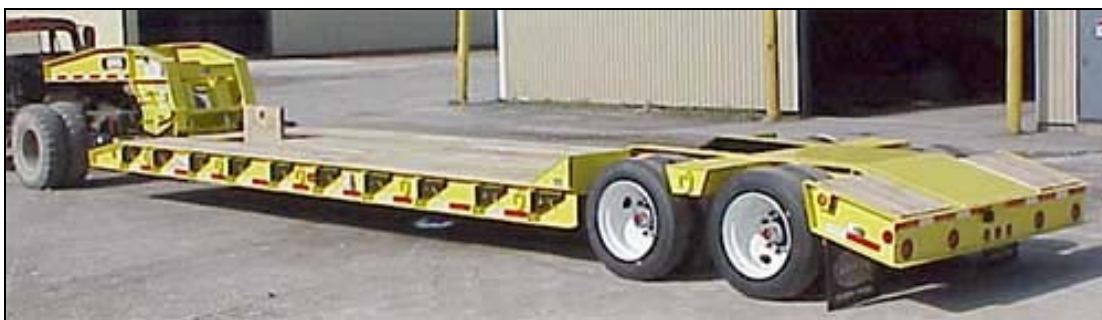
**Photo 5.** Typical model TC3 Rogers Bros. Corp. trailer

The trailer was designed to be lowered and raised for the purposes of loading and unloading equipment while disengaged from the tractor. A small engine mounted on the trailer produced the power necessary to operate its hydraulic lifting mechanism. The design vertical ground clearance for the underside of the unloaded trailer involved in the accident was 7 inches (17.8 cm) minimum.
