**RAILWAY INVESTIGATION REPORT
R14C0142**

MAIN-TRACK TRAIN DERAILMENT

**CANADIAN PACIFIC RAILWAY
FREIGHT TRAIN 205-25
MILE 82.1, LAGGAN SUBDIVISION
BANFF, ALBERTA
26 DECEMBER 2014**

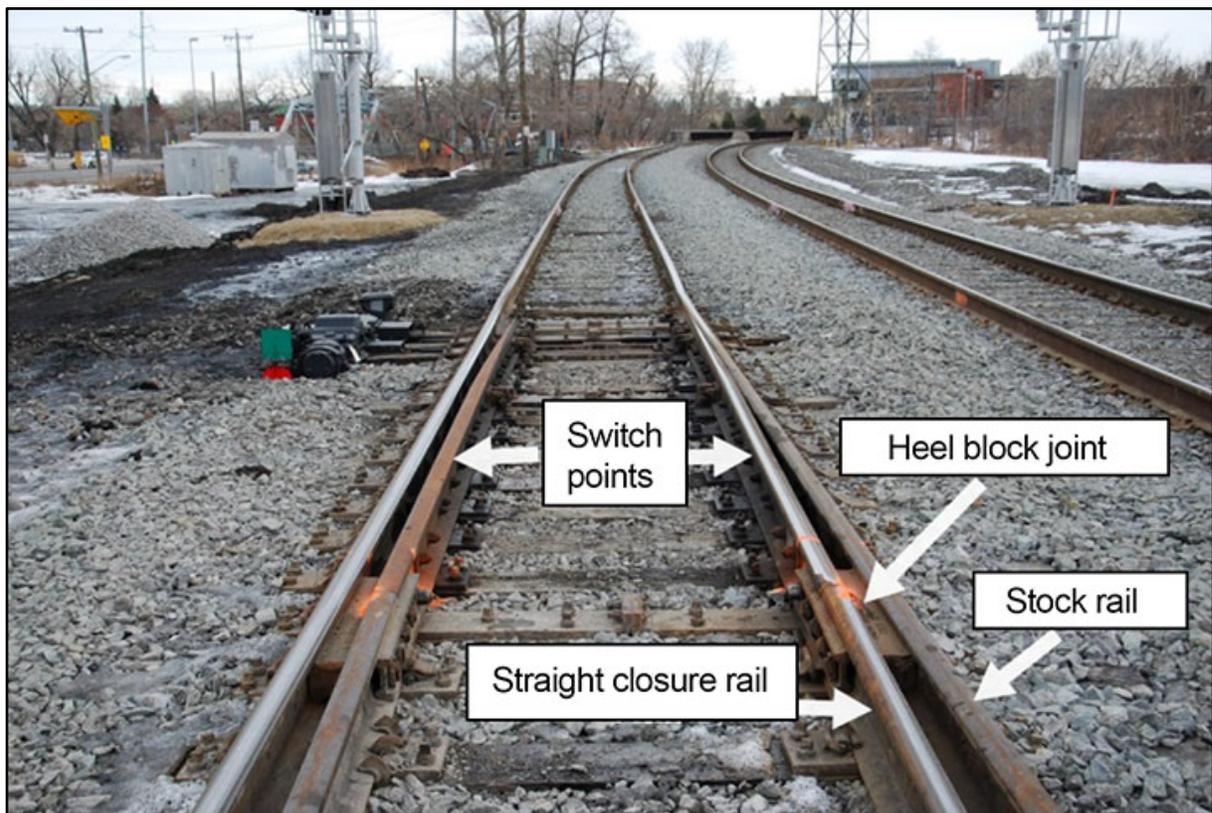
The switch was a No. 13 LH 136-pound RE dual control switch. The 22-foot long left hand Samson switch point was 2007 NKK head-hardened rail. The switch point, bent stock rail, and straight closure rail were connected at a five-hole heel block casting (Photo 5).

Photo 5. A similar No. 13 switch (not the switch at the derailment location)
