RAILWAY INVESTIGATION REPORT R16W0004

Main-track train derailment

Canadian National Railway Company

Mile 13.45, Redditt Subdivision

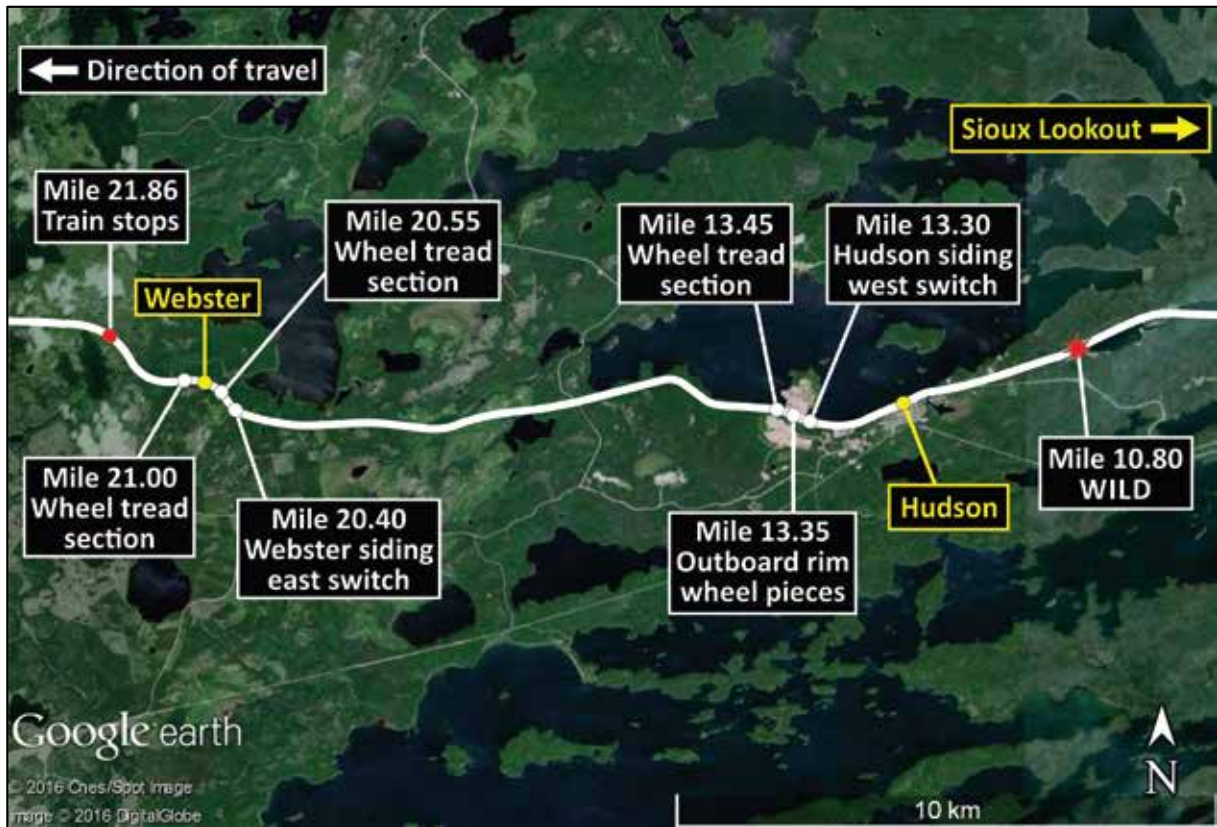
Figure 2. Site diagram between the Hudson wheel impact load detector site (Mile 10.80) and where the train came to a stop (Mile 21.86) (Source: Google Earth, with TSB annotations)

Starting at Mile 13.45, where the first wheel tread section broke away from the wheel plate, impact marks from the derailed wheel were observed on the track infrastructure extending westward. The train had continued until the derailed No. 1 wheel set contacted the track work associated with the Webster siding east switch at Mile 20.40.

Figure 2 identifies the location of the CN Hudson WILD site, the various locations at which pieces of the L1 wheel were recovered, and the location where the train stopped.
