AVIATION INVESTIGATION REPORT
A07A0134

TOUCHDOWN SHORT OF RUNWAY

BOMBARDIER BD-700-1A11 (GLOBAL 5000) C-GXPR

FOX HARBOUR AERODROME, NOVA SCOTIA

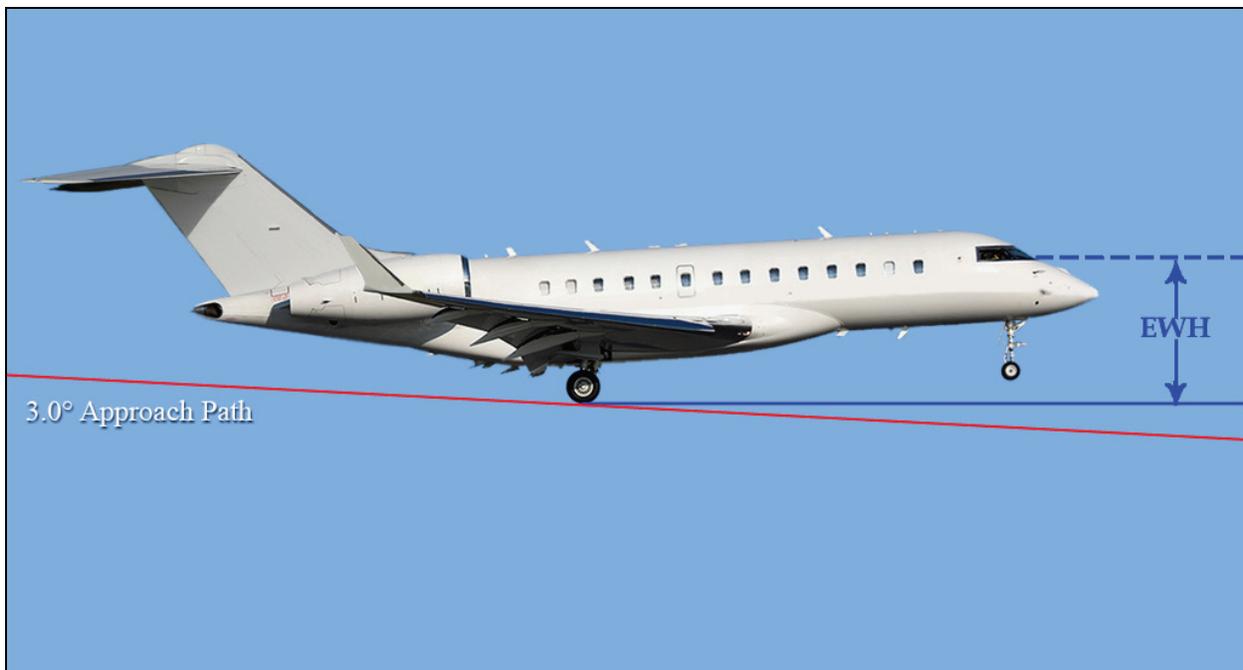
The vertical distance from a pilot's eyes to the lowest portion of the aircraft in the landing attitude is called the eye-to-wheel height ¹² (EWH) (see Photo 5). This distance varies from less than 4 feet to 45 feet for some wide-bodied aircraft, such as the Boeing 747. Knowledge of an aircraft's EWH is necessary for flight crews to assess the adequacy of a visual glide slope indicator (VGSI) system for the aircraft type flown.

Photo 5. Aircraft eye-to-wheel height

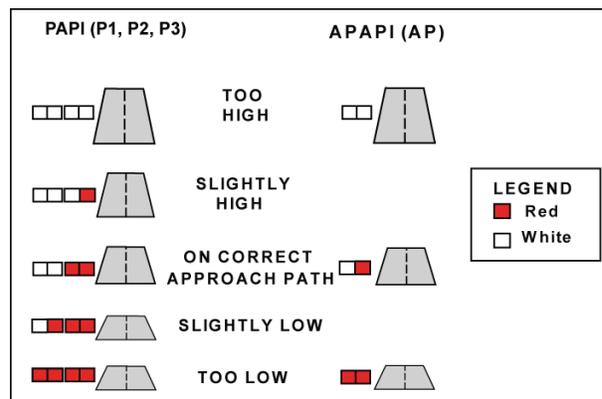
Although both the PAPI and APAPI offer visual glide path indications to pilots, a PAPI has the advantage of giving incremental deviation indications (see Figure 2) because it has four light units instead of the APAPI's two light units. This allows the pilot to better anticipate flight path corrections. This is especially important when making flight path corrections at low altitude, as the width of the visual signal narrows and it is easy to fly through the signal, from a white/white too-high, through the red/white on correct approach path, to the red/red too-low indication.

Figure 2. PAPI indications

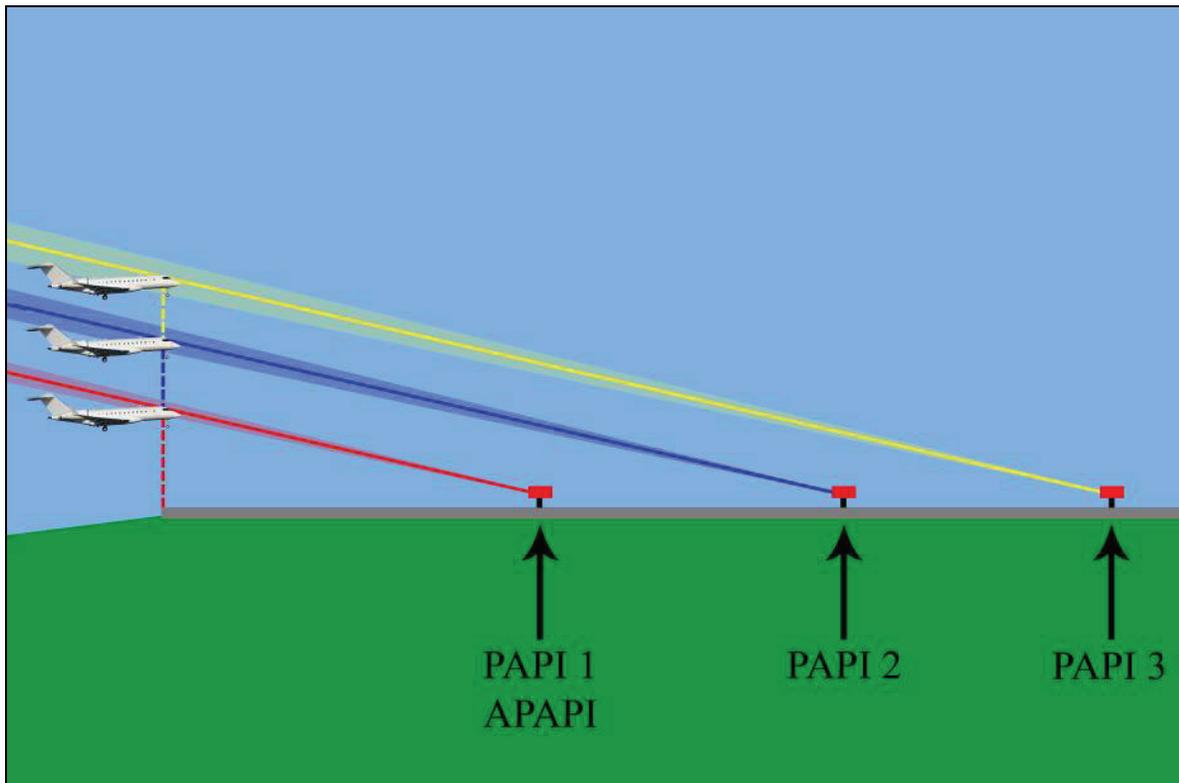
It is possible to provide for safe wheel clearance over the threshold for aircraft with different EWH by varying the distance of the wing bar from the runway threshold (see Figure 3). By increasing the distance between the threshold and the PAPI units, a greater TCH is obtained. A PAPI 2 is required to ensure safe TCH for the Global 5000 with its EWH of 17.2 feet.

Figure 3. Depiction of different PAPI types and associated threshold crossing height

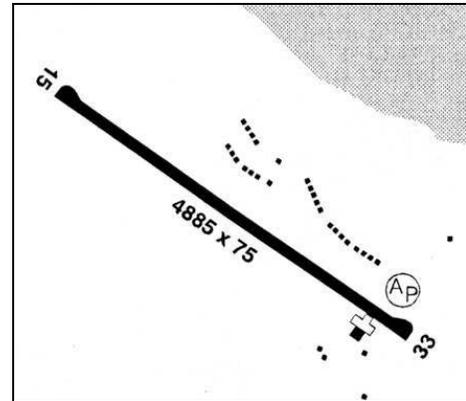
Information regarding the type of VGSI currently in use in Canada can be found in the *Canada Air Pilot* (CAP) published by NAV CANADA. The VGSI configuration appears on a legend found in the CAP general pages (CAP GEN). For any given instrument approach published, an aerodrome chart is located at the bottom right of the page. On this chart, a circle is displayed in which the type of VGSI is indicated (see Figure 4). By taking a quick glance, a pilot knows exactly the type of VGSI in use for the runway on which he plans to conduct an approach.

Figure 4. Fox Harbour aerodrome (CFH4) *Canada Air Pilot* chart

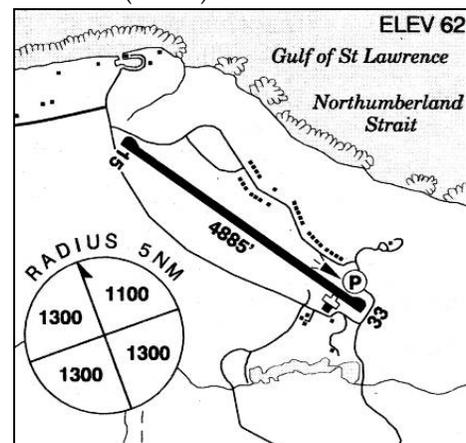
Information is also available in the *Canada Flight Supplement* (CFS) published by NAV CANADA, but it is displayed differently. The CFS aerodrome chart is very similar to the aerodrome chart found in the CAP; however, the symbol used to display the type of VGSI is simply a circle in which the letter “P” or the letter “V” indicates to the pilot whether a PAPI or a VASIS is available (see Figure 5). To confirm the type of PAPI or VASIS, the pilot has to refer to the lighting section of the aerodrome description. In that section, the description of all lighting available for each runway is available. The type of PAPI is indicated as AP, P1, P2, or P3, while the type of VASIS is indicated as AV, V1, V2, or V3.

Figure 5. Fox Harbour aerodrome (CFH4) *Canada Flight Supplement* chart

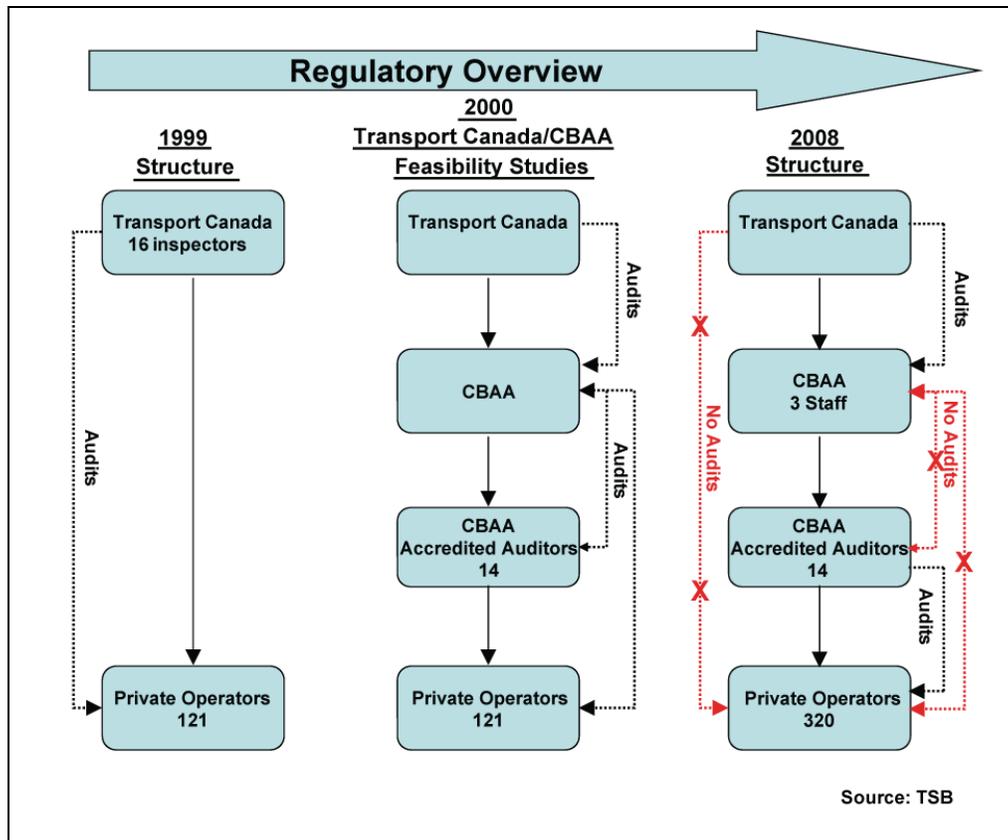
As shown in Figure 8 (1999 Structure), before the inception of the CBAA POC program, Transport Canada was responsible for the regulation, certification and oversight of business operators. The feasibility studies proposed a new oversight model where the CBAA would be responsible for the administration of the POC program, which involved the use of CBAA-accredited auditors.

The model as used (2008 Structure), however, contains none of these mitigation measures. Oversight is left primarily to the accredited auditors. The CBAA does not have a quality assurance program in place to verify the effectiveness of its accredited auditors or its member operators' systems. The current model consists of informal communications between the CBAA and its accredited auditors and operators during liaison visits and trade shows. Pairing an

accredited auditor with insufficient SMS knowledge and an operator still following a traditional safety management scheme could allow the operator to take on unacceptable risks that will go undetected. Transport Canada has not ensured that the CBAA is fulfilling its responsibilities for oversight, therefore increasing the risk that safety deficiencies will not be identified.

Figure 8. Business aviation safety oversight models
