**AVIATION INVESTIGATION REPORT**  
**A09A0016**

**MAIN GEARBOX MALFUNCTION / COLLISION WITH WATER**

**SIKORSKY S-92A, C-GZCH**

**12 MARCH 2009**

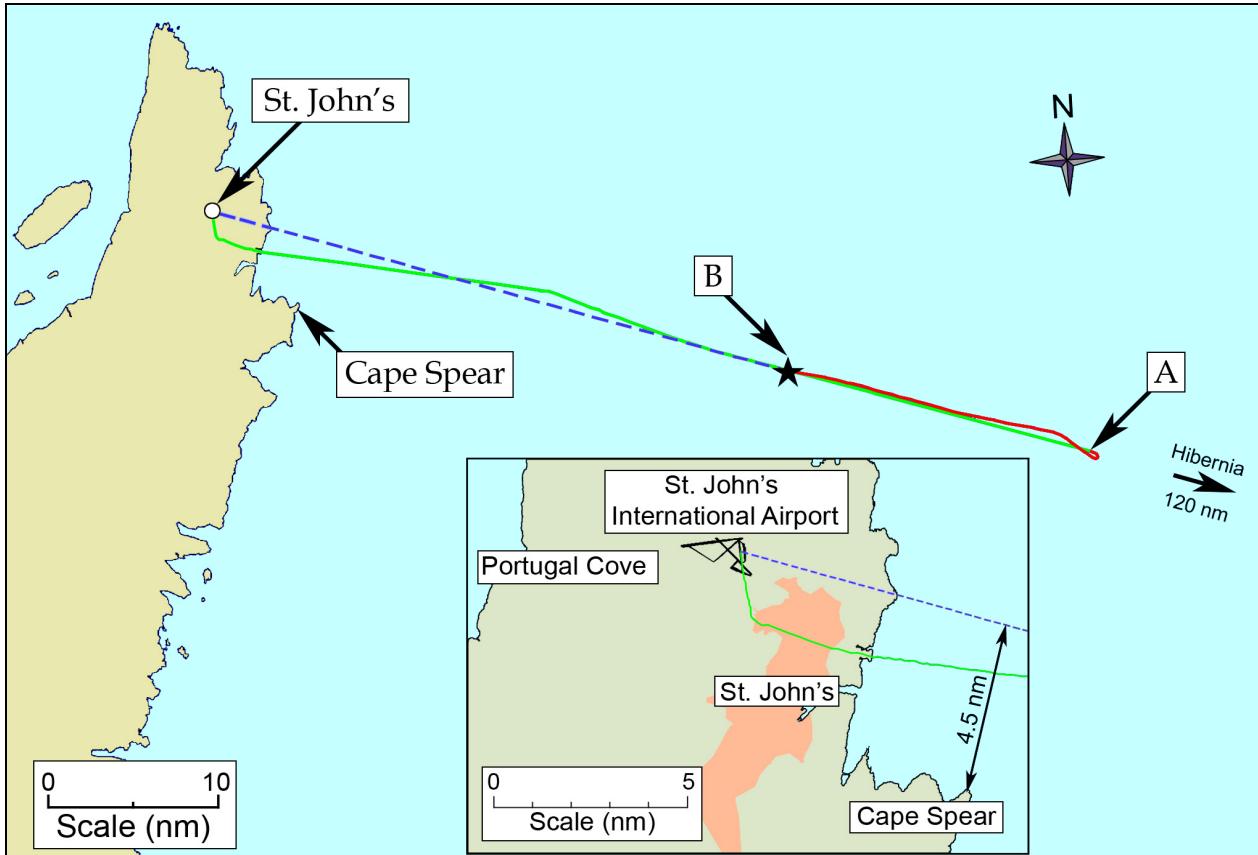
**Figure 1.** Area map with helicopter track and impact position

Figure 1 depicts the outbound portion of CHI91's flight path prior to the red MGB OIL PRES warning message (solid green line), the point where the oil pressure loss occurred (see Point A), the return portion of the flight (red line), and the approximate position it impacted with the water (see Point B). The blue dashed line is the projected track from the impact position direct to CYYT. The inset shown in Figure 1 depicts the distance between Cape Spear and the direct track followed by the helicopter, from the diversion point to CYYT.

The accident location was approximately 35 nautical miles (nm) from CYYT (approximate position of 47°26'03"N, 051°56'35"W), on a direct track between the diversion point and CYYT (see Figure 1).

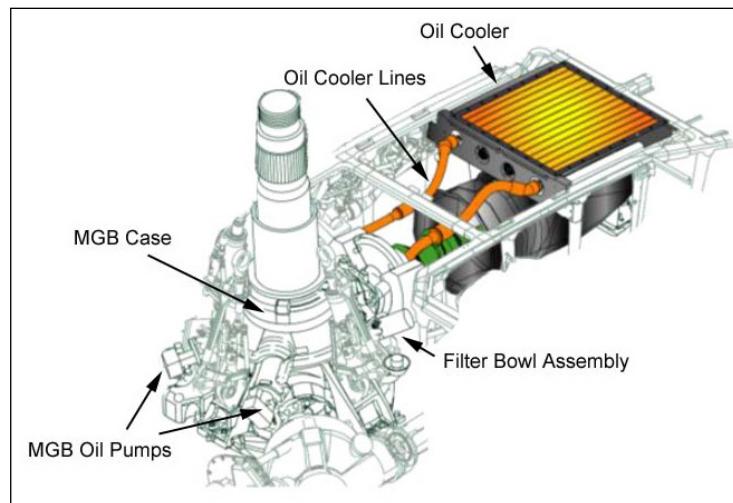
**Figure 7.** MGB Lubrication System Components

The MGB incorporates an oil bypass system that allows the pilot to bypass the MGB oil cooler in the event of a leak in the oil cooler or its components (i.e., oil cooler system) (see Figure 7). The MGB oil bypass switch allows the pilot to test the system for proper operation or to electrically activate the bypass valve. When the valve is activated, oil is routed back into the gearbox, bypassing the oil cooler system, and a MGB BYPASS caution message is displayed on the multi-function display (MFD).

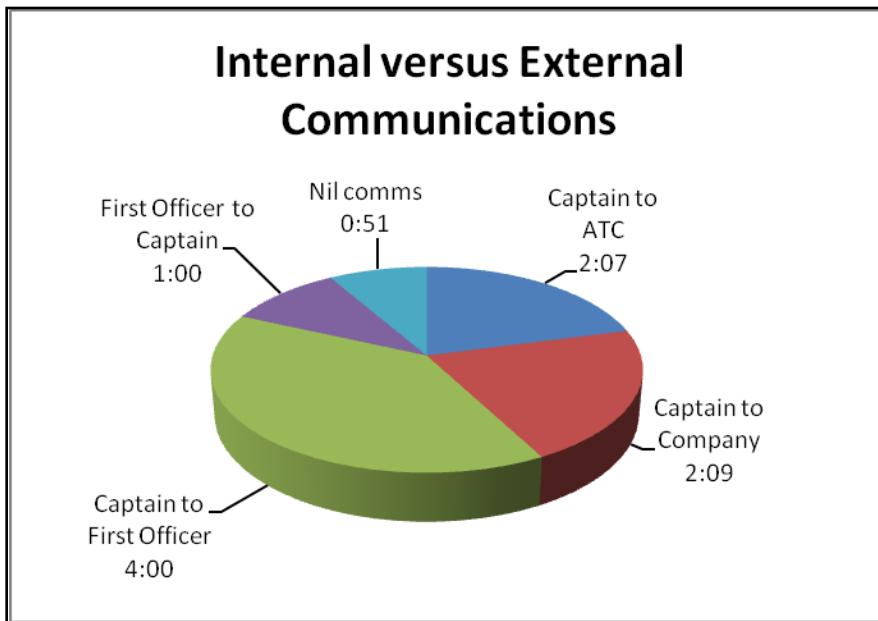
**Figure 9.** Internal versus External Communications

From the moment the red MGB OIL PRES warning message light illuminated, until the power interruption to the flight recorder just prior to ditching, 10 minutes and 7 seconds elapsed. During this time the captain was in communication with Gander ACC and the Cougar dispatch centre for roughly 4 minutes and 16 seconds, leaving 5 minutes and 51 seconds for internal communications between crew members (see Figure 9).

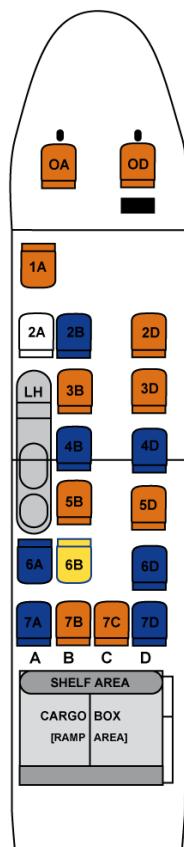
**Figure 10. Occupant Injury Chart**

- White Seat 2A: no passenger
  - Blue Seats (no significant antemortem injury); 2B; 4B; 4D; 6A; 6D; 7A and 7D
  - Yellow Seat (minor injury) : 6B  
- contusion to right shoulder
  - Orange Seats (broken bones and other injuries):
- OA - multiple facial fractures, multiple fractures to both arms, chest injuries and internal bleeding;  
 OD - multiple facial fractures, right hip fracture, chest injuries;  
 1A - compound fracture of left leg;  
 2D - compound fracture of left jaw;  
 3B - fracture/dislocation of left ankle;  
 3D - burst fracture to spinal disc, fracture of right ankle, chest injuries;  
 5B - compound fractures of both legs;  
 5D - laceration to lip, fracture to left ankle;  
 7B - compound fracture to left leg, laceration to lower lip;  
 7C - fracture to left ankle, contusions to right ankle.

CHI91 impacted with the water with an estimated force in the magnitude of 20g to 25g. Much of the impact force was absorbed by the fuselage, the attenuating seats, and four-point harness system. The g-force experienced by each individual differed depending on the force applied to the fuselage in the area where they were seated. Except for the four passenger seats that bottomed out, the occupants were generally subjected to inertia load factors between at least 5.3g and 8.6g in the direction of the vertical seat axis. In addition, the helicopter struck the surface with a forward velocity of approximately 55 to 60 knots which would have introduced a horizontal force on the occupants of approximately 5g to 8g.

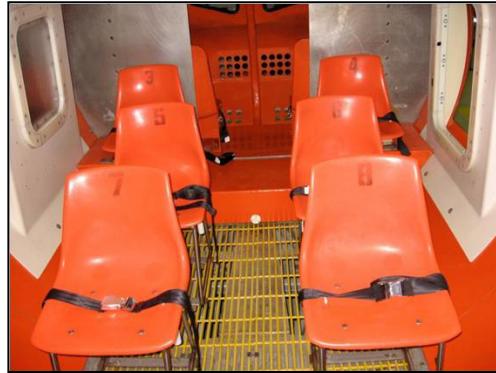
**Photo 10.** Marine Institute HUET simulator seats

The Marine Institute's helicopter underwater escape trainer (see Photo 10) was designed to simulate a wide variety of helicopters and does not expressly represent the S-92A. It has short-backed seats with legs that are not representative of the S-92A's attenuating seats. It does not use four-point restraint harnesses like the S-92A; instead it is fitted with a lap belt. The trainer has three different sized windows with rubber strip seals that must be pulled out to remove the plexiglass windows and egress. None of the windows operate like those on the S-92A.

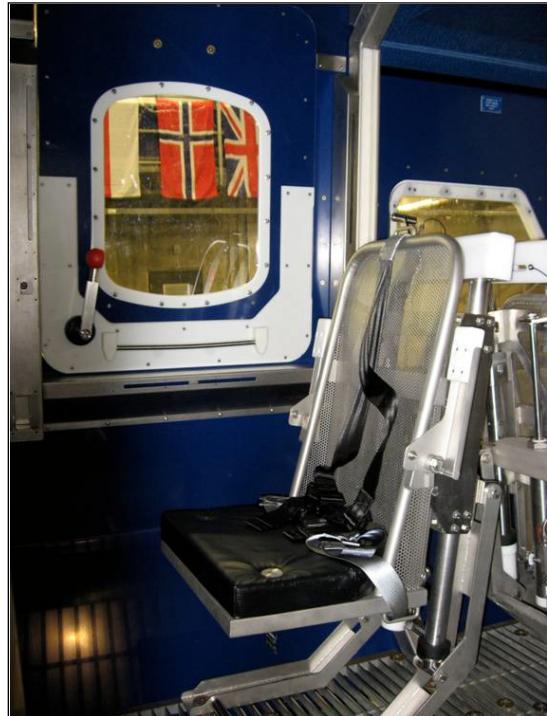
**Photo 11.** Survival Systems Training's HUET simulator seats

Survival Systems Training Ltd.'s helicopter underwater escape trainer (see Photo 11) was designed to simulate the S-92A. It has high-backed seats that can be adjusted to simulate a stroked seat, four-point restraint harnesses, and windows that are similar in size and operation to those of the S-92A. The stroked seat positions allow the students to practice egressing from the various stroking configurations that may be encountered during a ditching. Egress difficulty levels associated with the various stroking configurations can vary for students of different heights, flexibility, and arm length.

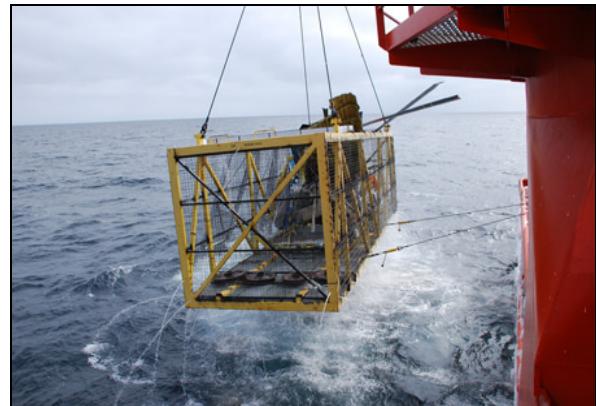
**Photo 18.** Main wreckage recovery

By 17 March 2009, all victims had been recovered as well as the MPFR. Due to the fragile condition of the main wreckage, the TSB determined early in the recovery operation that it would not be effective or safe to lift the main wreckage, unsupported, to the surface and onto the ship. With this in mind, a rigid spool deployment frame was modified to serve as a large cage. After two of the main rotor blades were cut underwater to allow the wreckage to sit in the cage, a strap was secured around the main rotor head and used to lift the main wreckage into the cage, and then the cage was lifted to the surface (see Photo 18). The *Atlantic Osprey*, with the main wreckage aboard, arrived in St. John's harbour the afternoon of 18 March 2009.
