AIR TRANSPORTATION SAFETY INVESTIGATION REPORT A19A0055

INADVERTENT DESCENT DURING APPROACH

Canadian Helicopters Offshore
Sikorsky S-92A (helicopter), C-GICB
Halifax, Nova Scotia, 155 NM ESE
24 July 2019

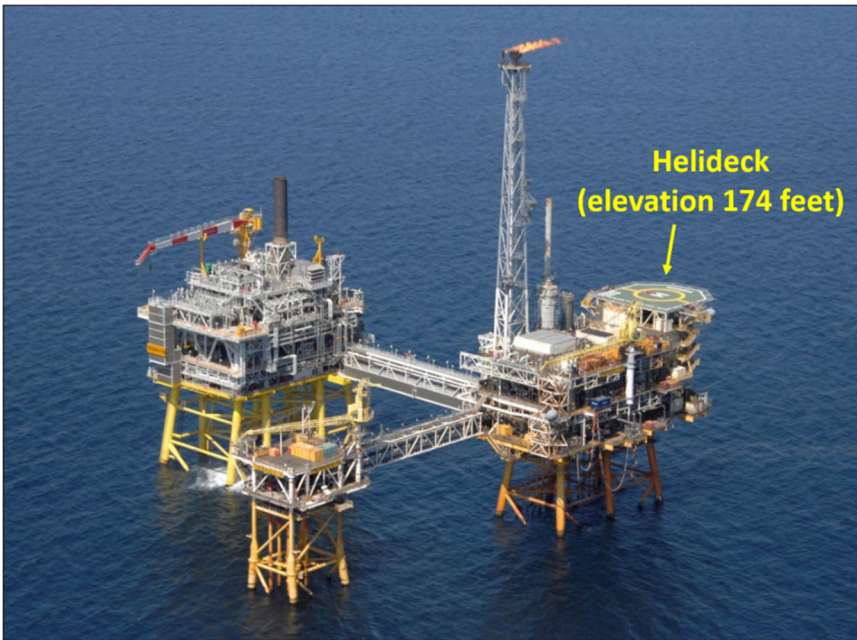
Figure 3. Photo taken in visual meteorological conditions showing approximate orientation of the Thebaud Complex¹⁴ as the helicopter rolled out on final approach (Source: ExxonMobil, with TSB annotations)

At 1332:15, approximately 1.1 NM from the TCF, the helicopter rolled out on a heading of 182°M and the crew planned their third approach. There was a ragged layer of fog below the helicopter and a scattered-to-broken layer of cloud at least several hundred feet above it. The pilots could see the water through the fog, directly beneath the helicopter. Since the winds were light (i.e., not registering on the primary flight displays [PFDs]¹³), the pilots decided to, and briefed that they would, turn right to roll out on an inbound track of approximately 240°M, rather than continue arcing, as originally intended, until reaching the original inbound track of 320°M. Because the pilots planned to fly the final approach offset to the right of the TCF, this option was considered to be more expeditious and to provide better references for the first officer (who would fly the approach), since it would place the TCF off the left-hand side of the helicopter during the final stages of the approach to the helideck (Figure 3 shows approximate orientation before turning final). The pilots decided to remain at 500 feet RADALT.

At 1332:55, when the helicopter was 0.6 NM from TCF, it rolled out on final approach, on a heading of 271°M. The helicopter was level at 46% engine torque, coupled to RADALT at 500 feet and 61 KIAS. The airspeed and groundspeed were approximately the same.

The first officer stowed his approach plate, and prepared to take control. Because the first officer was seated in the left seat, he did not have visual contact with the TCF until the helicopter rolled out on final. When the helicopter rolled out, the captain transferred control to the first officer (who was now the PF). The helicopter was still flying above the fog layer, and both pilots had a clear line of sight to the helideck. The estimated flight visibility was approximately 3 SM in the direction of the TCF; however, there was no discernible horizon behind the TCF.

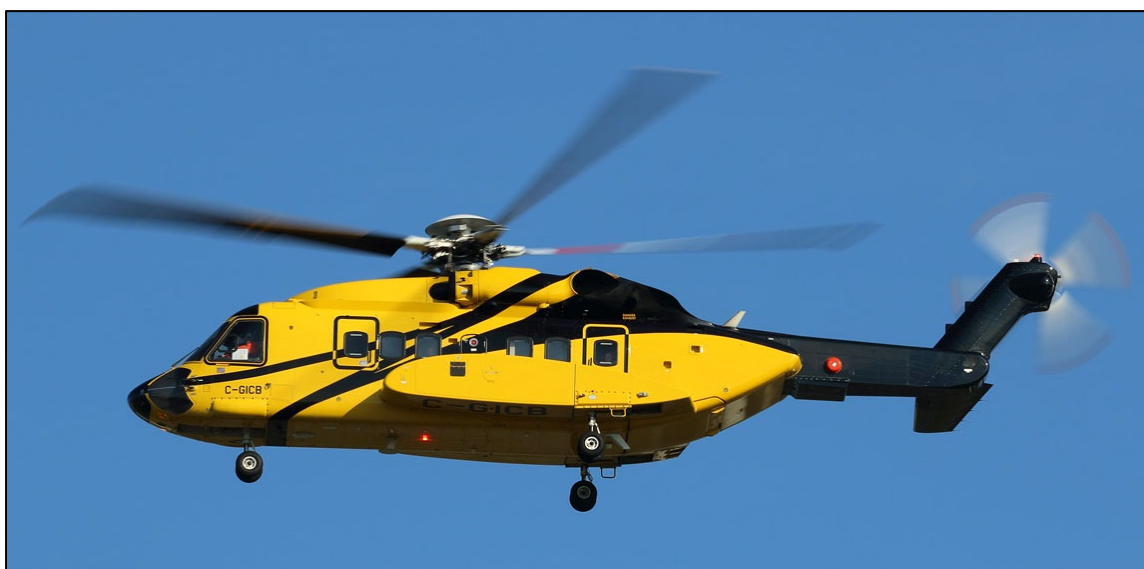
Figure 5. Occurrence helicopter (Source: Third party, with permission)

The S-92A is a four-bladed twin-engine medium-lift helicopter built by Sikorsky (Figure 5). The occurrence helicopter was configured to carry 2 crew members, 1 internal auxiliary fuel tank, and up to 16 passengers in the cabin. Records indicate that the helicopter was certified and equipped in accordance with existing regulations and was within its weight and centre-of-gravity limits. There was no indication of an aircraft system malfunction before the inadvertent descent.

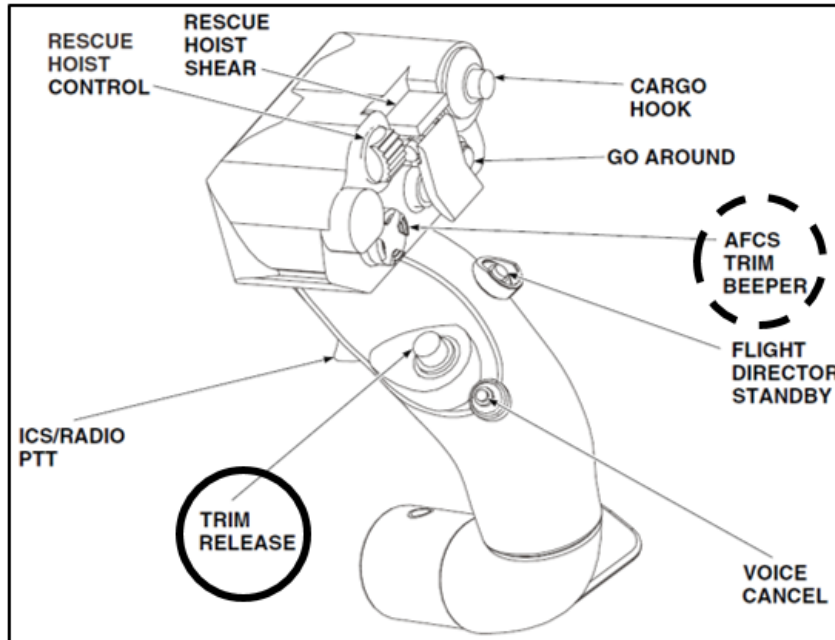
Figure 9. S-92A cyclic stick, trim release (solid circle); trim beeper switch (dashed circle) (Source: Sikorsky, *FAA Approved Rotorcraft Flight Manual: Sikorsky Model S-92A*, SA S92A-RFM-003, Revision 8 [02 May 2012], Part 2, Section I, with TSB annotations)

Inputs from the trim actuators can be disengaged by depressing the trim release button located on the cyclic (solid circle, Figure 9), the trim release trigger on the collective (solid circle, Figure 10), or the tail rotor pedals. The actuators can also be controlled by the 4-way trim beeper switches located on the cyclic and collective (dashed circles, Figure 9 and Figure 10).

In ATT mode,⁶⁰ pressing and releasing the cyclic trim release button will re-reference the cyclic trim force to the new stick position and corresponding pitch and roll attitude. If the pilot applies a cyclic input without first depressing the trim release, it will “result in an increasing force towards the reference.”⁶¹

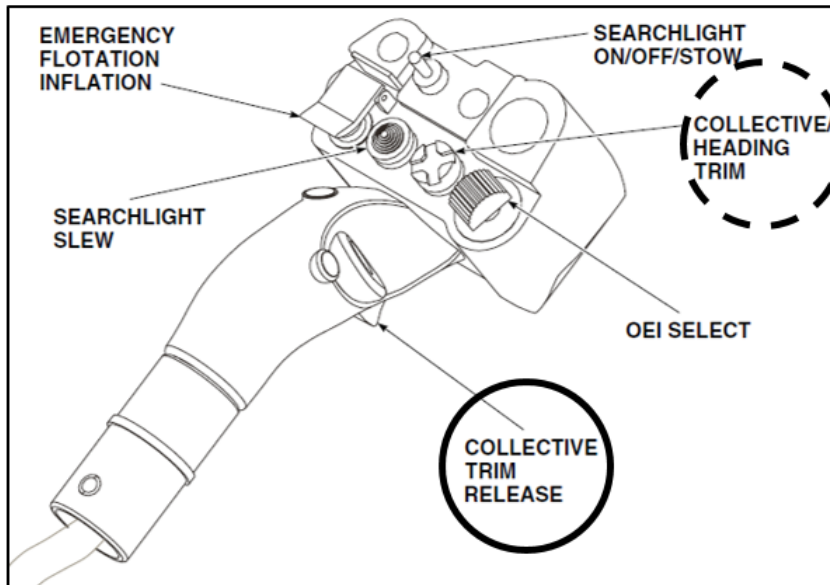
Figure 10. S-92A collective stick, trim release (solid circle); heading trim (dashed circle) (Source: Sikorsky, *FAA Approved Rotorcraft Flight Manual: Sikorsky Model S-92A*, SA S92A-RFM-003, Revision 8 [02 May 2012], Part 2, Section I, with TSB annotations)

Similarly, in ATT mode, pressing and releasing the collective trim release trigger will re-reference the collective to the new position. The collective/heading trim beeper will raise or lower the collective, increasing or decreasing engine torque.

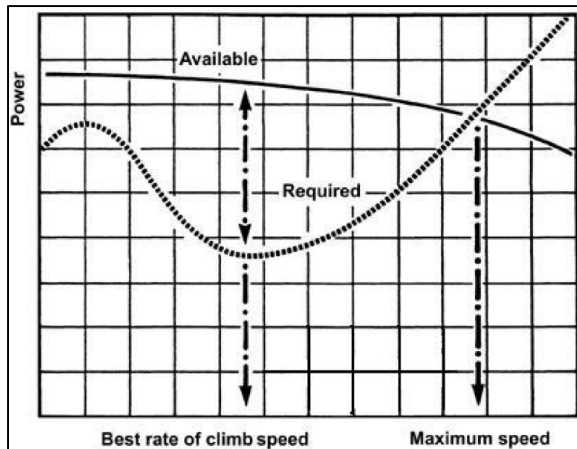
Figure 11. Sample helicopter power curve (Source: Transport Canada, TP 9982, *Helicopter Flight Training Manual*, Second Edition [June 2006])

In the S-92A, power is measured in terms of engine torque. Depending on the conditions, a given torque setting will be required to maintain an altitude and an airspeed. As a helicopter accelerates from a hover, an initial power increase is required to prevent sink; however, the power required will then decrease until the helicopter reaches its best rate of climb/maximum endurance airspeed (referred to as the bucket speed). Beyond that point, power required to maintain altitude or to climb will increase as a result of fuselage profile drag. The curve formed by plotting airspeed versus power (i.e., torque) required is called the power curve (Figure 11).

As airspeed decreases below the bucket speed, induced drag increases. This is commonly referred to as “flying on the back side of the power curve”. When flying on the back side of the power curve, an increase in power will be required to maintain vertical speed (i.e., maintain level flight or the rate of descent/climb). If power is not increased to maintain a desired rate of descent, as airspeed decreases, an excessive rate of descent may develop. Therefore, effective power management requires that pilots maintain an active cross-check to ensure that the power applied meets the requirements for that flight regime.⁸³

Shortly after the occurrence, performance calculations were completed by the manufacturer and verified by the TSB. According to the S-92A cruise performance charts in the S-92A RFM, at the helicopter’s weight⁸⁴ and in the environmental conditions at the time of the occurrence, an engine torque setting of 48% would have been required to maintain altitude at 60 KIAS on final for the visual approach. A 500-fpm descent (the maximum rate of descent per the stabilized approach criteria) at 60 KIAS would require a reduction of engine torque setting to 39% (Appendix E).⁸⁵ However, as airspeed continues to decrease on final (i.e., moving further along the backside of the power curve), more torque would be required as the helicopter slows down, to maintain a constant rate of descent (i.e., maximum 500 fpm). As a result, the 27% engine torque used in this occurrence was significantly lower than the minimum power required to remain below the maximum rate of descent of 500 fpm, during the final approach.

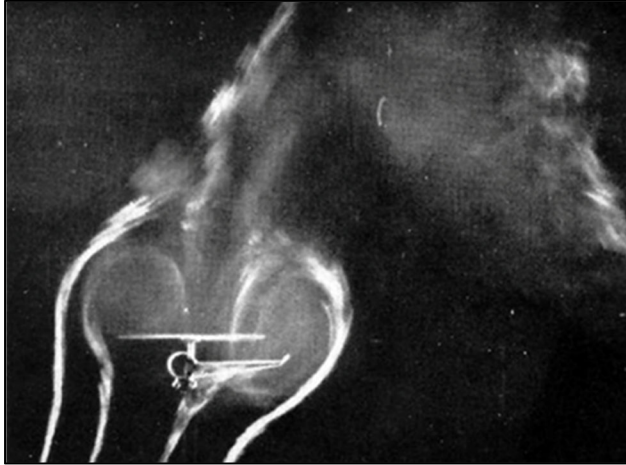
Figure 12. Air circulation during vortex ring state (Source: J. Drees and W.P. Hendl, "Airflow Patterns in the Neighbourhood of Helicopter Rotors", *Aircraft Engineering*, Vol. 23, No. 266 [April 1951])

Helicopters are susceptible to an aerodynamic phenomenon known as the vortex ring state (VRS). VRS occurs when a helicopter's flight path, airspeed, and rate of descent coincide with the helicopter's downwash.⁸⁸ In normal flight, airflow from the main rotors is directed downward. In VRS, the tip vortices generated by the main rotors re-circulate through the rotor, adversely affecting lift (Figure 12). Applying more power (increasing collective pitch) serves to further accelerate the downwash through the main rotor, exacerbating the condition. In a fully developed vortex ring state, the helicopter may experience uncommanded pitch and roll oscillations, and the rate of descent may approach 6000 fpm if allowed to develop.⁸⁹

The *Helicopter Flying Handbook*⁹⁰ published by the U.S. Federal Aviation Administration (FAA) identifies the following combination of conditions as being likely to cause VRS:

- A vertical descent or nearly vertical descent of at least 300 fpm;
- Powered flight, typically within the range of 20-100% engine torque;
- Horizontal velocity slower than effective translational lift.⁹¹
