AIR TRANSPORTATION SAFETY INVESTIGATION REPORT A22W0005

LOSS OF CONTROL AND COLLISION WITH TERRAIN

Delta Helicopters Ltd.
Bell 206B JetRanger II (helicopter), C-FCQJ
Camrose Aerodrome, Alberta, 23 NM ESE
23 January 2022

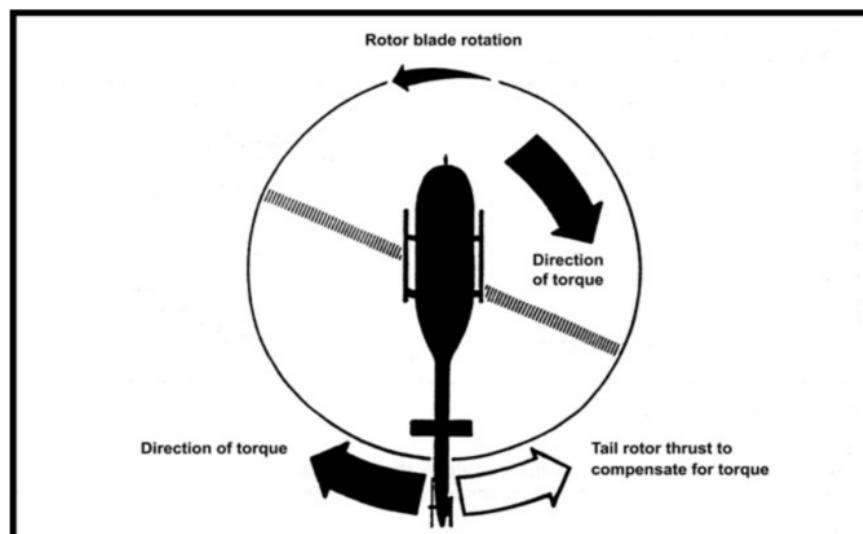
Figure 4. Torque effect (Source: Transport Canada, TP 9982, Helicopter Flight Training Manual, Second Edition [June 2006], Figure 3.3)

When seen from above, the main rotor blades of the Bell 206B turn counterclockwise. Due to this rotation, the helicopter experiences a torque reaction in the opposite direction, which results in the helicopter yawing to the right (Figure 4).

To counter this movement, the helicopter is equipped with a tail rotor that produces lateral thrust. To compensate for the torque created by the main rotor during many normal regimes of flight, the pilot applies pressure to the anti-torque pedals to increase or reduce tail rotor thrust, as required.
