**MARINE INVESTIGATION REPORT**  
**M05C0033**

**COLLISION**

**BETWEEN THE TANKER *JO SPIRIT***  
**AND THE BULK CARRIER *ORLA***  
**SOUTH SHORE CANAL, ST. LAWRENCE SEAWAY, QUEBEC**  
**19 JULY 2005**

Report Number M05C0033

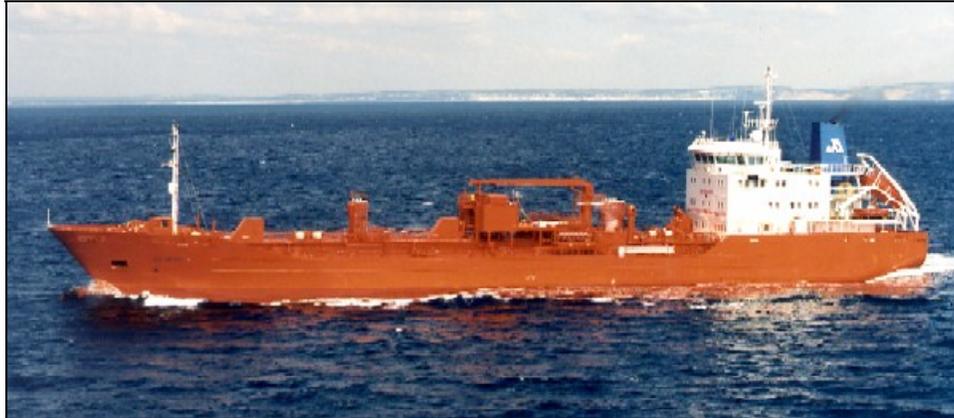
**Photo 2.** The *Jo Spirit*

The *Jo Spirit* is a tanker with the engine room and accommodation aft. Vessel movements, either ahead or astern, are controlled from the wheelhouse using a controllable-pitch control unit. The controllable-pitch control was slightly offset such that, when the control lever was set at zero pitch, the vessel would make headway estimated at between 1 and 3 knots. The vessel was also equipped with a bow thruster.

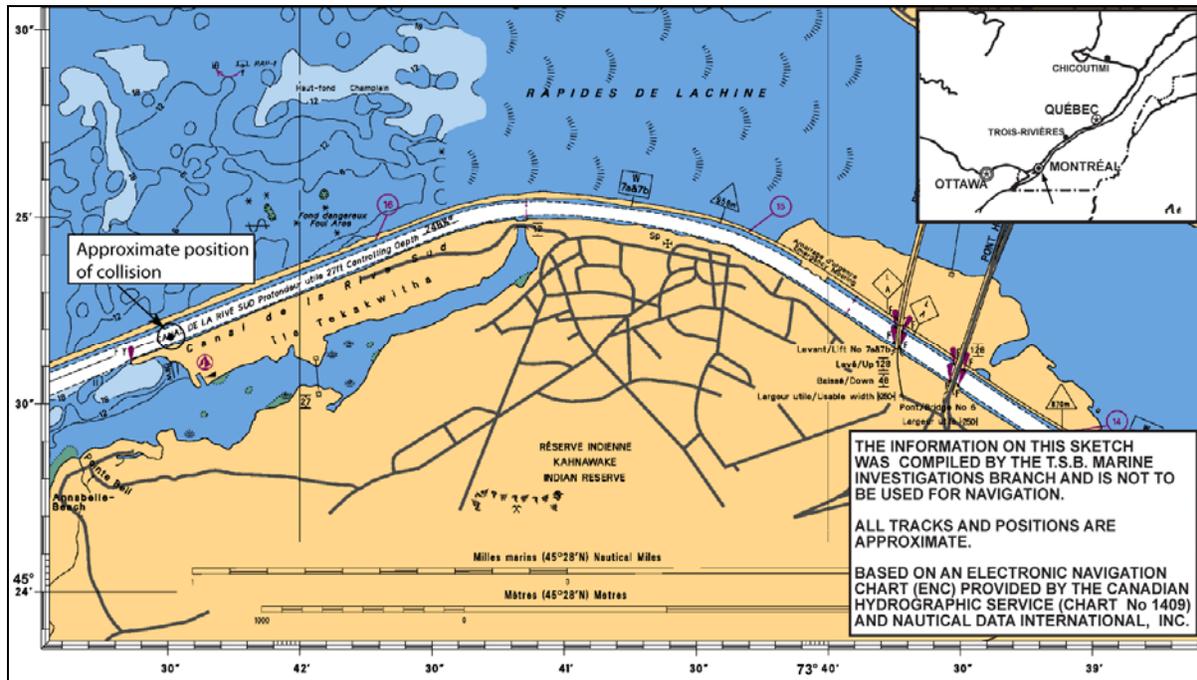
Figure 1. St. Lawrence Seaway: South Shore Canal of Kahnawake, Quebec

At about 2243, on a heading of 232° (G), the *Jo Spirit* made contact with the *Orla* in position latitude 45°24'43" N and longitude 073°42'21" W, approximately 0.51 nm upstream of Mile 16 of the South Shore Canal (see Figure 1).
