## **RAIL TRANSPORTATION SAFETY INVESTIGATION REPORT R17W0267**

### **EMPLOYEE FATALITY**

Canadian National Railway Company  
Remote control locomotive system  
Extra yard assignment Y1XS-01  
Melville, Saskatchewan  
22 December 2017

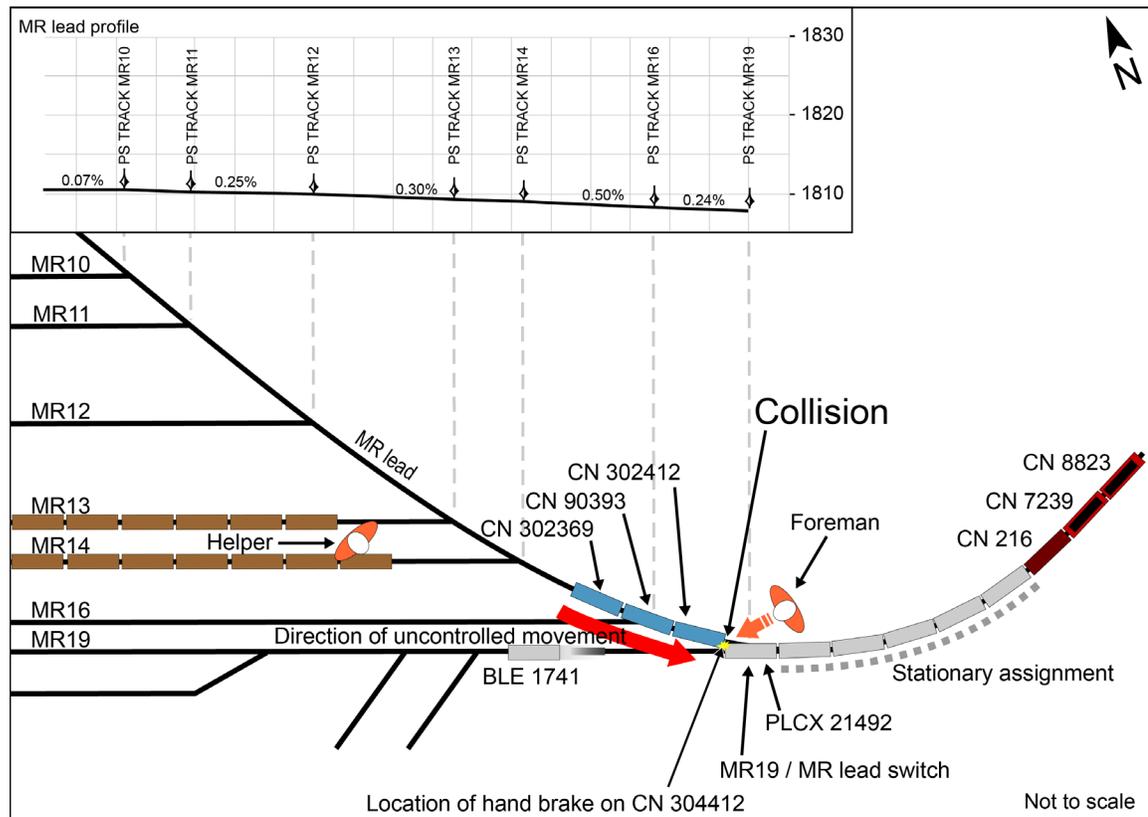
Yard work at Melville Yard was flat switching, primarily performed using RCLS. During switching operations, “kicking”<sup>6</sup> freight cars was a normal practice and was permitted throughout the yard. Access to the tracks from the east end of the yard was generally through the MR-lead track, which accessed tracks MR19 to MR10. The MR-lead track grade (east-to-west) ranged from 0.24% west of the MR19 switch to 0.50% between the MR16 and MR14 switches. The rest of the MR-lead track grade was generally undulating (Figure 2).

Figure 2. Diagram of the accident location in Melville Yard, with an inset diagram of the track profile showing the ascending westward grade (Source of main diagram: TSB. Source of inset diagram: Canadian National Railway)

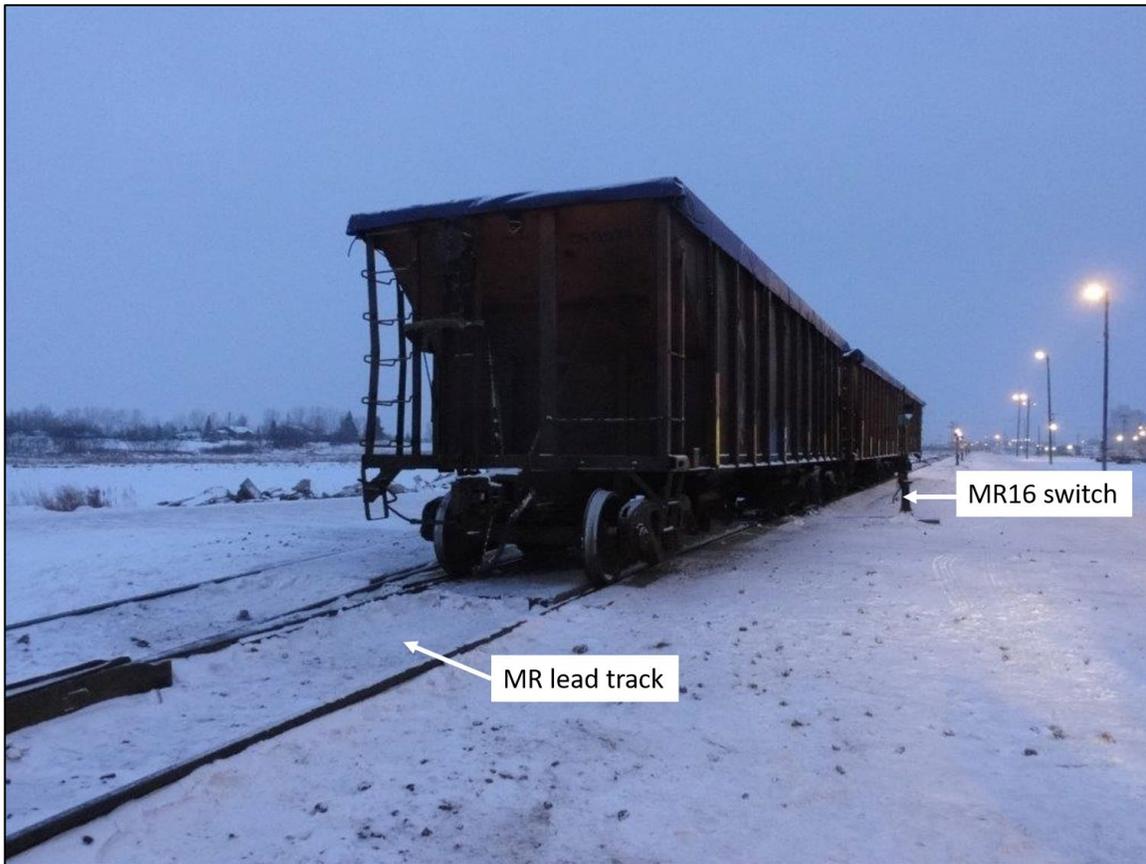
As the assignment came to a stop, with the uncoupling lever on CN 302412 lifted, the 3 open-top hopper cars (Figure 3) released and separated (and thus were kicked) from the assignment. Under their own momentum, the 3 cars travelled on the MR-lead track over the MR19 switch toward track MR13. The remainder of the assignment stopped east of the MR19 switch.

Figure 3. Occurrence open-top hopper cars staged on the MR lead track near the MR16 switch (Source: Canadian National Railway Company, with TSB annotations)

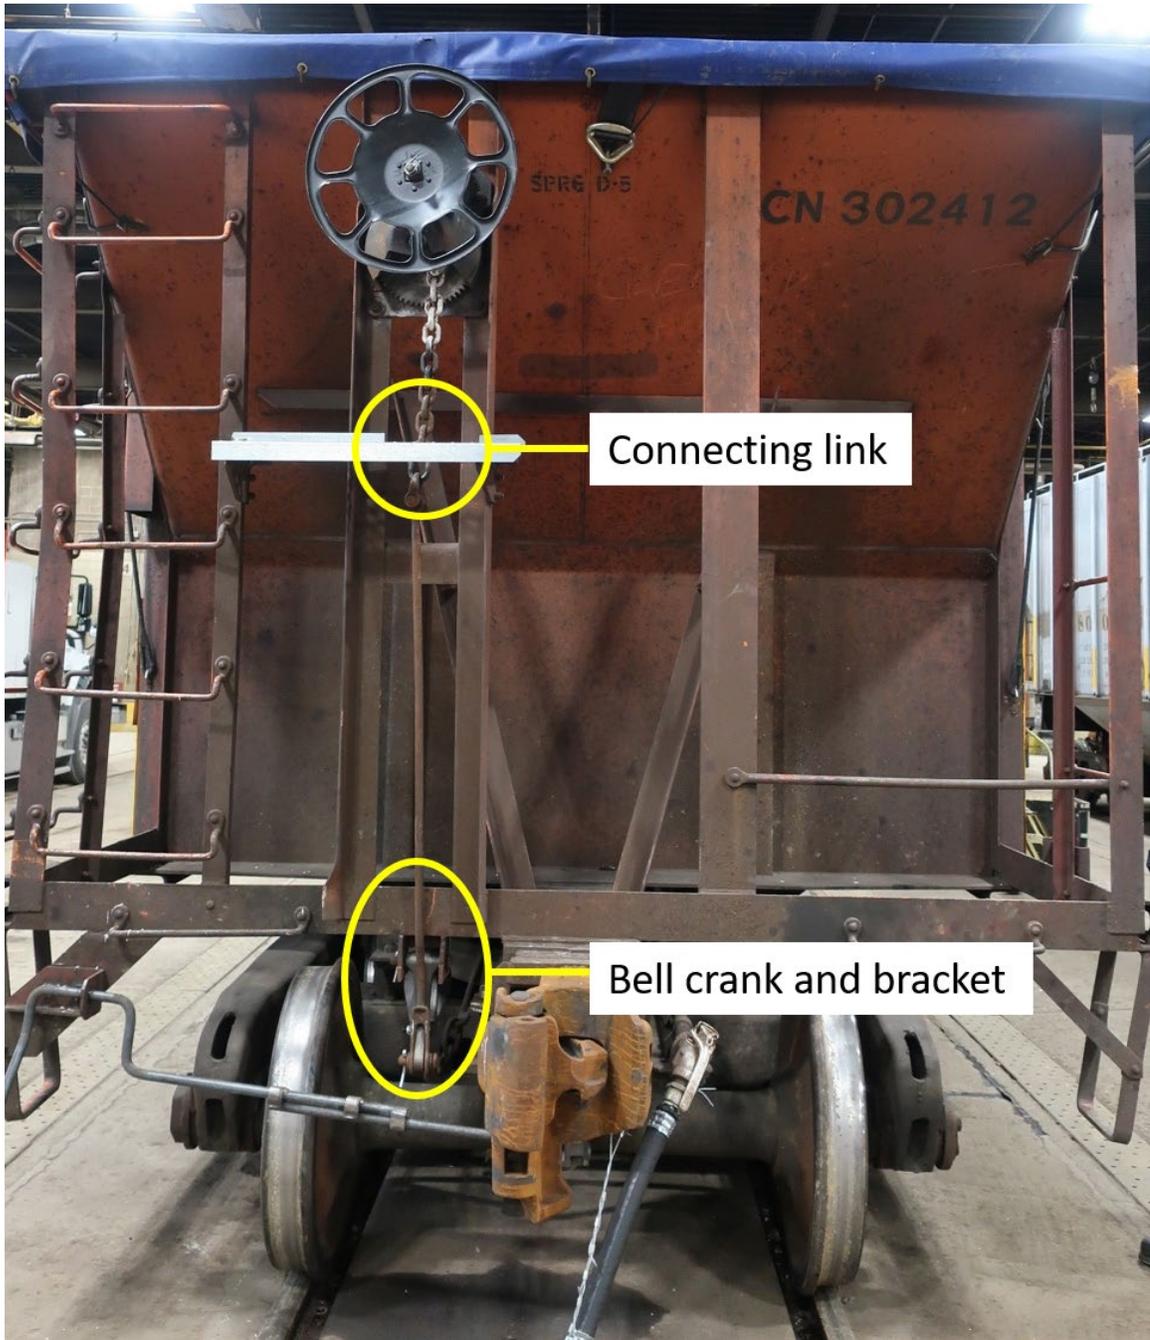
Figure 9. B end of CN 302412 in shop with no hand brake applied (Source: TSB)

On 25 January 2018, the TSB conducted hand-brake force testing on open-top hopper car CN 302412 at the Symington Yard car shop. In preparation for testing, the car was placed inside the car shop with no hand brake applied (Figure 9).

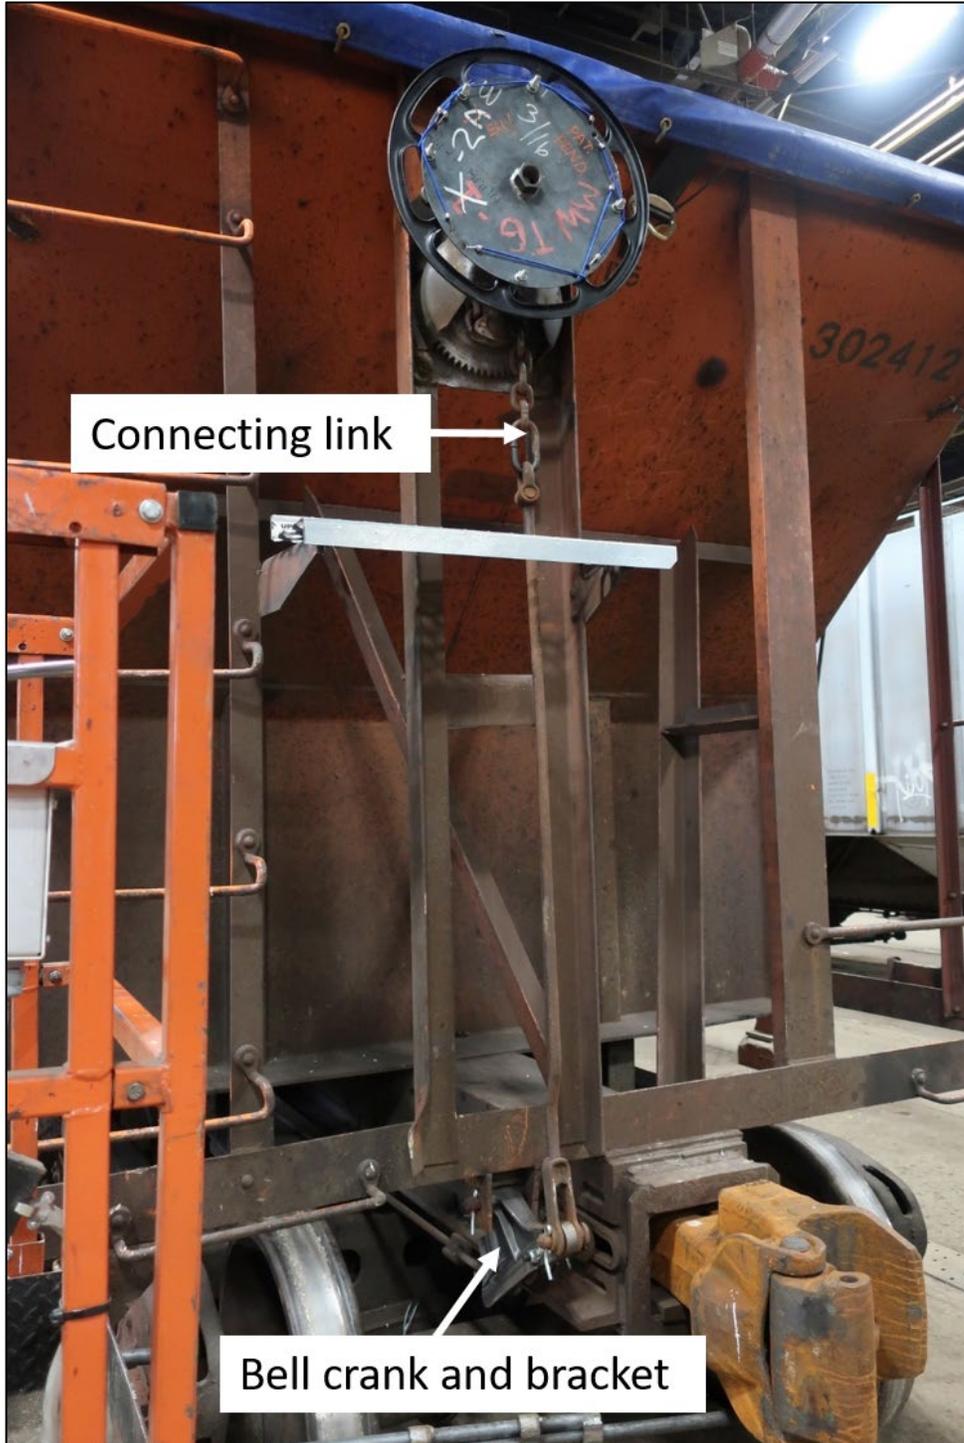
Figure 10. B end of CN 302412 in shop with hand brake applied (Source: TSB)

During testing, the hand brake (which had been repaired) was fully applied (Figure 10). The position of the hand brake components was recorded.

With the hand brake fully applied, the positions of the repaired hand brake components were compared to the position of the components following the accident, but before repairs (Figure 5). Before repairs, the large connecting chain link had pulled up close to the hand brake housing rather than remaining below the housing. In addition, the hand-brake connecting rod and bell crank were pulled tight against the end sill.

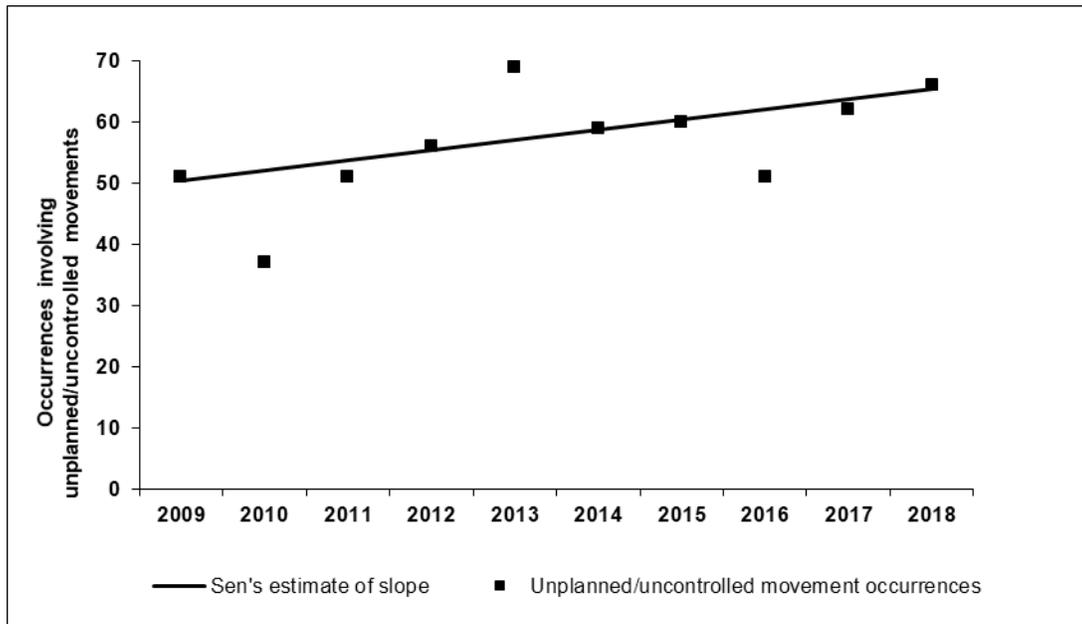
Kendall’s  $\tau_b$  correlation coefficient<sup>74</sup> was calculated on the overall number of uncontrolled movements by year from 2009 to 2018. There was a strong positive correlation indicating an upward trend in occurrences involving unplanned/uncontrolled movements overall ( $\tau_b = 0.5521, p = 0.0293$ ). Based on Sen’s estimate of slope,<sup>75</sup> the average increase per year for all categories was 1.67 occurrences per year (Figure 17).

Figure 17. Average increase per year of occurrences involving unplanned/uncontrolled movements, 2009 to 2018

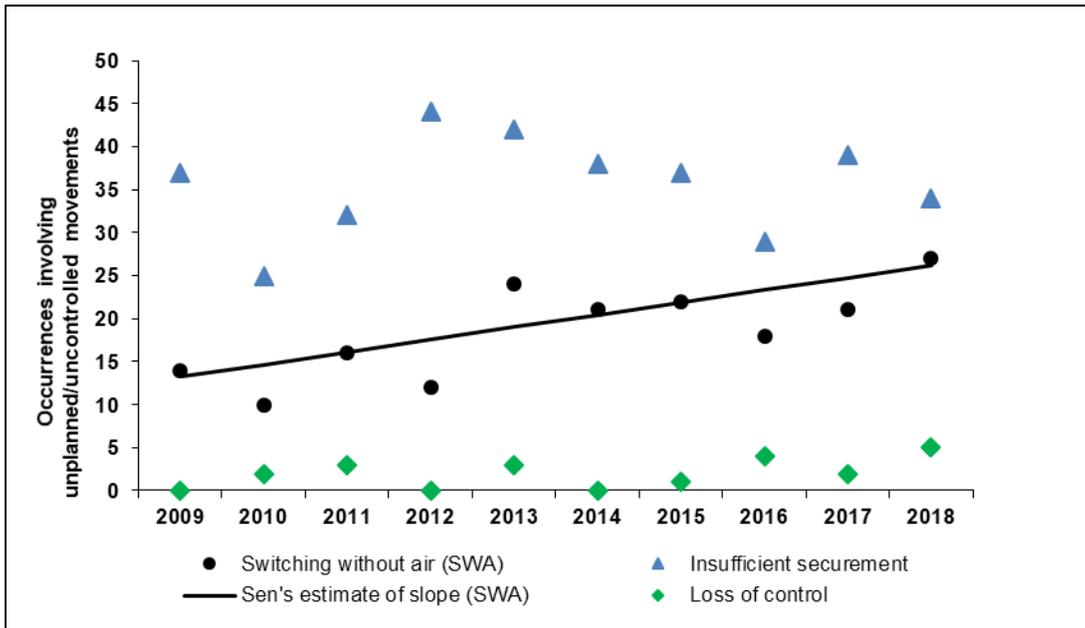
Kendall's  $\tau_b$  correlation coefficient was then calculated on the 3 categories (see Table 2) by year from 2009 to 2018. Of the 3 categories, only switching without air showed a significant increase over the period. There was a strong positive correlation indicating an upward trend in occurrences involving unplanned/uncontrolled movements that occurred while switching without air. Based on Sen's estimate of slope, the average increase per year was 1.44 occurrences per year (Figure 18). These estimates indicate that 86% of the 10-year annual increase in overall occurrences involving unplanned/uncontrolled movements was associated with switching without air.

Figure 18. Occurrences involving unplanned/uncontrolled occurrences by causal category
